# UPPER, MIDDLE, AND LOWER POTOMAC RIVER

## WATERSHED ASSESSMENT

MAY | 2018

KCI TECHNOLOGIES, INC.  
936 RIDGEBROOK ROAD  
SPARKS, MD 21152

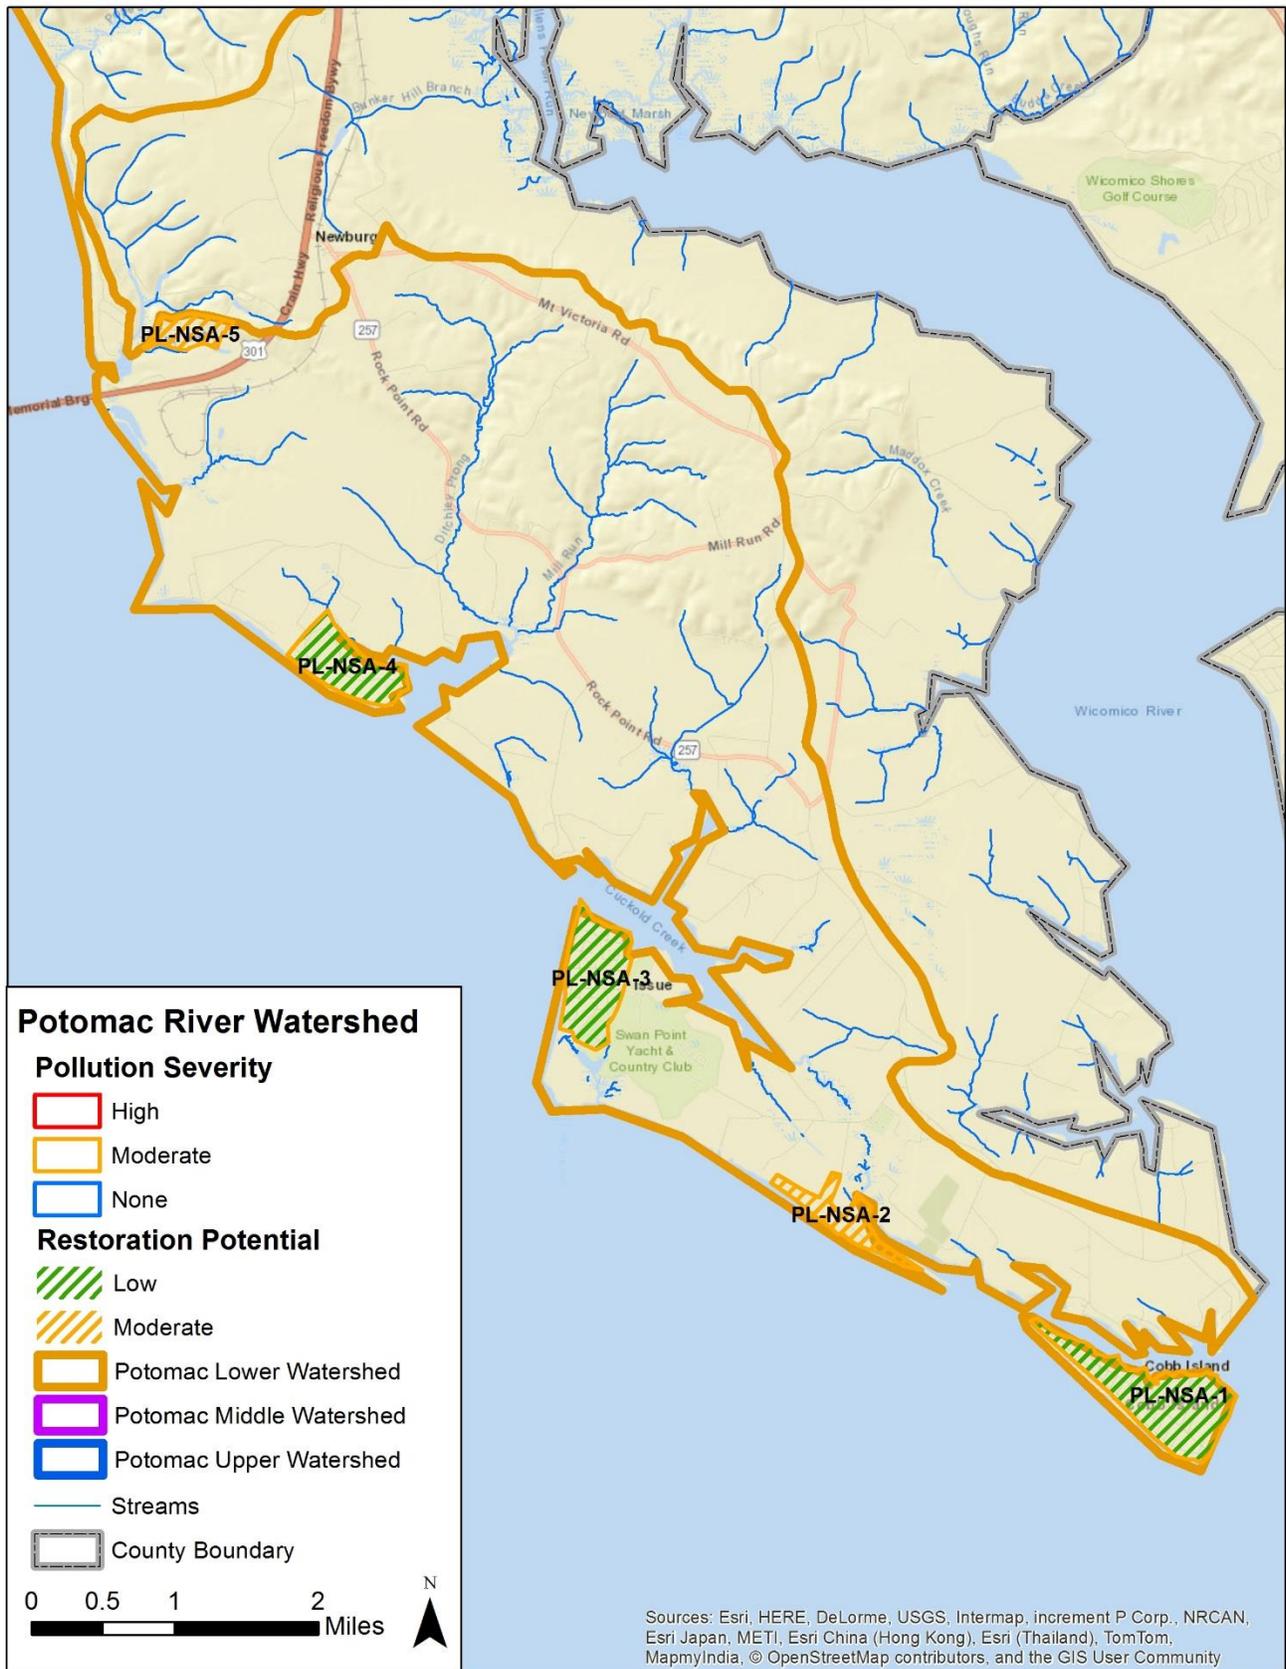
FIGURE 3: NEIGHBORHOOD SOURCE ASSESSMENT RESULTS, SOUTHERN PORTION

A total of twelve neighborhoods were assessed in the Potomac River watershed (Figure 3). General characteristics of each neighborhood are presented in Table 4. A complete record of NSA data is included in Appendix A.

The neighborhoods in these watershed are generally very rural and spread out. All of the twelve neighborhoods assessed received a 'moderate' pollution severity rating. Potential pollution types included nutrient and bacteria (Table 5).

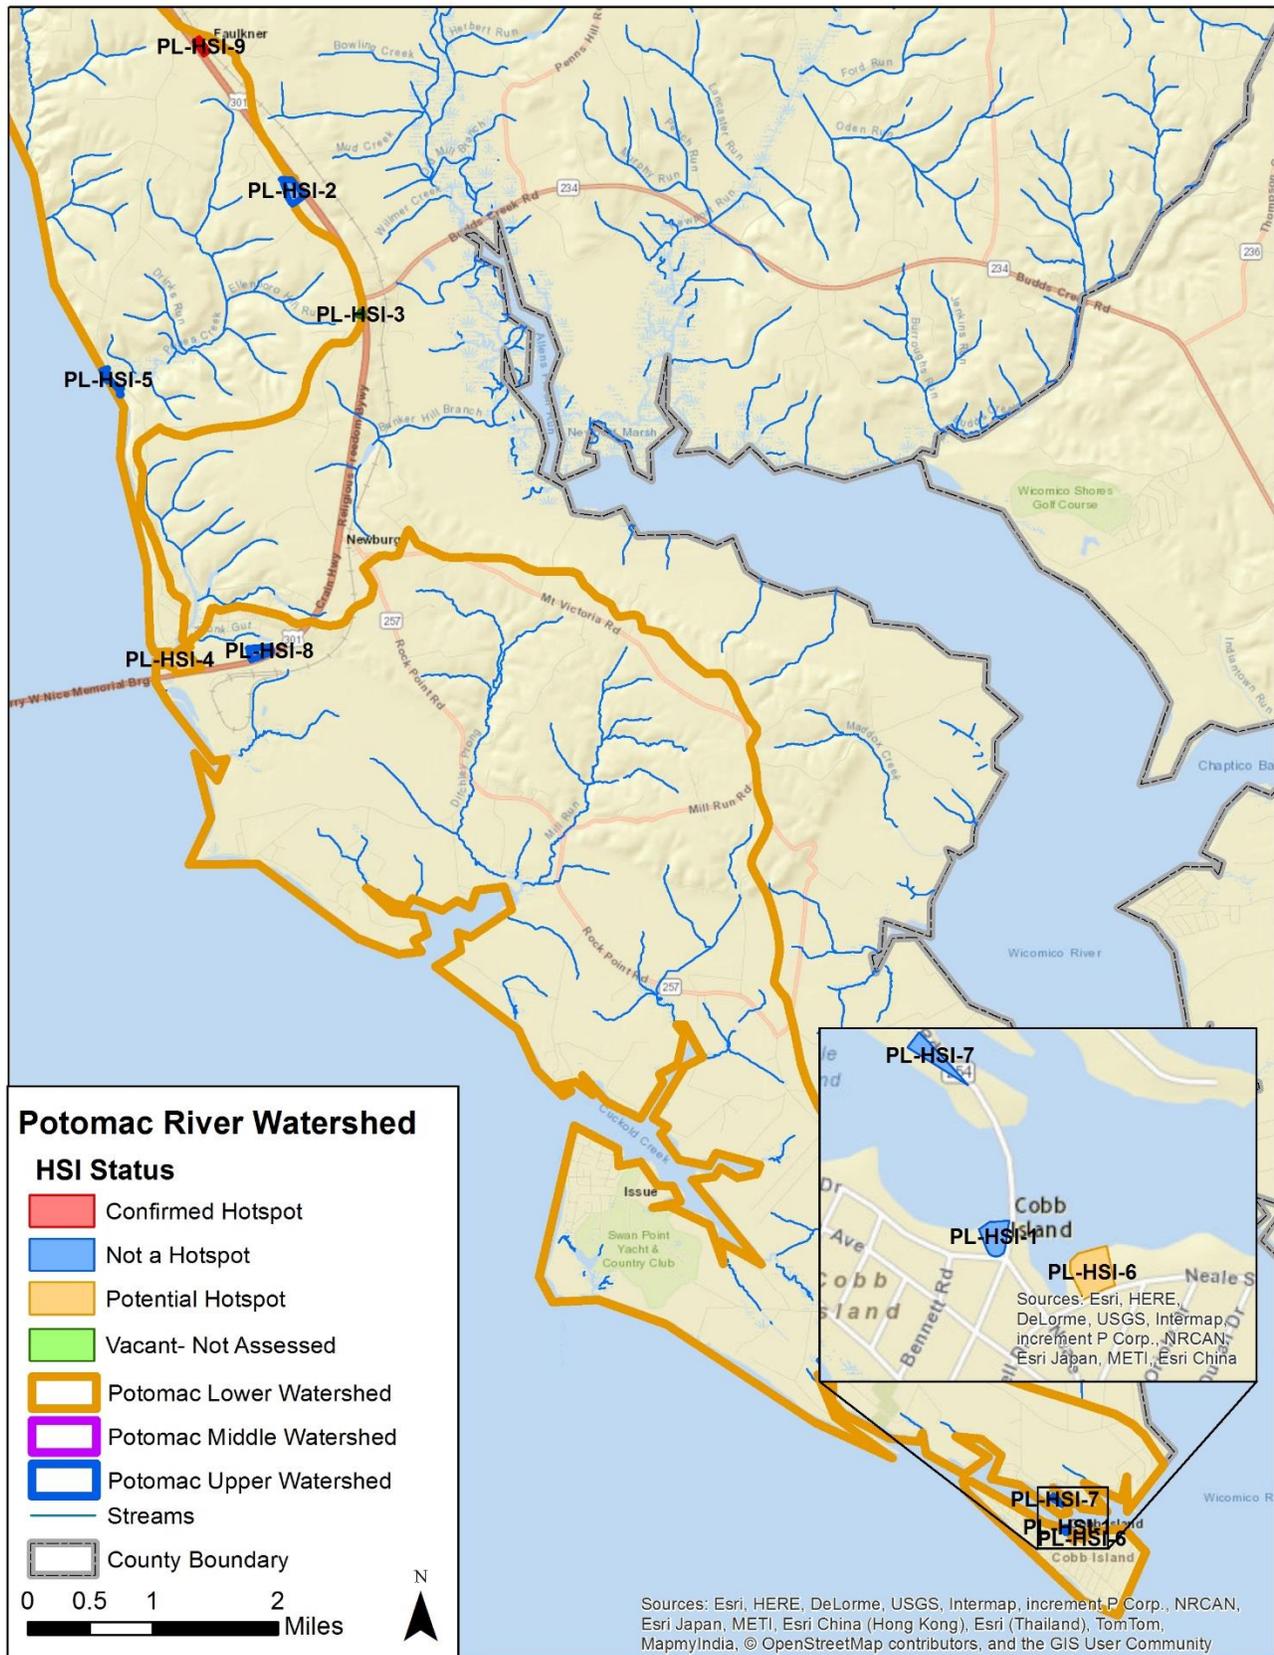
FIGURE 5: HOT SPOT INVESTIGATION RESULTS, SOUTHERN PORTION

A total of nine sites were investigated in the Potomac Lower watershed and three sites were investigated in the Potomac Middle watershed (Figure 5). No potential hotspot sites were identified in the Potomac Upper watershed. The location, general description, and common operations (i.e., vehicle operations, outdoor materials, waste management, physical plant, turf/landscaping) of each site investigated are presented in Table 6. A complete record of HSI data is included in Appendix B.

Of the twelve sites investigated, only one (PL-HSI-9) site's scoring results designated it as 'confirmed' as having potential for discharging pollutants into stormwater runoff (Table 6), however no serious pollution sources were observed during the site investigation and impervious surfaces at the site were being treated by a infiltration facility at the rear of the property. A total of two locations were designated as 'potential' hotspots, while the remaining seven sites were 'not a hotspot'. Two sites (PL-HSI-3 and PM-HSI-1) were not assessed because they were vacant. It was recommended that five sites be revisited during the stormwater BMP Retrofit Reconnaissance Investigation (RRI) to analyze the site in more detail for BMP opportunities. Specific recommendations for each site can be found in Table 6.

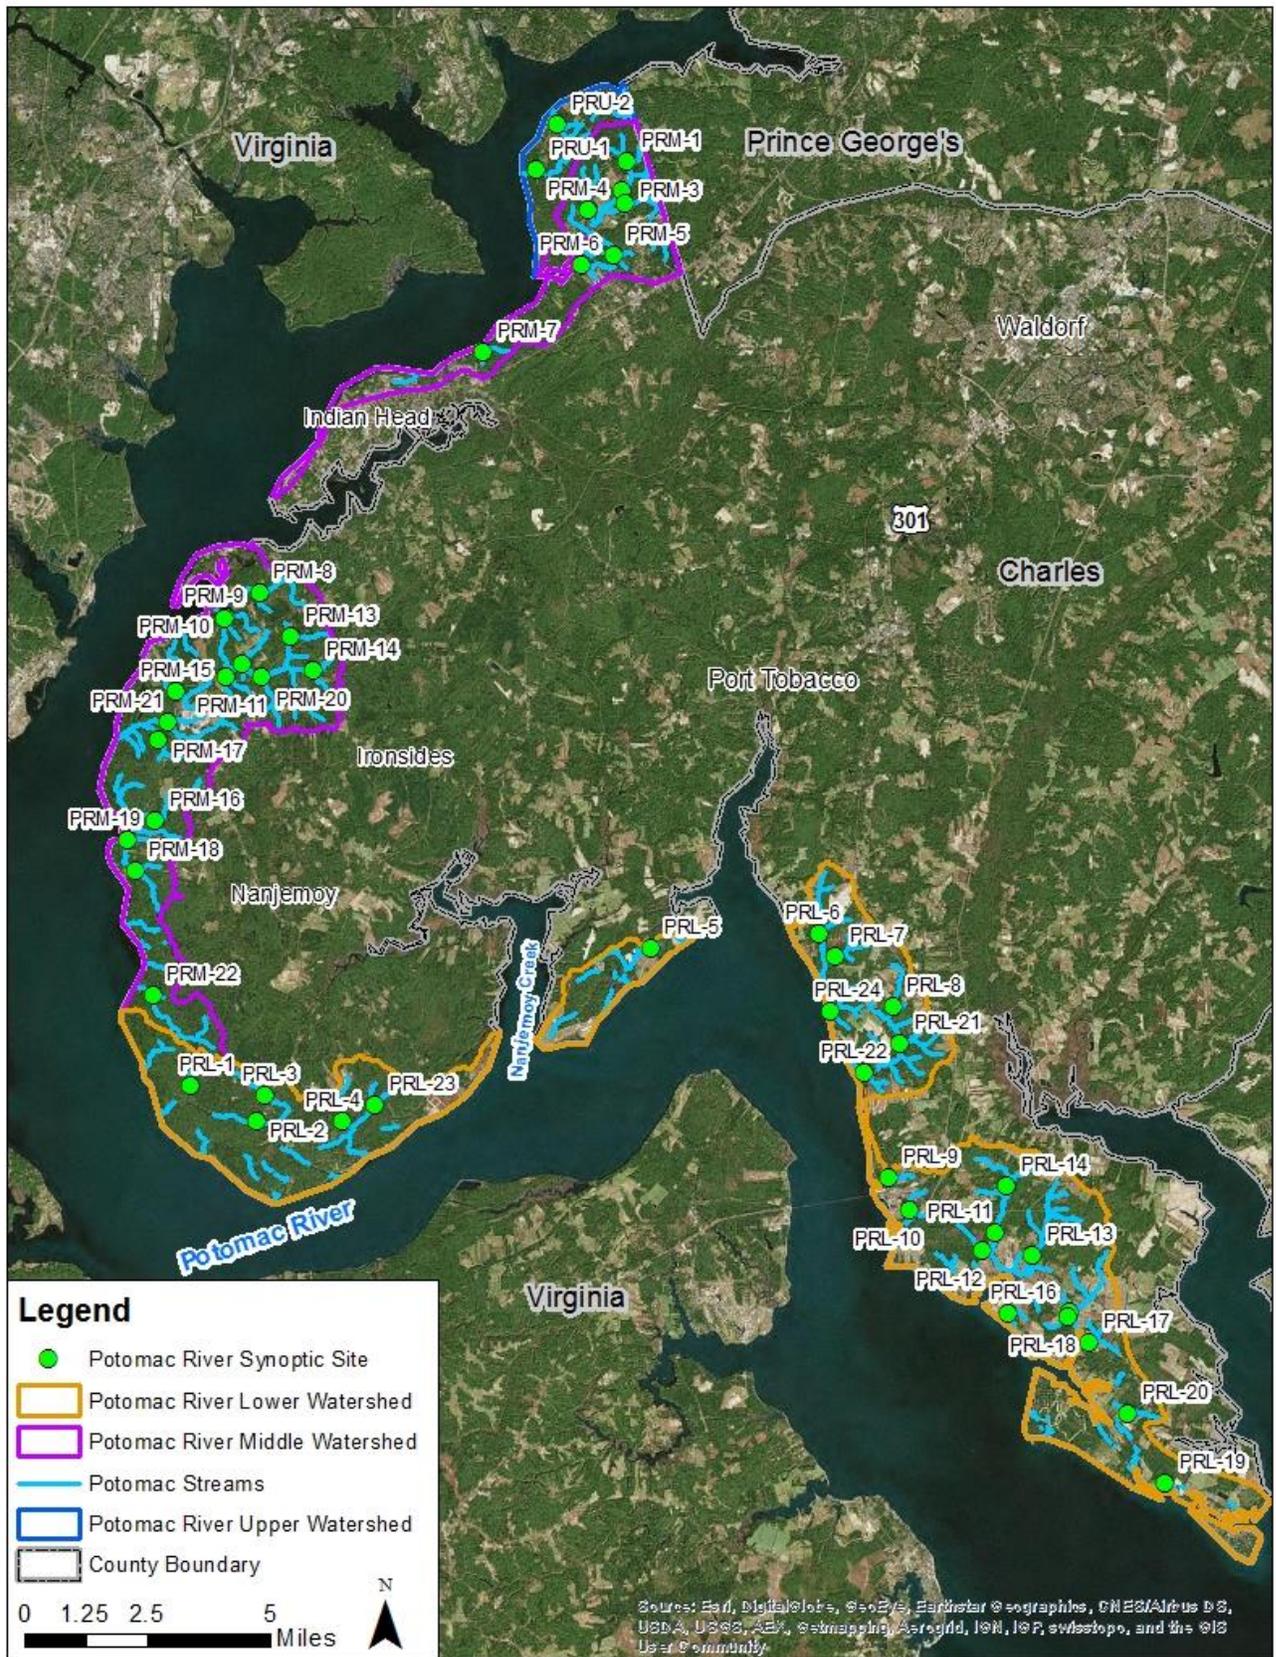
FIGURE 7: SYNOPTIC WATER QUALITY SURVEY SAMPLING LOCATIONS

Synoptic water quality sampling was performed across the Potomac River watershed from March 6-16, 2017. A total of 48 sites were visited (Figure 7) for water quality and discharge measurements; however, 14 sites were either dry, too large and deep (> 100' wide), a pond, or within a swamp/wetland with no visible flow or channel and therefore no samples could be collected for water quality analysis. All sites selected for synoptic sampling are shown in Figure 7.

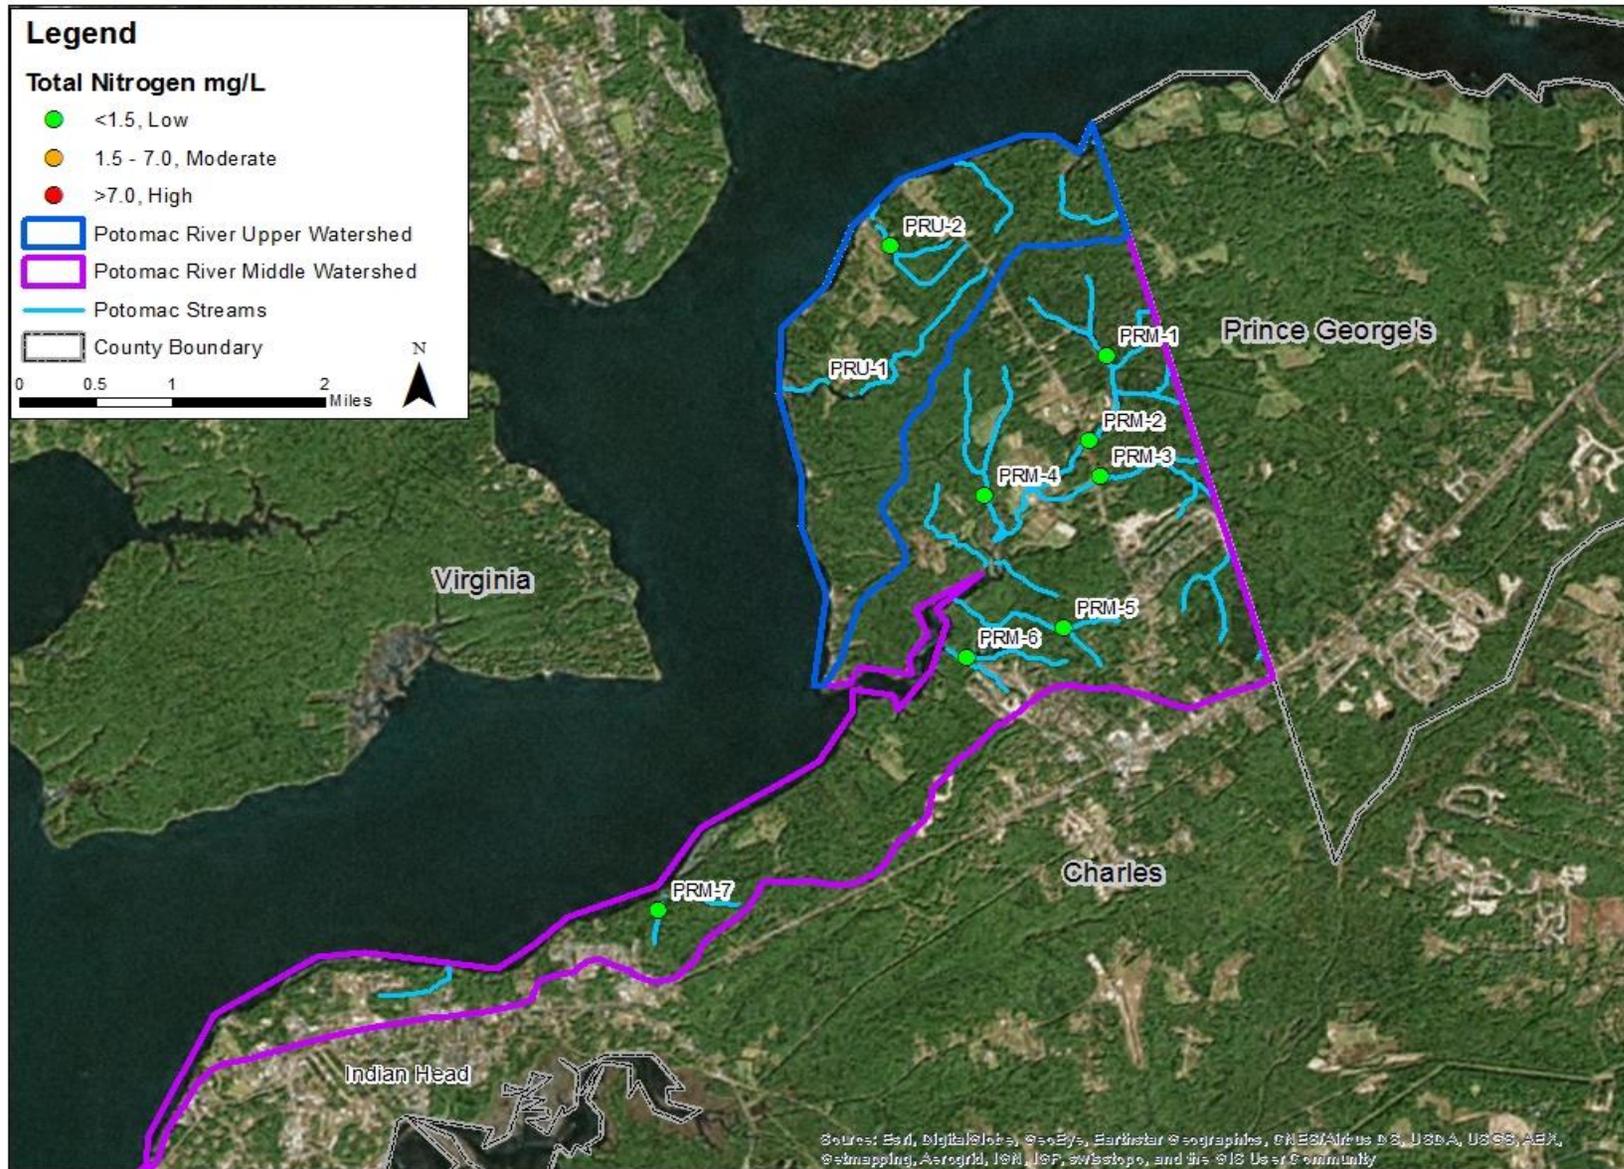
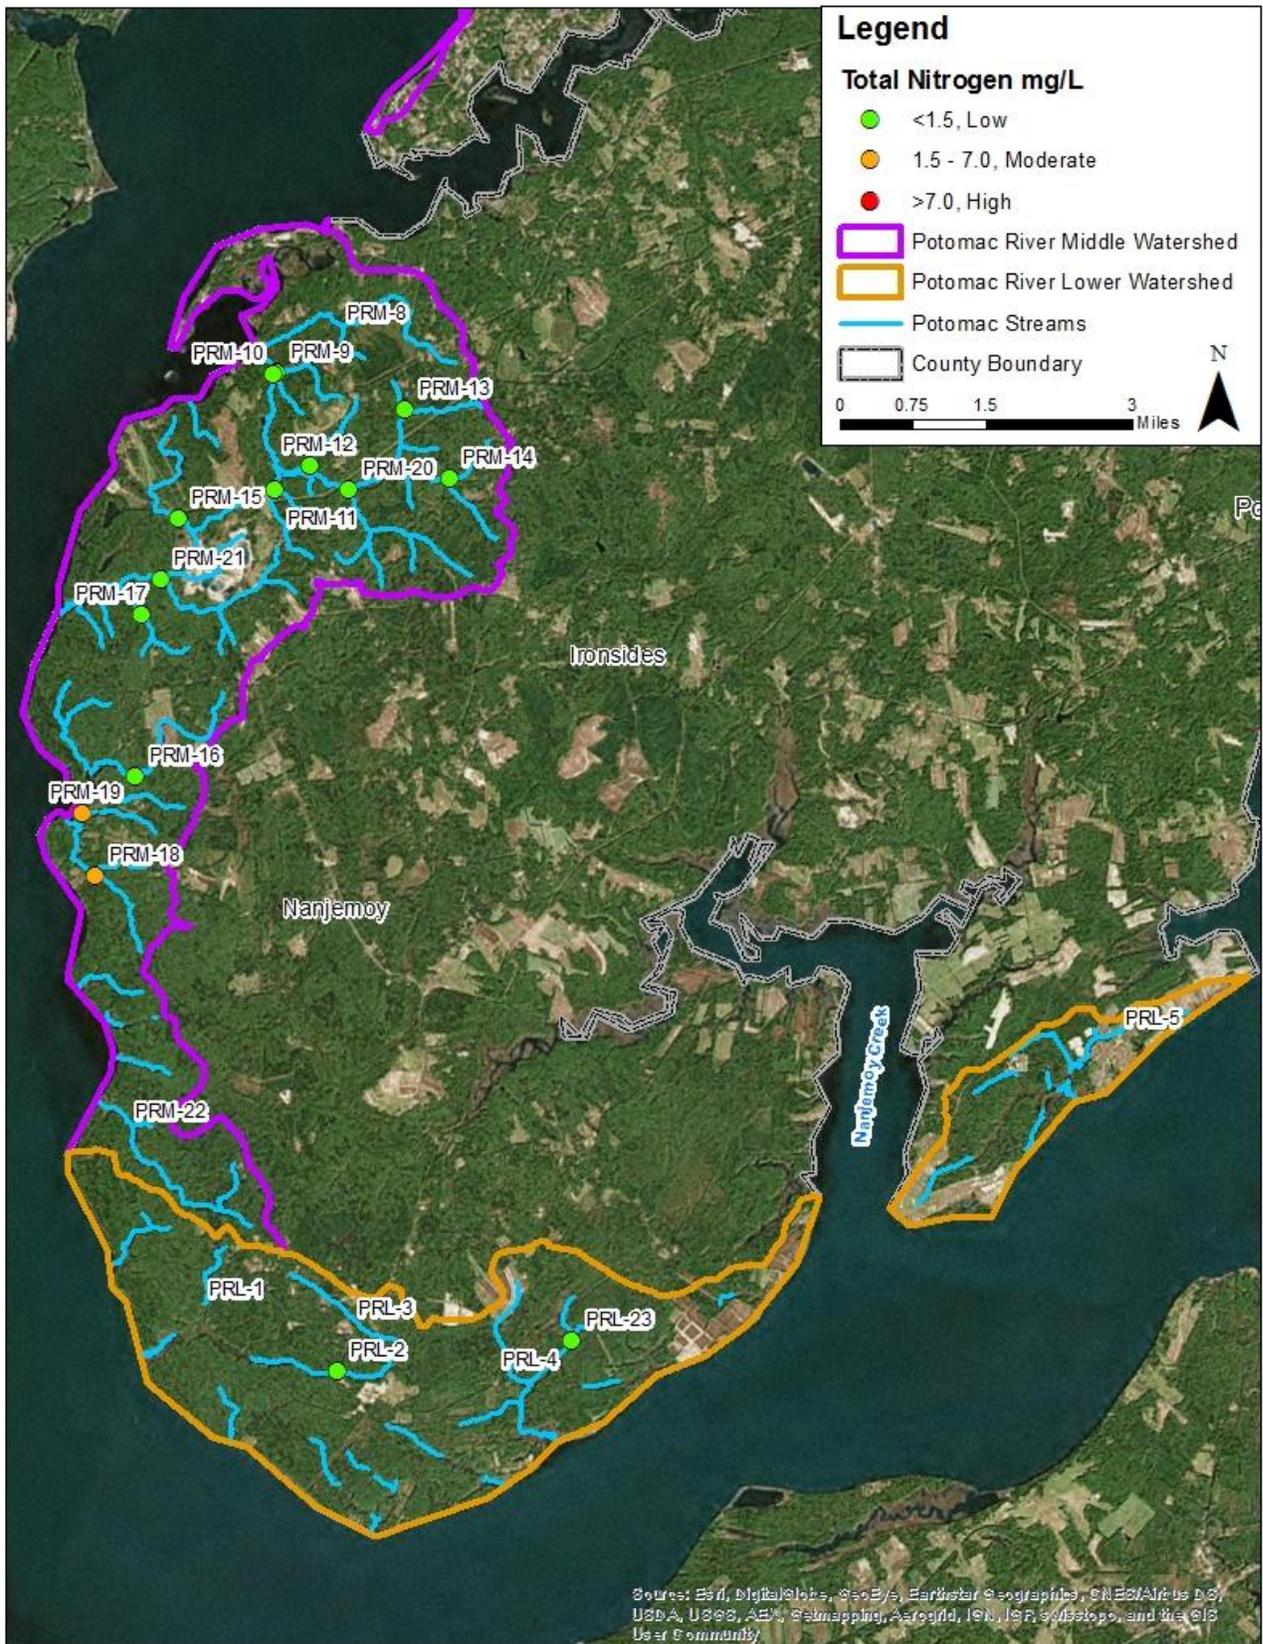
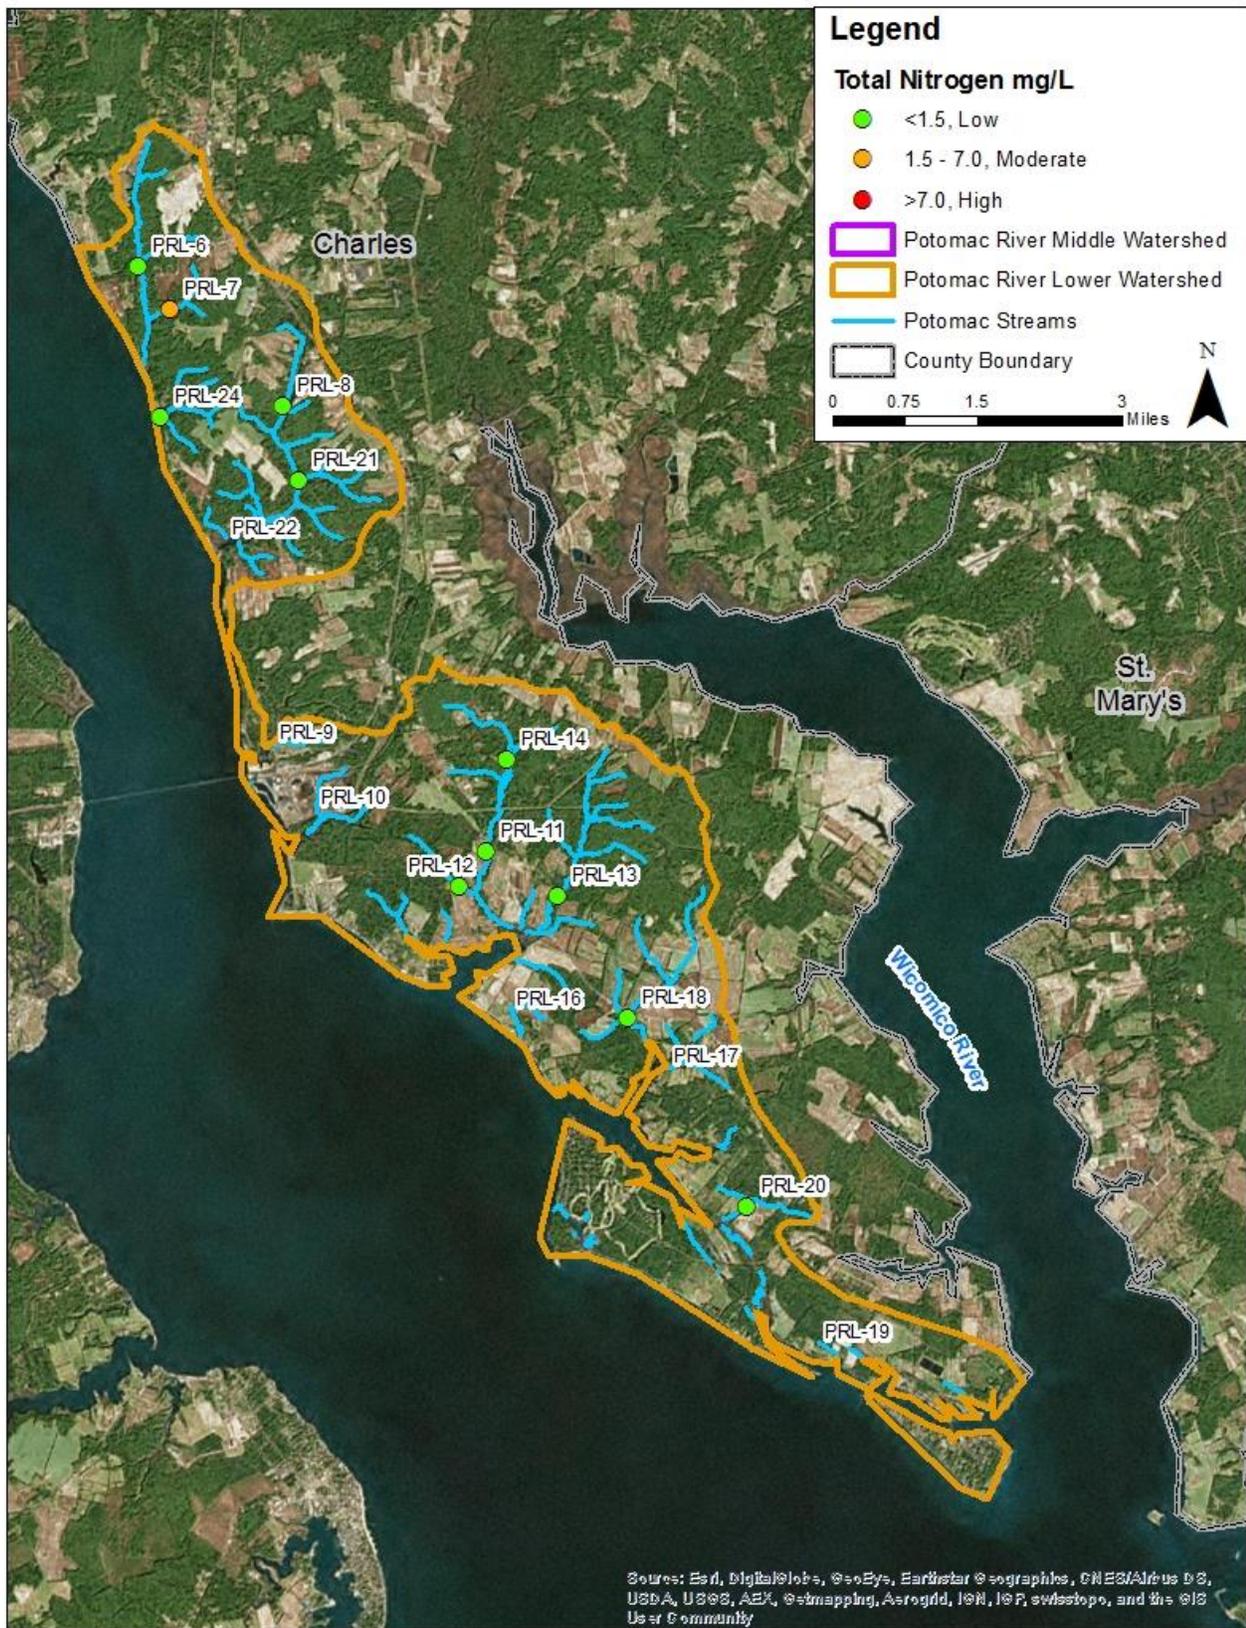
FIGURE 8: SYNOPTIC WATER QUALITY SURVEY SAMPLING RESULTS: TOTAL NITROGEN CONCENTRATION POTOMAC UPPER AND MIDDLE

FIGURE 9: SYNOPTIC WATER QUALITY SURVEY SAMPLING RESULTS: TOTAL NITROGEN CONCENTRATION POTOMAC MIDDLE AND LOWER

FIGURE 10: SYNOPTIC WATER QUALITY SURVEY SAMPLING RESULTS: TOTAL NITROGEN CONCENTRATION POTOMAC LOWER

Total nitrogen concentrations were low in Potomac Upper. Two sites had moderate concentrations in the Potomac Middle while only one site was moderate in Potomac Lower. (Figure 8, Figure 9, Figure 10 and Table 10). Within the Potomac Upper, all nitrate/nitrite concentrations were low. One site had moderate concentrations in the Potomac Middle and two sites had moderated levels within two subwatersheds of the Potomac Lower. Baseline conditions were found in the remaining sites (Figure 11, Figure 12, and Table 10). In the Potomac Upper, instantaneous nitrate/nitrite loads were low at all sites. In the Potomac Middle, one site had excessive loads, one site had high loads and three sites had moderate loads. Within the Potomac Lower, only one site had moderate load of nitrate/nitrite while the rest of sites were found to be low (Figure 11, Figure 12, and Table 10). Total phosphorus concentrations in the Potomac Upper were low at all sites. In the Potomac Middle, six sites within two subwatersheds had high concentrations, one site was moderate and the others were low. In the Potomac Lower, six sites had high concentrations in three subwatersheds, five sites were moderate within three subwatersheds and the remaining were low (Figure 14, Figure 15, Figure 16 and Table 10). Within the Potomac Upper, only one site had moderate concentrations of orthophosphate, while in the Potomac Middle, one site was found to be excessive, one site was high and 17 were found to have moderate concentrations. In the Potomac Lower, a total of ten sites had excessive concentrations of orthophosphate within three subwatersheds and three more sites were found to have moderate concentrations (Figure 17, Figure 18, Figure 19 and Table 10). High concentrations were found at one site. Moderate concentrations were found at 30 sites within 12 subwatersheds, however half the detection limit for orthophosphate (0.005) falls between the baseline and moderate ratings, therefore the 31 sites that were below the detection limit should be considered to have baseline levels. Instantaneous orthophosphate loads show no elevated sites within the Potomac Upper, two sites with excessive loads, one with high and four with moderate loads within the Potomac Middle. The Potomac Lower did not have any elevated orthophosphate loads (Figure 17, Figure 18, Figure 19 and Table 10).

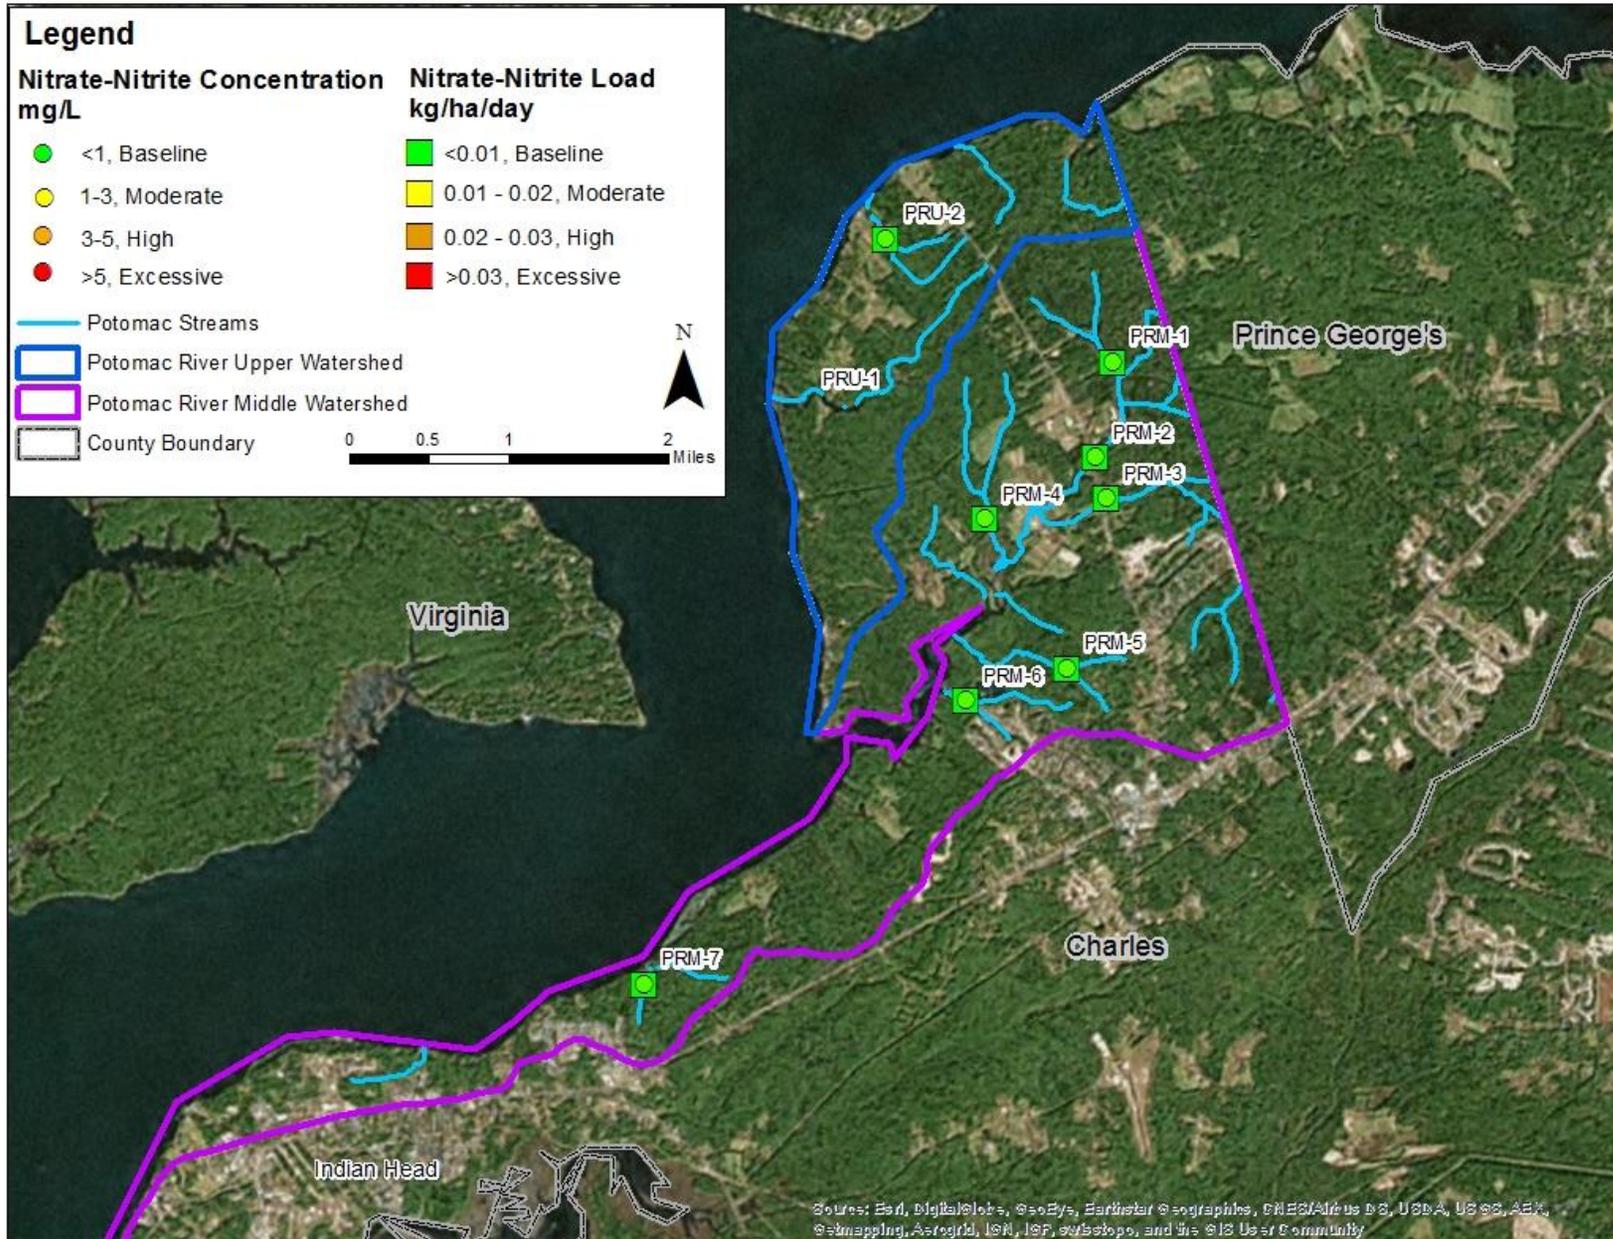
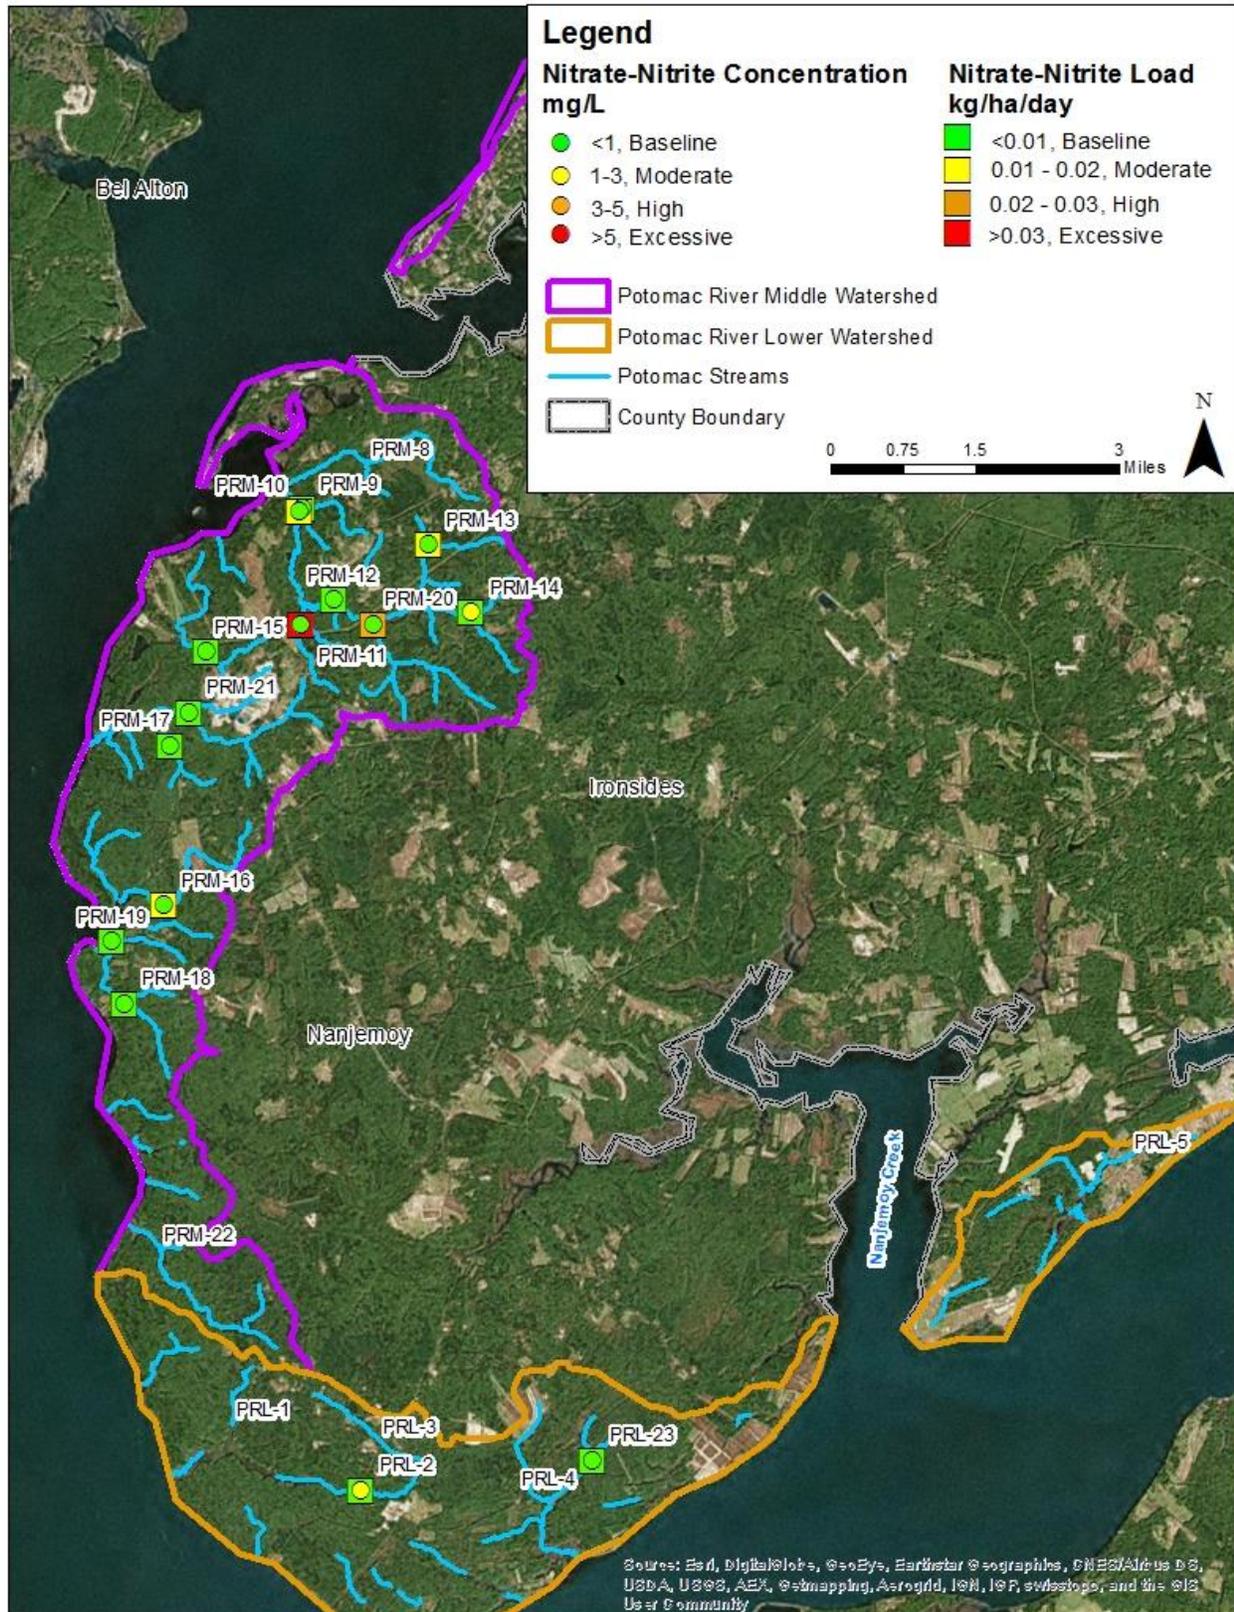
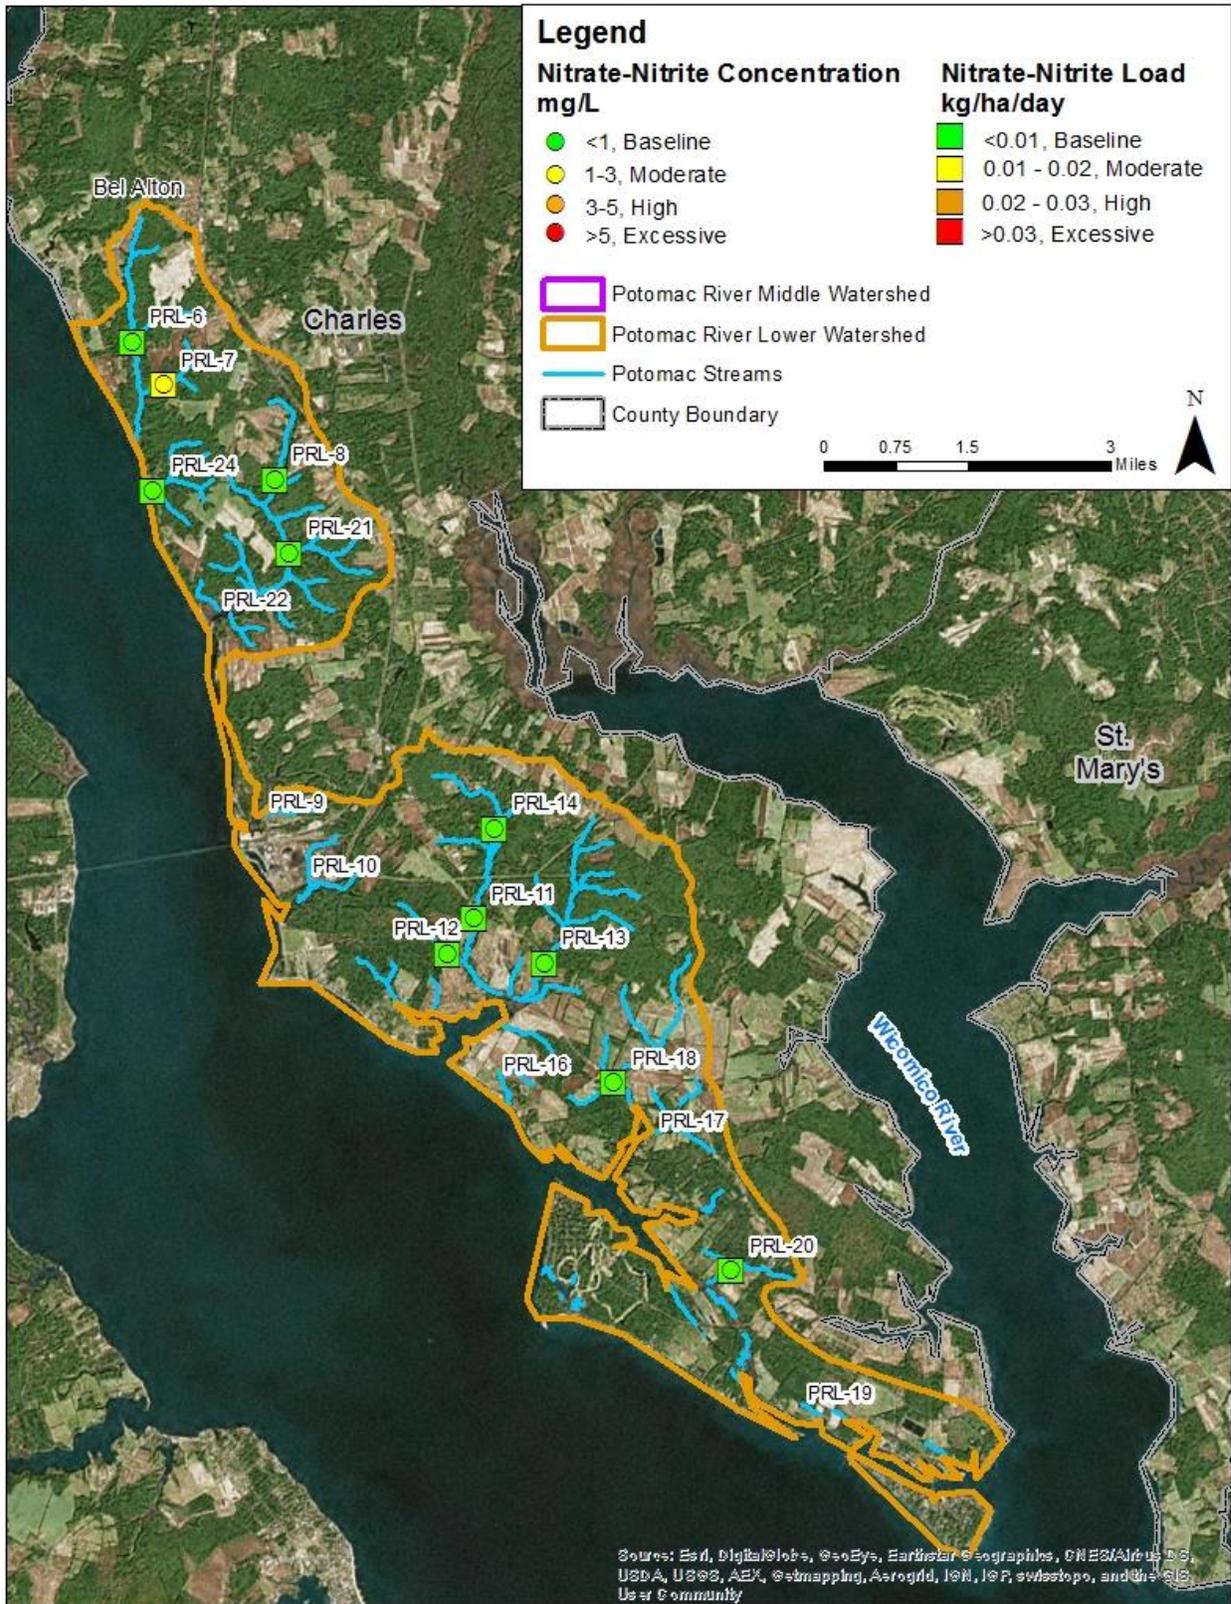
FIGURE 11: SYNOPTIC WATER QUALITY SURVEY SAMPLING RESULTS: NITRATE-NITRITE CONCENTRATION AND LOAD: POTOMAC UPPER AND MIDDLE

FIGURE 12: SYNOPTIC WATER QUALITY SURVEY SAMPLING RESULTS: NITRATE-NITRITE CONCENTRATION AND LOAD: POTOMAC MIDDLE AND LOWER

FIGURE 13: SYNOPTIC WATER QUALITY SURVEY SAMPLING RESULTS: NITRATE-NITRITE CONCENTRATION AND LOAD: POTOMAC LOWER
