# UPPER, MIDDLE, AND LOWER POTOMAC RIVER

## WATERSHED ASSESSMENT

MAY | 2018

KCI TECHNOLOGIES, INC.  
936 RIDGEBROOK ROAD  
SPARKS, MD 21152

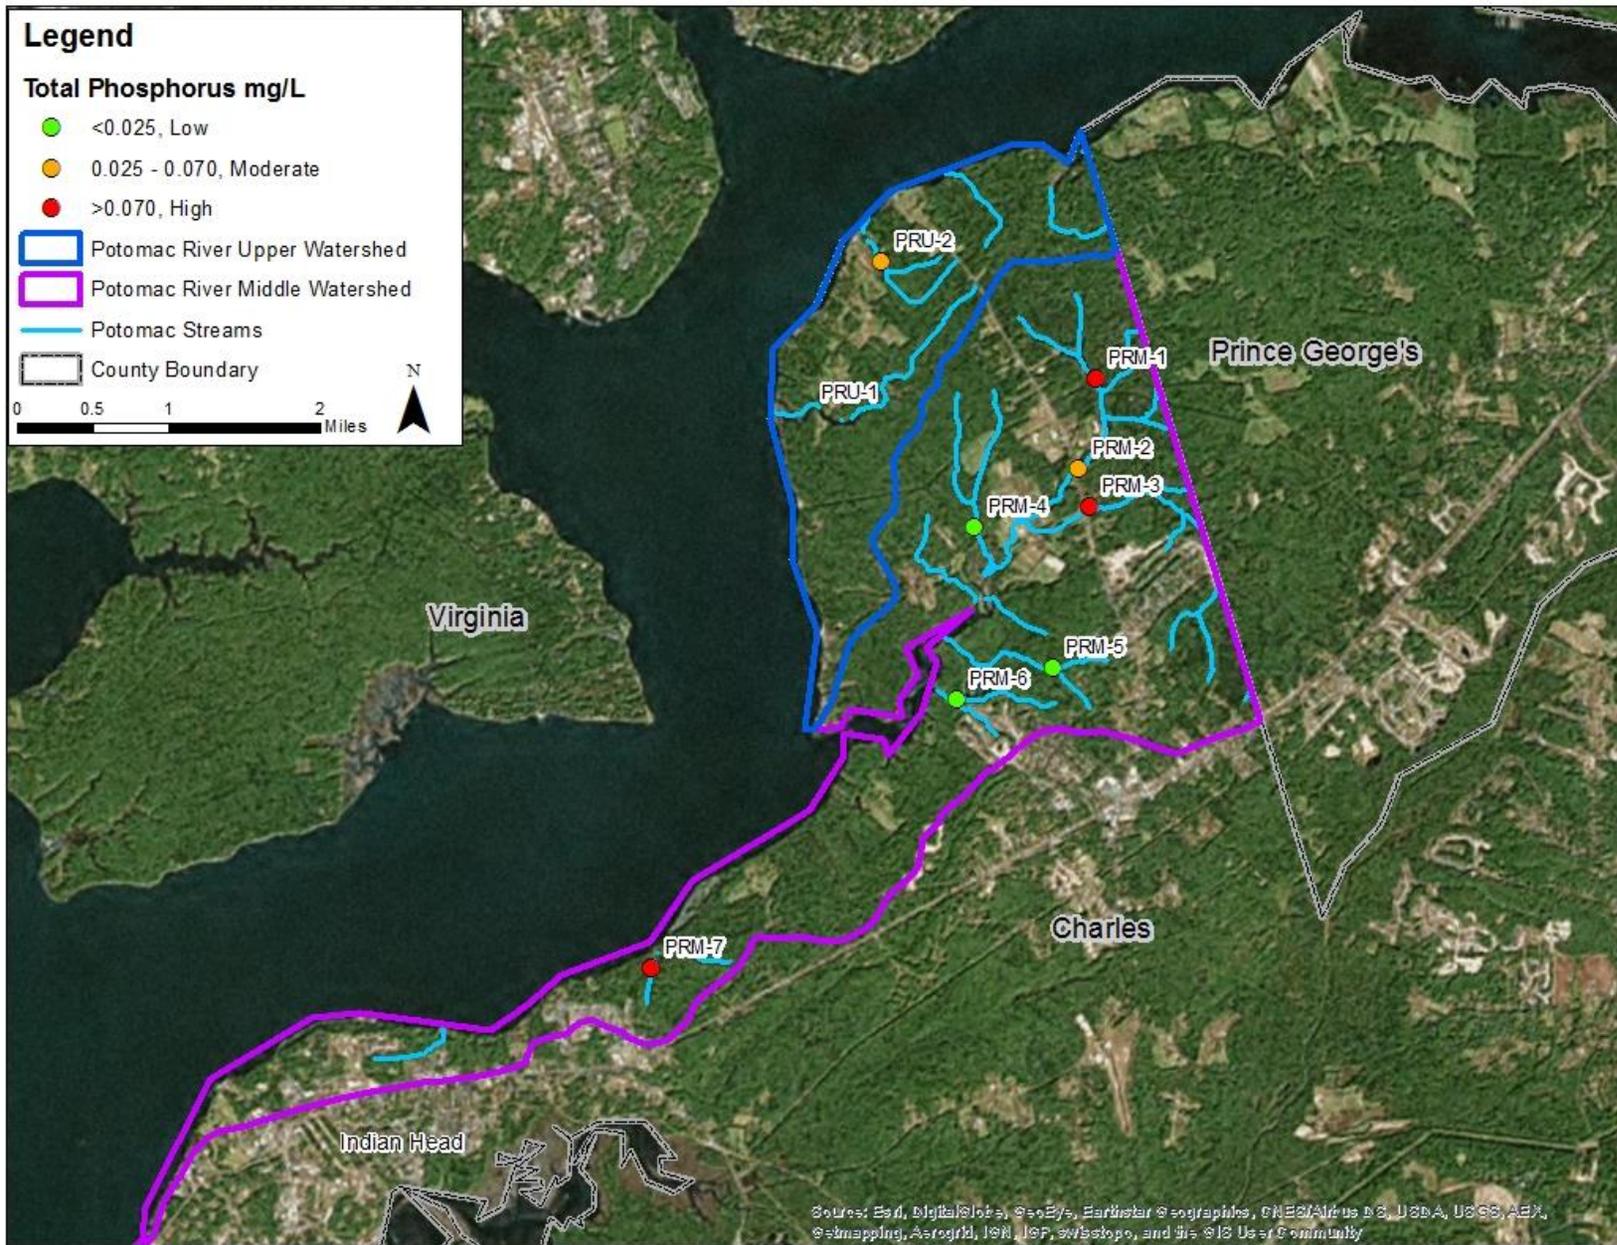
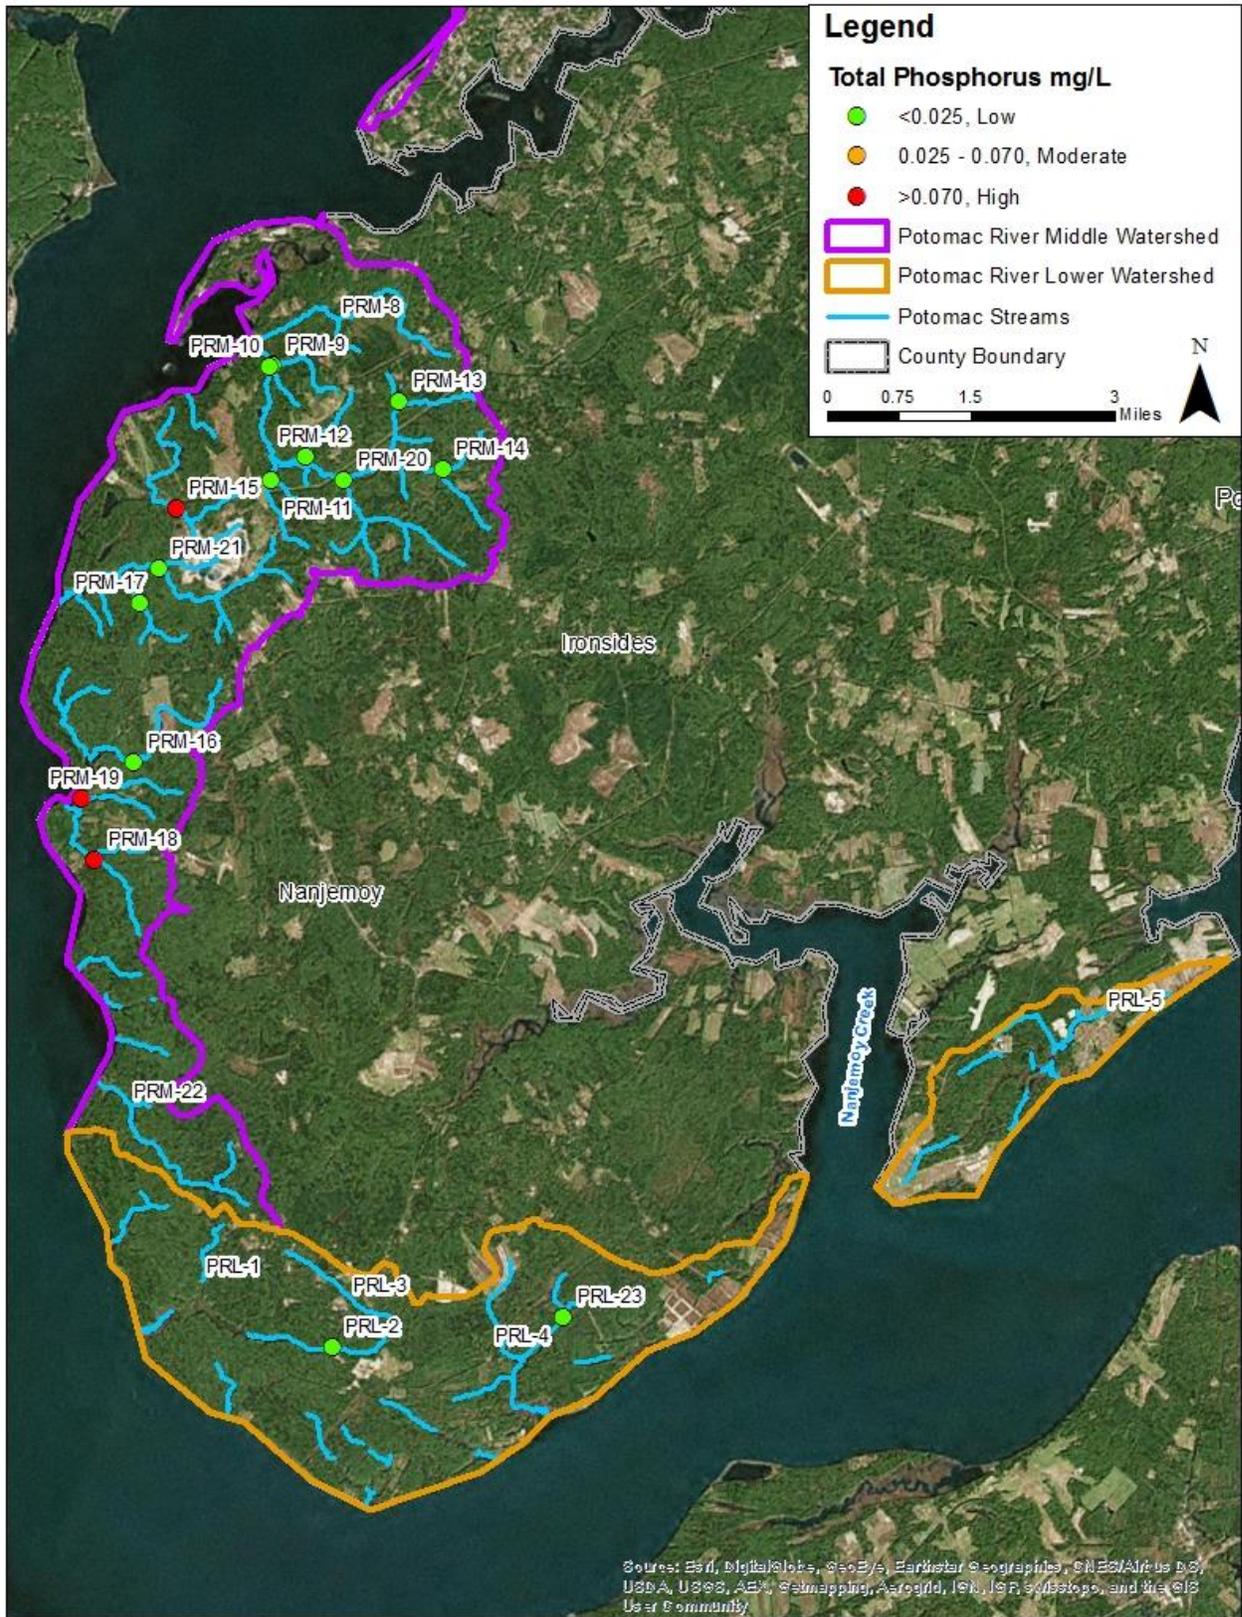
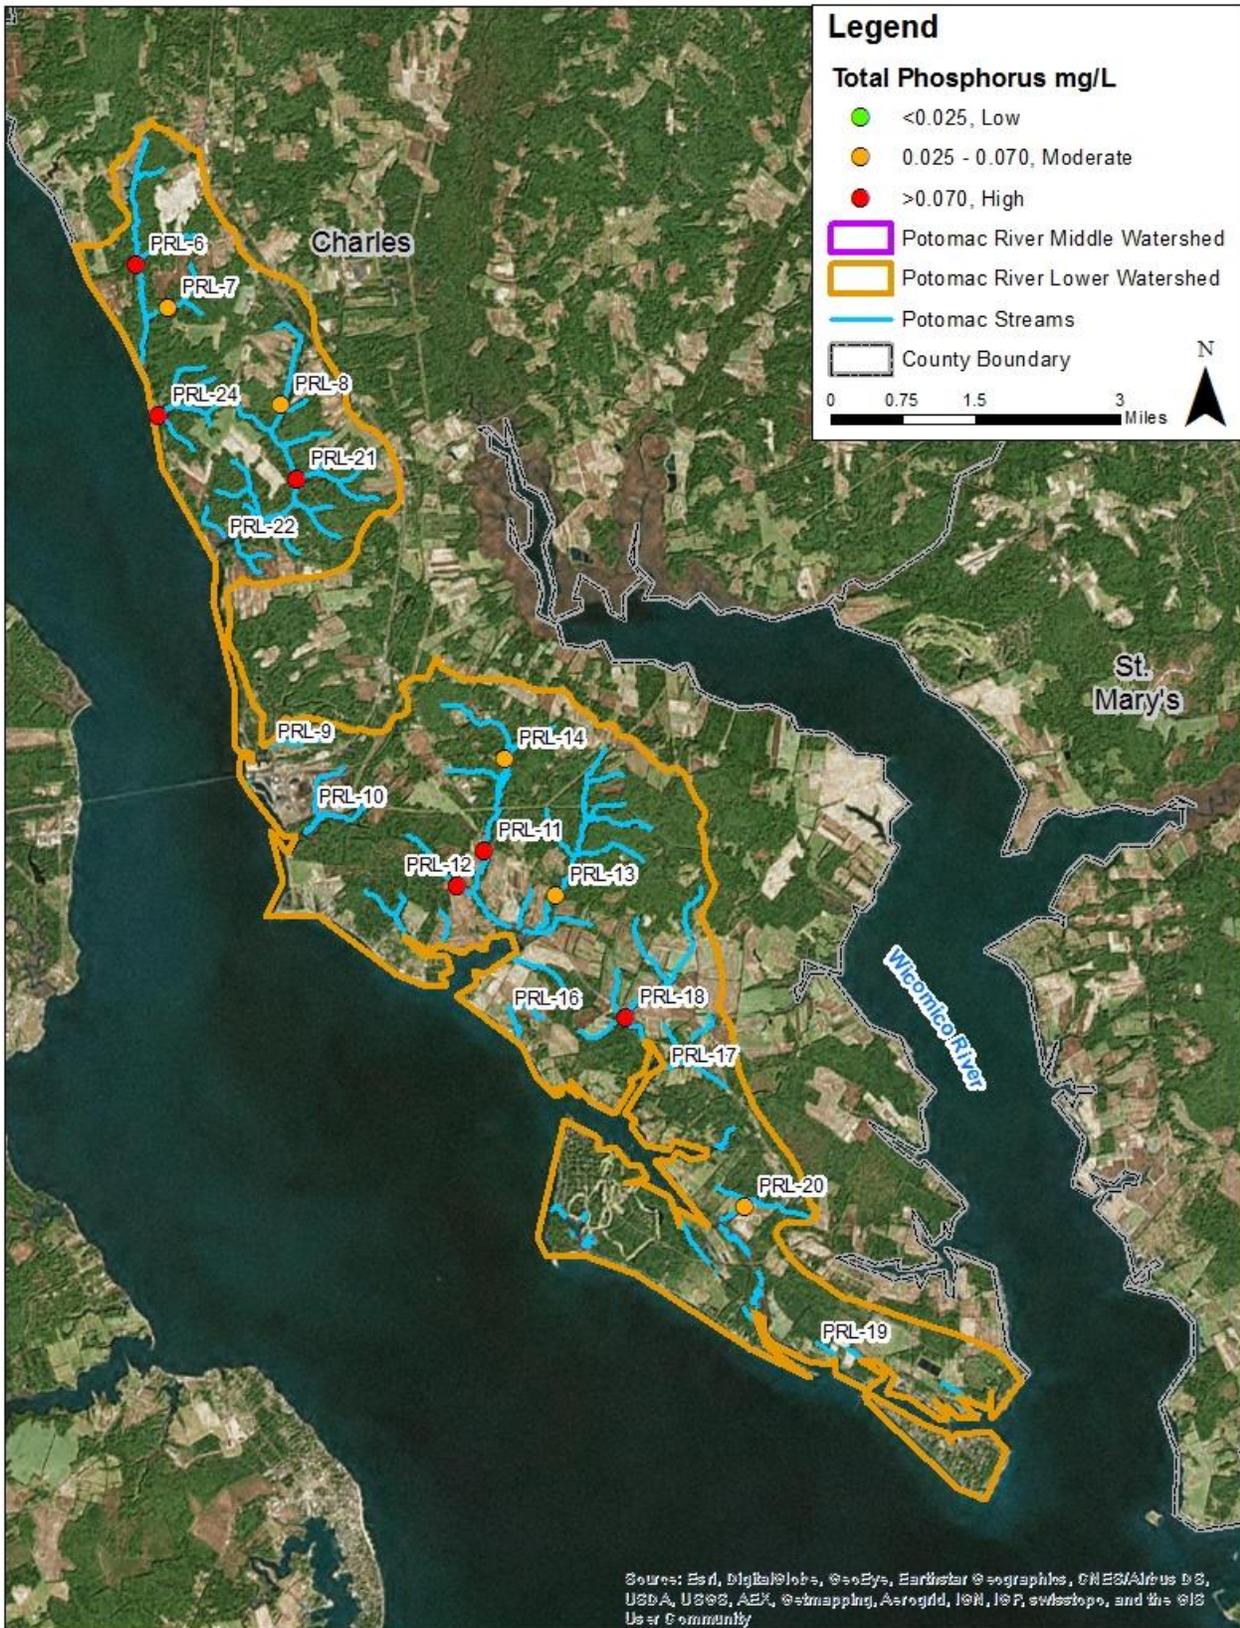
FIGURE 14: SYNOPTIC WATER QUALITY SURVEY SAMPLING RESULTS: TOTAL PHOSPHORUS CONCENTRATION: POTOMAC UPPER AND MIDDLE

FIGURE 15: SYNOPTIC WATER QUALITY SURVEY SAMPLING RESULTS: TOTAL PHOSPHORUS CONCENTRATION: POTOMAC MIDDLE AND LOWER

FIGURE 16: SYNOPTIC WATER QUALITY SURVEY SAMPLING RESULTS: PHOSPHORUS CONCENTRATION: POTOMAC LOWER

Total nitrogen concentrations were low in Potomac Upper. Two sites had moderate concentrations in the Potomac Middle while only one site was moderate in Potomac Lower. (Figure 8, Figure 9, Figure 10 and Table 10). Within the Potomac Upper, all nitrate/nitrite concentrations were low. One site had moderate concentrations in the Potomac Middle and two sites had moderated levels within two subwatersheds of the Potomac Lower. Baseline conditions were found in the remaining sites (Figure 11, Figure 12, and Table 10). In the Potomac Upper, instantaneous nitrate/nitrite loads were low at all sites. In the Potomac Middle, one site had excessive loads, one site had high loads and three sites had moderate loads. Within the Potomac Lower, only one site had moderate load of nitrate/nitrite while the rest of sites were found to be low (Figure 11, Figure 12, and Table 10). Total phosphorus concentrations in the Potomac Upper were low at all sites. In the Potomac Middle, six sites within two subwatersheds had high concentrations, one site was moderate and the others were low. In the Potomac Lower, six sites had high concentrations in three subwatersheds, five sites were moderate within three subwatersheds and the remaining were low (Figure 14, Figure 15, Figure 16 and Table 10). Within the Potomac Upper, only one site had moderate concentrations of orthophosphate, while in the Potomac Middle, one site was found to be excessive, one site was high and 17 were found to have moderate concentrations. In the Potomac Lower, a total of ten sites had excessive concentrations of orthophosphate within three subwatersheds and three more sites were found to have moderate concentrations (Figure 17, Figure 18, Figure 19 and Table 10). High concentrations were found at one site. Moderate concentrations were found at 30 sites within 12 subwatersheds, however half the detection limit for orthophosphate (0.005) falls between the baseline and moderate ratings, therefore the 31 sites that were below the detection limit should be considered to have baseline levels. Instantaneous orthophosphate loads show no elevated sites within the Potomac Upper, two sites with excessive loads, one with high and four with moderate loads within the Potomac Middle. The Potomac Lower did not have any elevated orthophosphate loads (Figure 17, Figure 18, Figure 19 and Table 10).

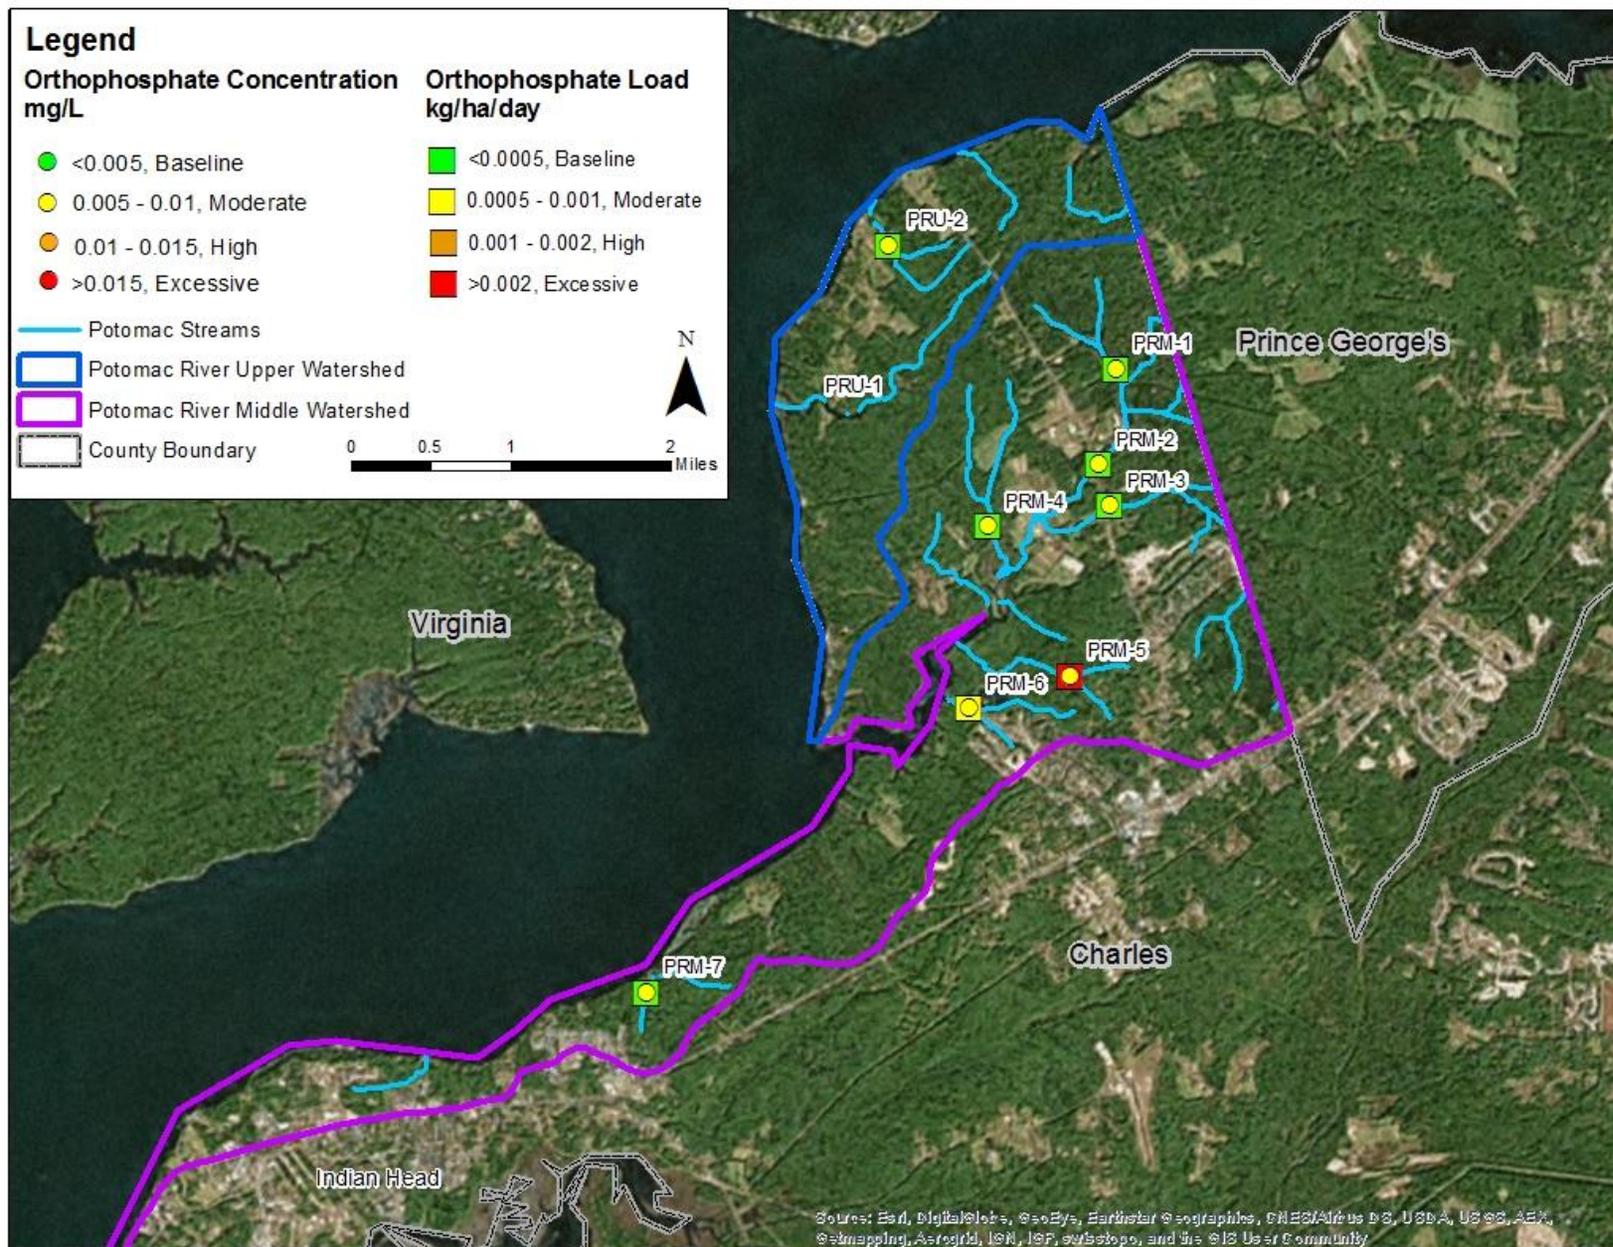
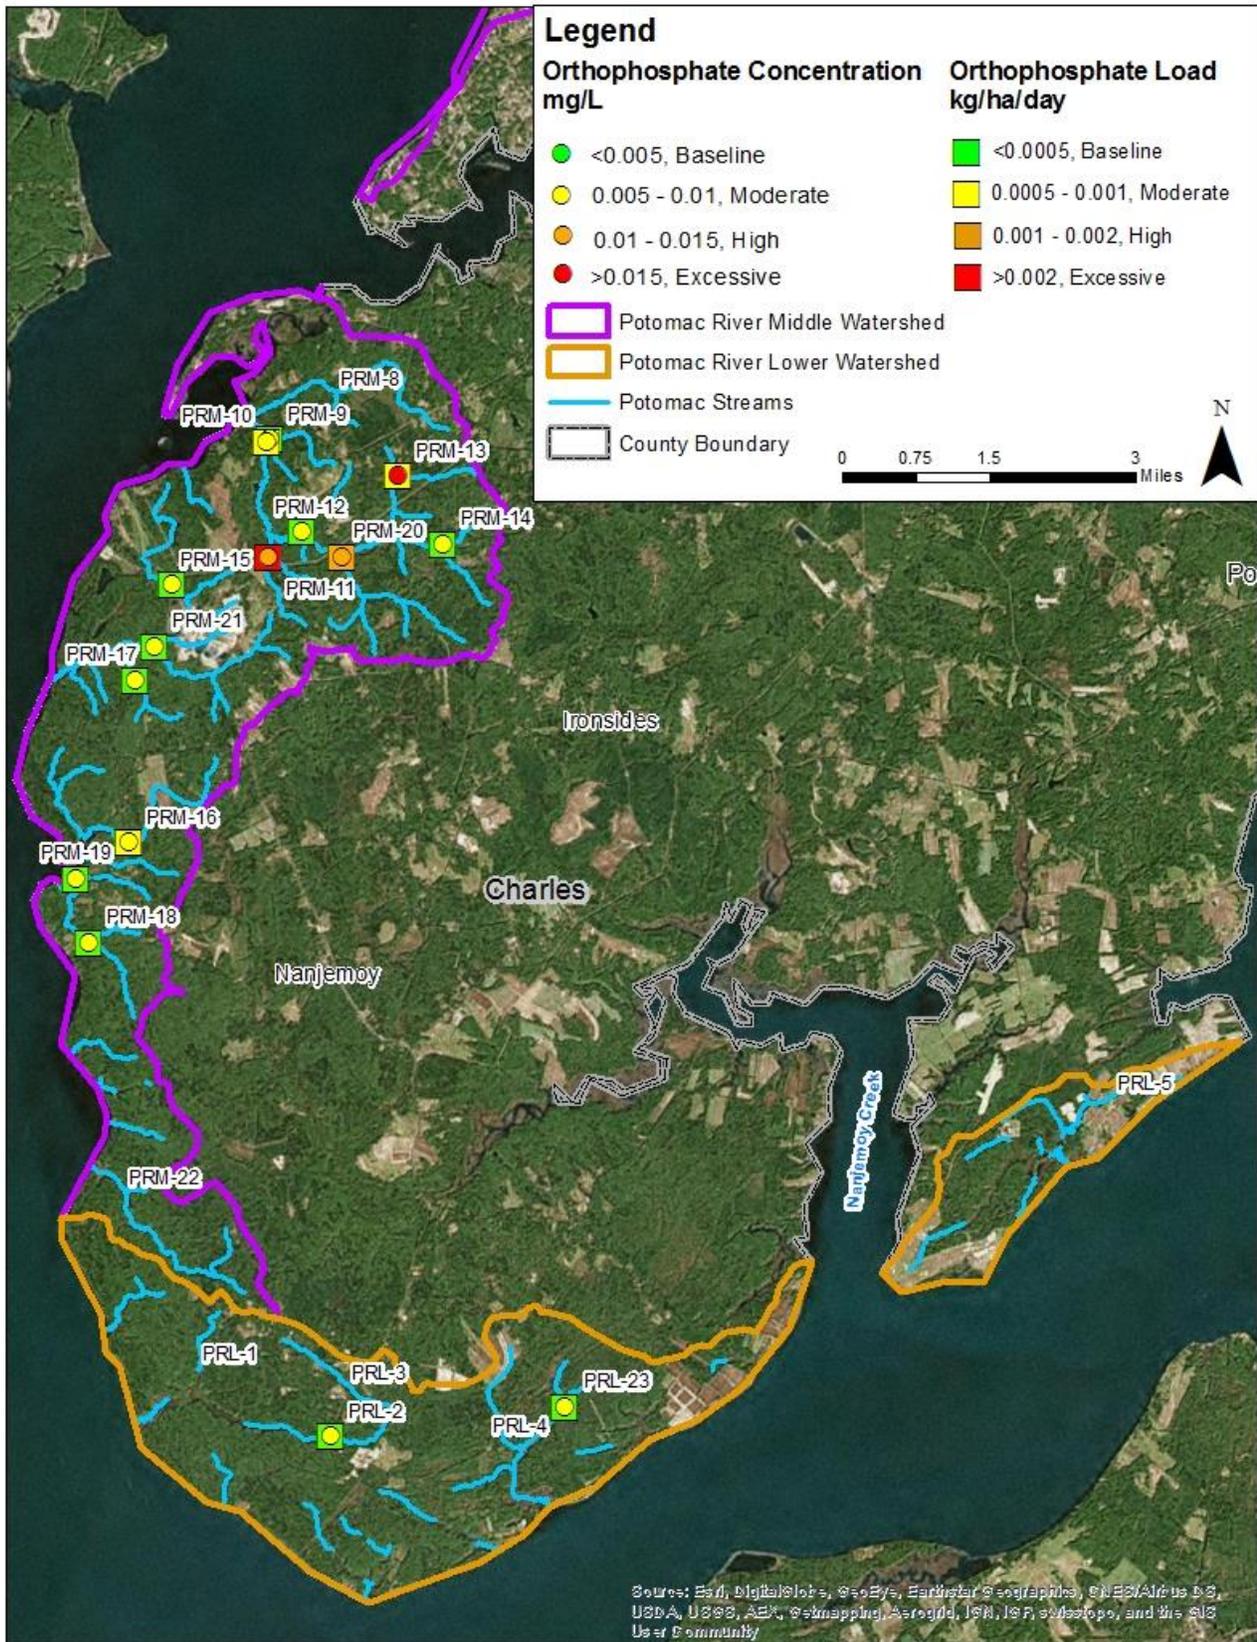
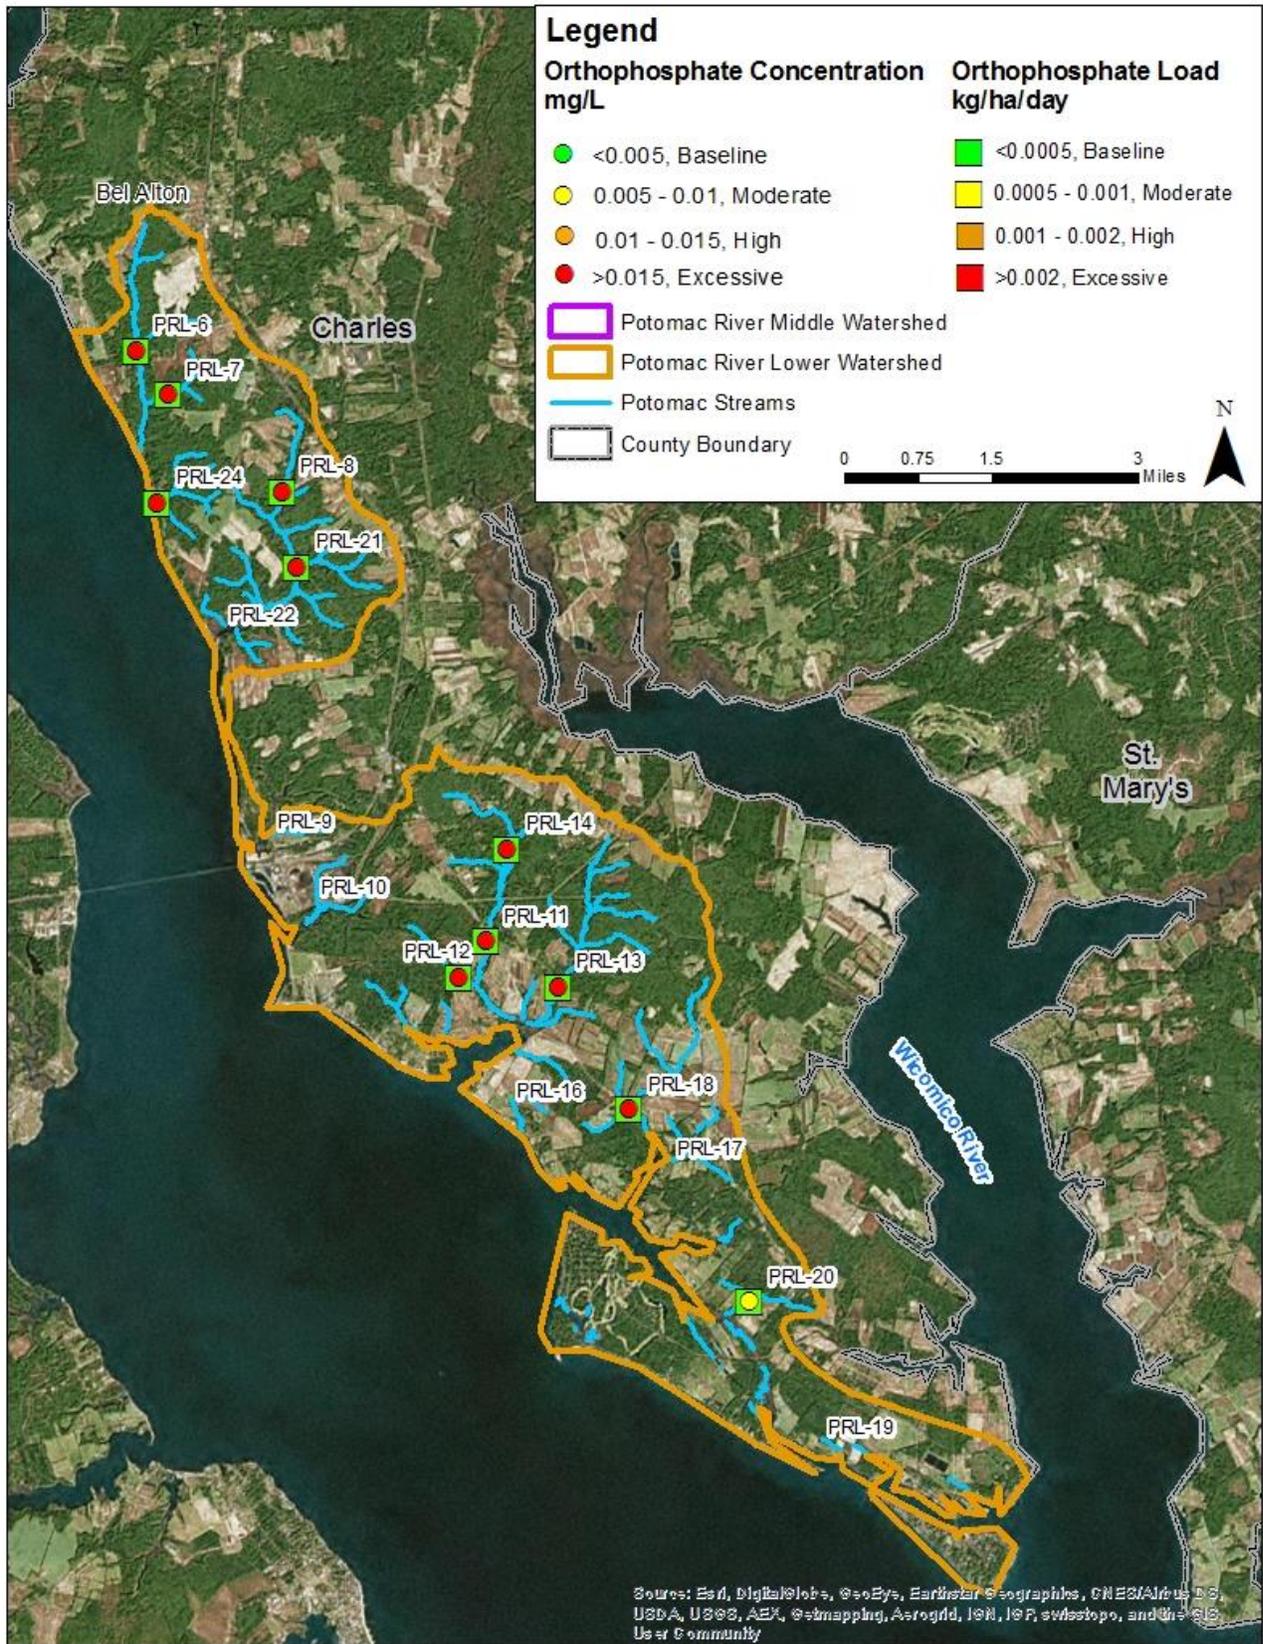
FIGURE 17: SYNOPTIC WATER QUALITY SURVEY SAMPLING RESULTS: ORTHOPHOSPHATE CONCENTRATION AND LOAD: POTOMAC UPPER AND MIDDLE

FIGURE 18: SYNOPTIC WATER QUALITY SURVEY SAMPLING RESULTS: ORTHOPHOSPHATE CONCENTRATION AND LOAD: POTOMAC MIDDLE AND LOWER

FIGURE 19: SYNOPTIC WATER QUALITY SURVEY SAMPLING RESULTS: ORTHOPHOSPHATE CONCENTRATION AND LOAD, POTOMAC LOWER

Orthophosphates, also termed phosphates, are the reactive phosphates that are most readily used by biota. Measures of orthophosphates provide a good estimation of the amount of phosphorus available for algae and plant growth. Orthophosphates are found naturally but elevated values may indicate human sources which include fertilizers for both agricultural and residential use, cleaners, and wastewater sewage. Phosphorus bound to sediments is also released through erosional processes. The measured elevated levels were clustered in the south central portions of the watershed and many sites were located adjacent to agricultural and residential properties.

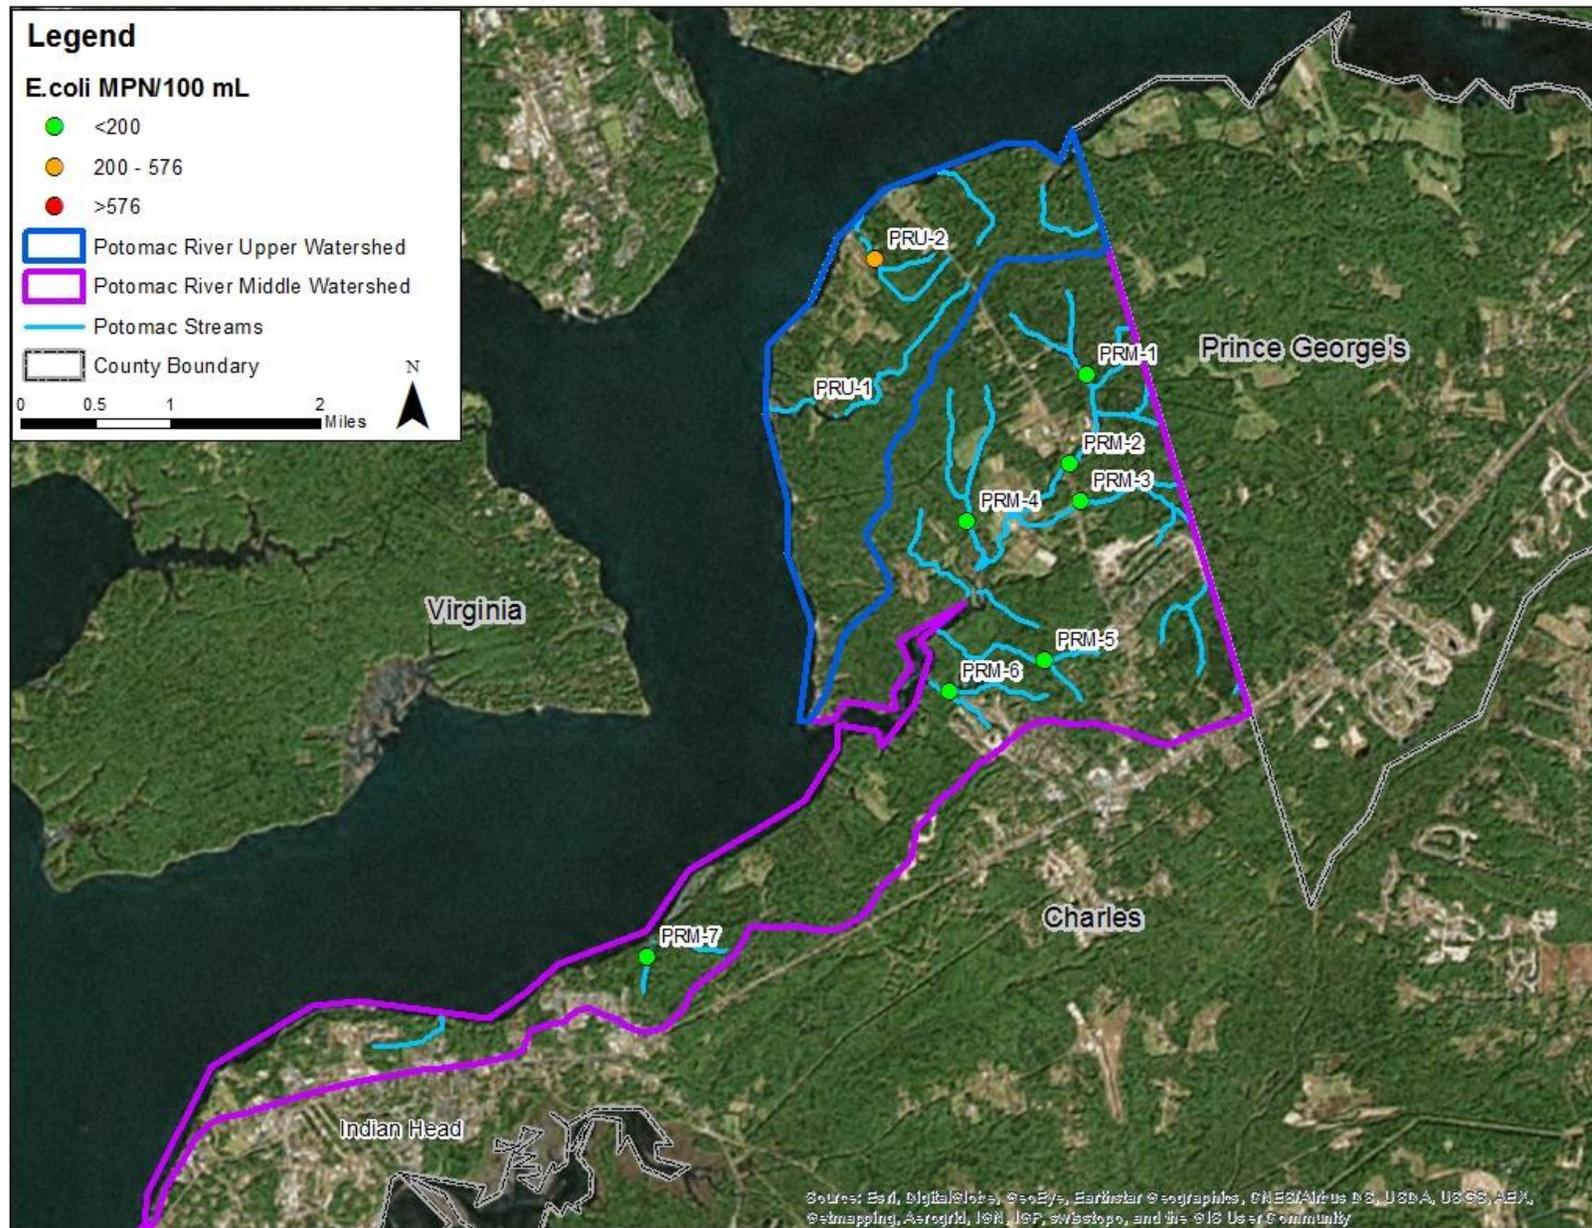
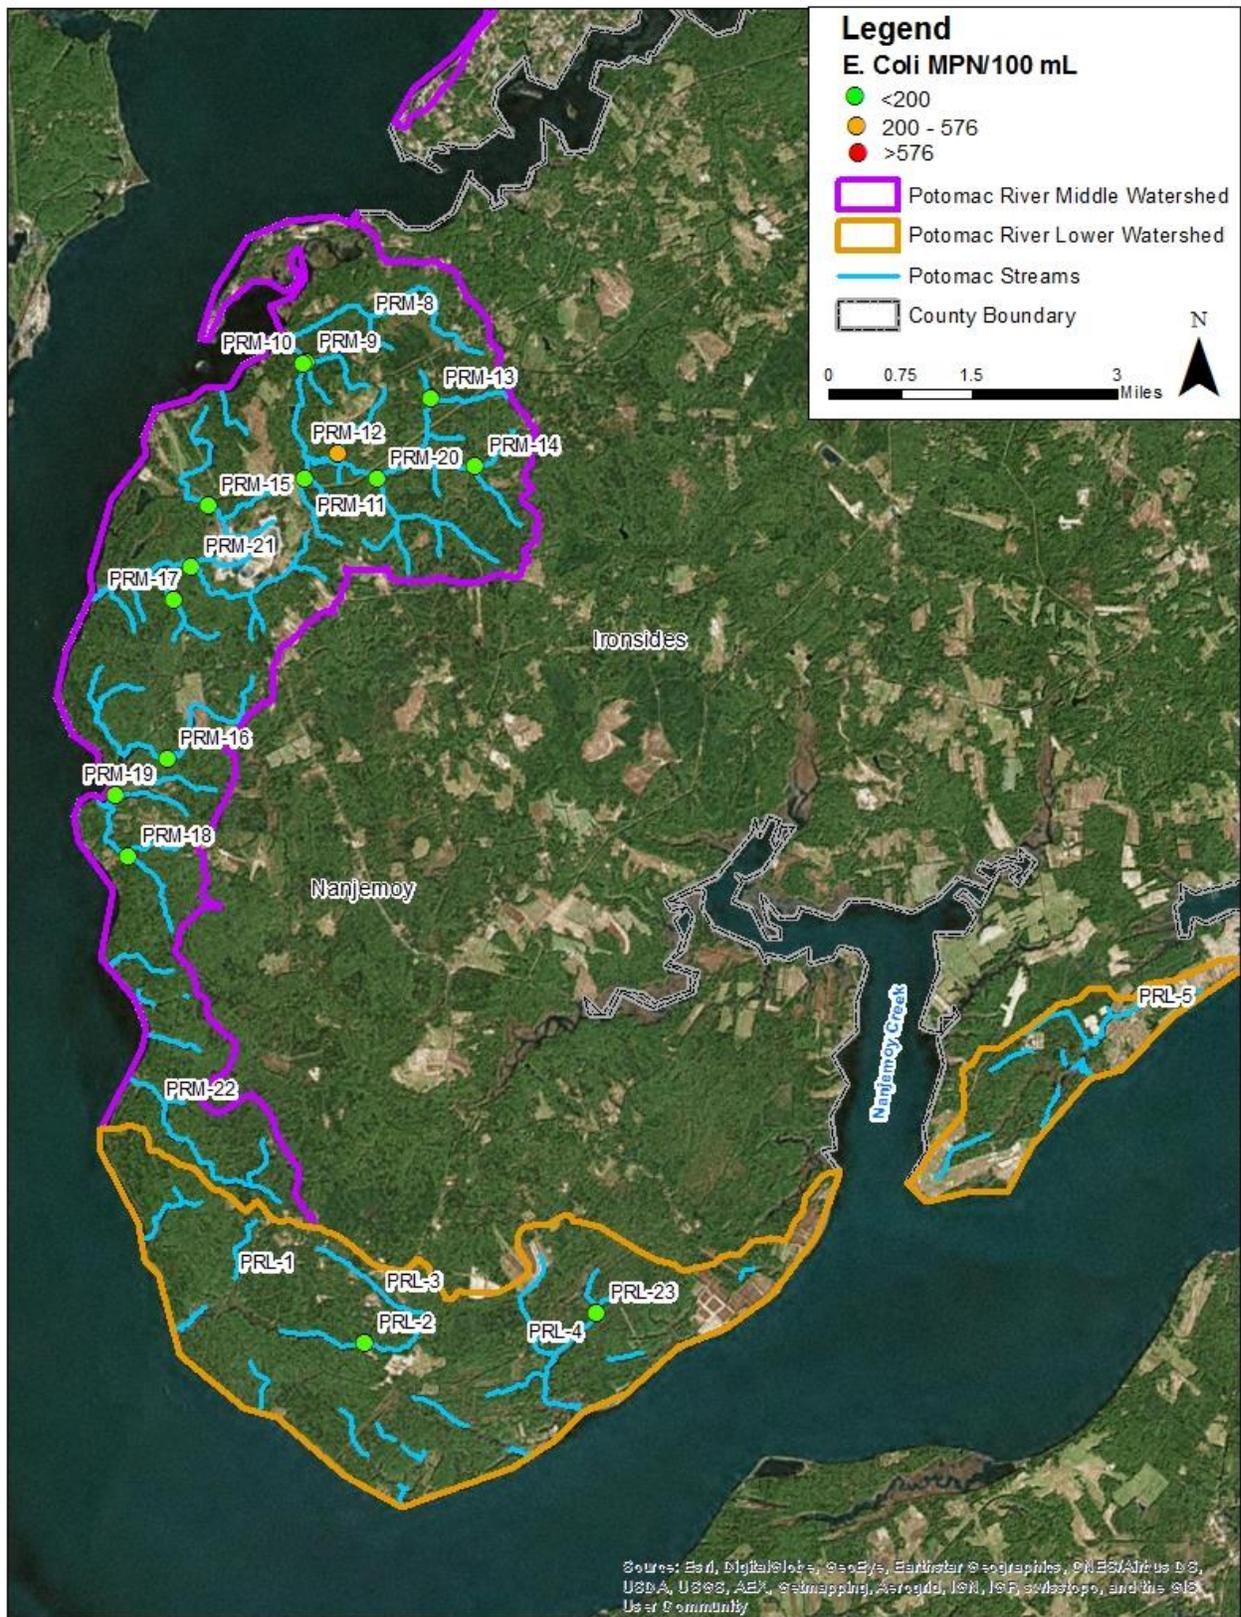
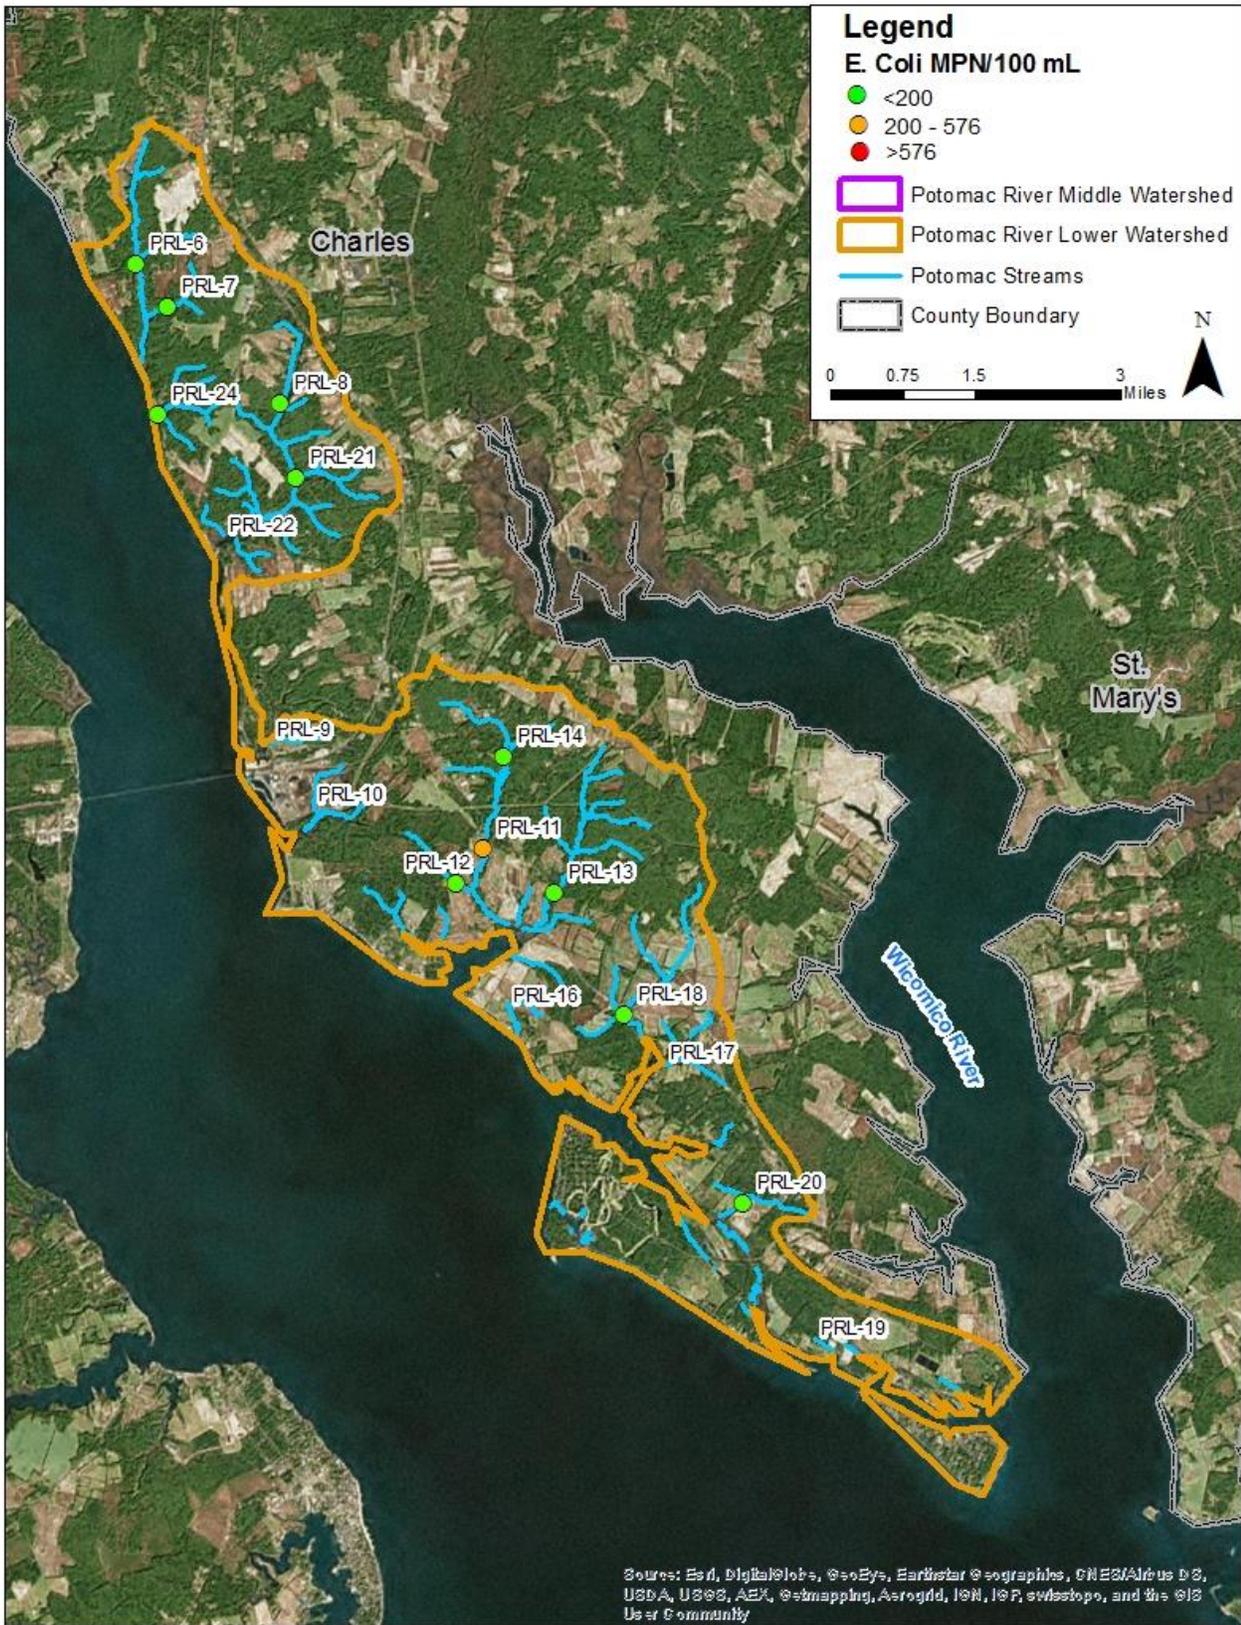
FIGURE 20: SYNOPTIC WATER QUALITY SURVEY SAMPLING RESULTS: BACTERIA: POTOMAC UPPER AND MIDDLE

FIGURE 21: SYNOPTIC WATER QUALITY SURVEY SAMPLING RESULTS: BACTERIA: POTOMAC MIDDLE AND LOWER

FIGURE 22: SYNOPTIC WATER QUALITY SURVEY SAMPLING RESULTS: BACTERIA: POTOMAC LOWER

Elevated bacteria levels (*E. coli* > 576 mpn/100 ml; mpn = most probable number) were found at none of the sites within the three watersheds, while one site in Potomac Middle and one site in Potomac Lower, had levels exceeding the standard for water contact recreation of 200 mpn/100 ml (Figure 20, Figure 21, Figure 22 and Table 10).
