# UPPER, MIDDLE, AND LOWER POTOMAC RIVER

## WATERSHED ASSESSMENT

MAY | 2018

KCI TECHNOLOGIES, INC.  
936 RIDGEBROOK ROAD  
SPARKS, MD 21152

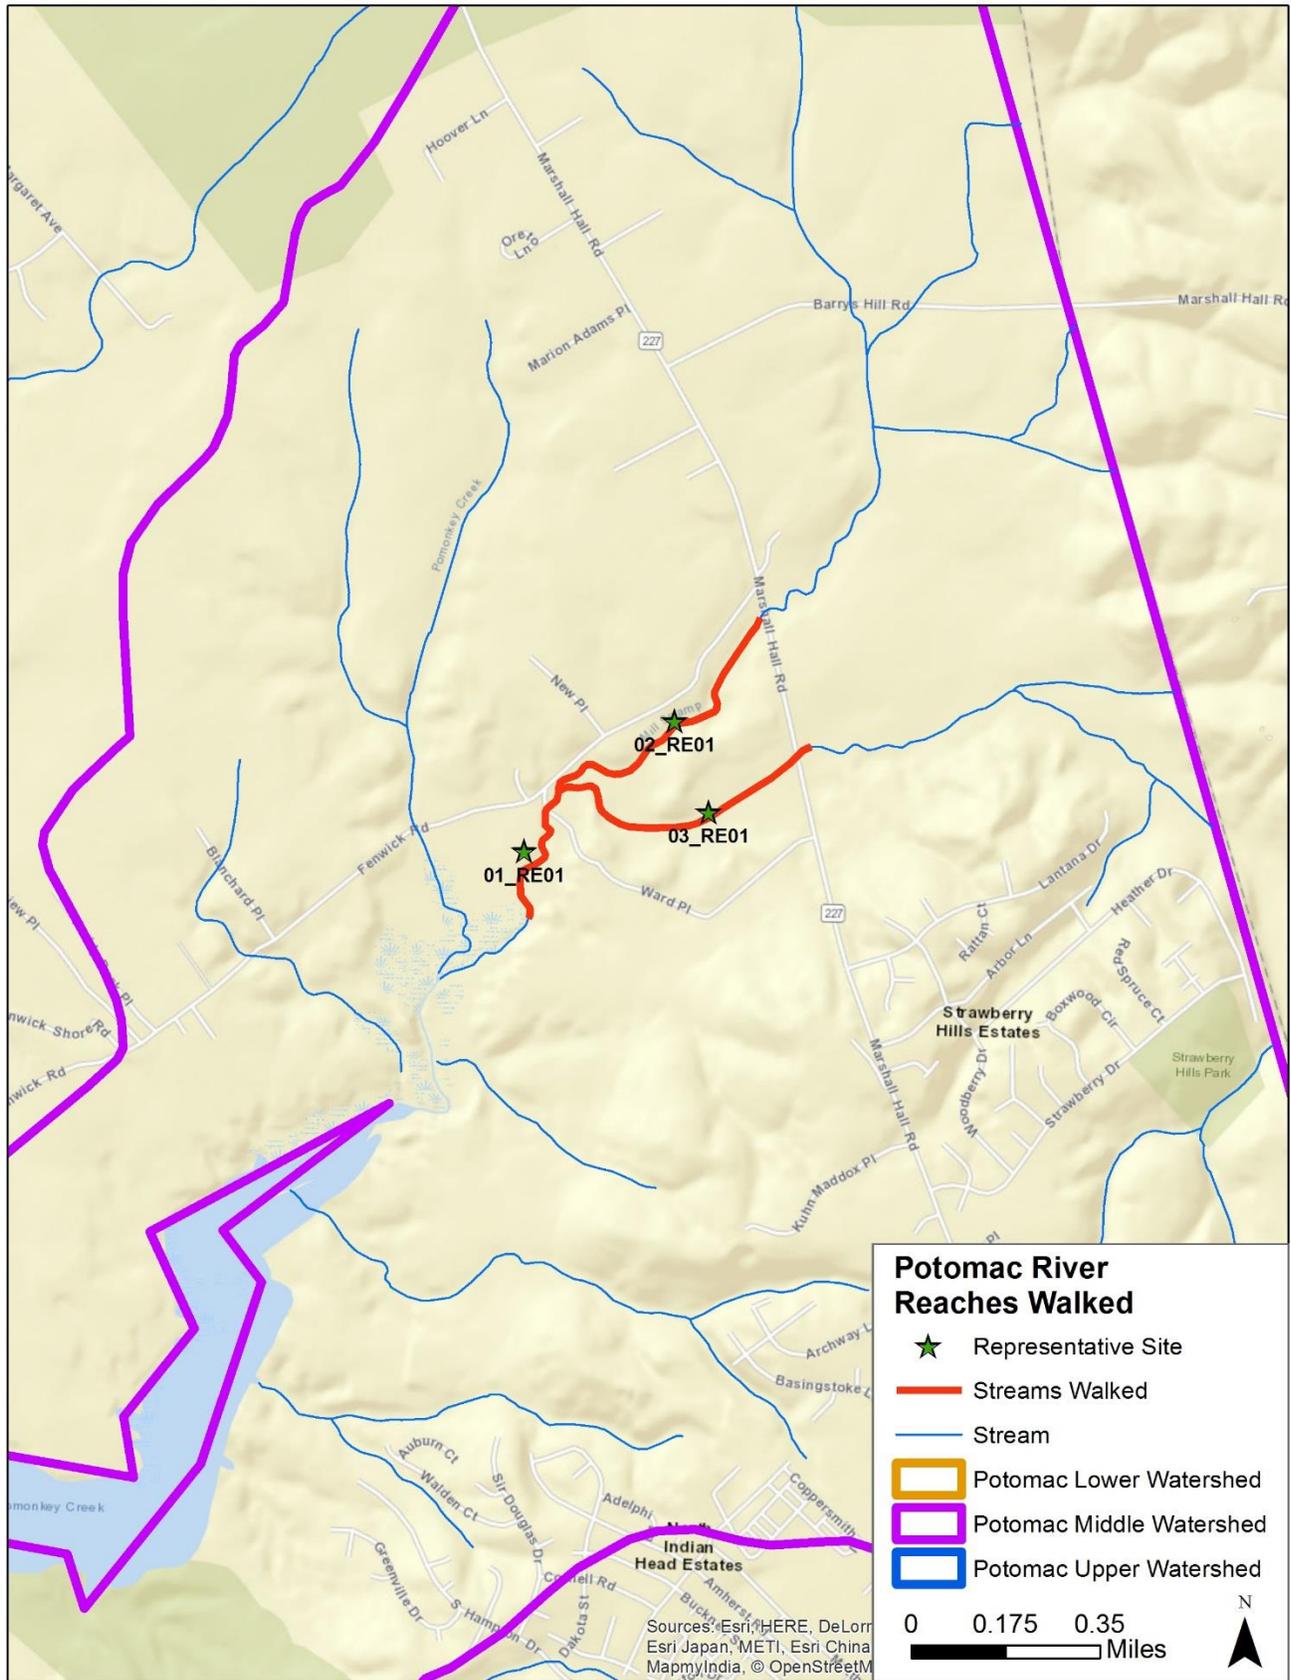
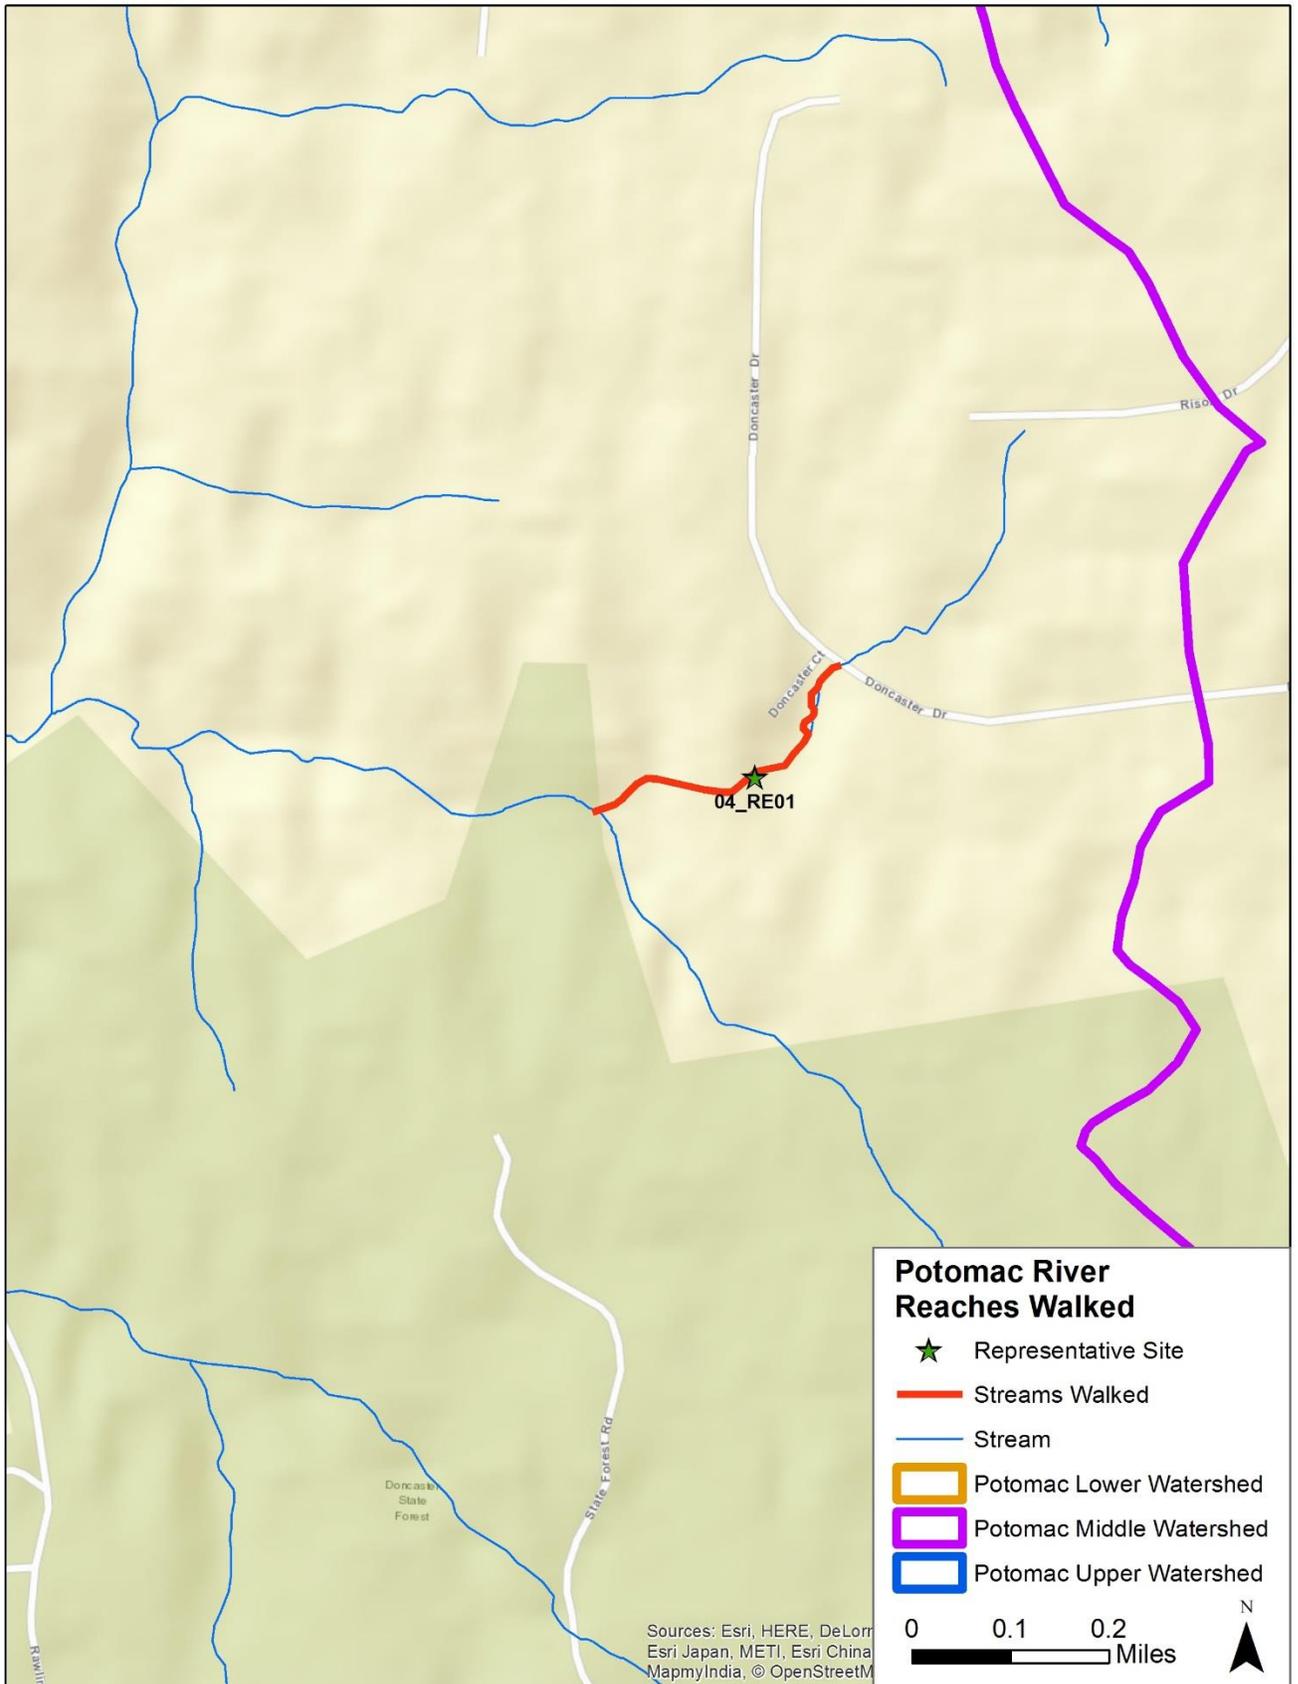
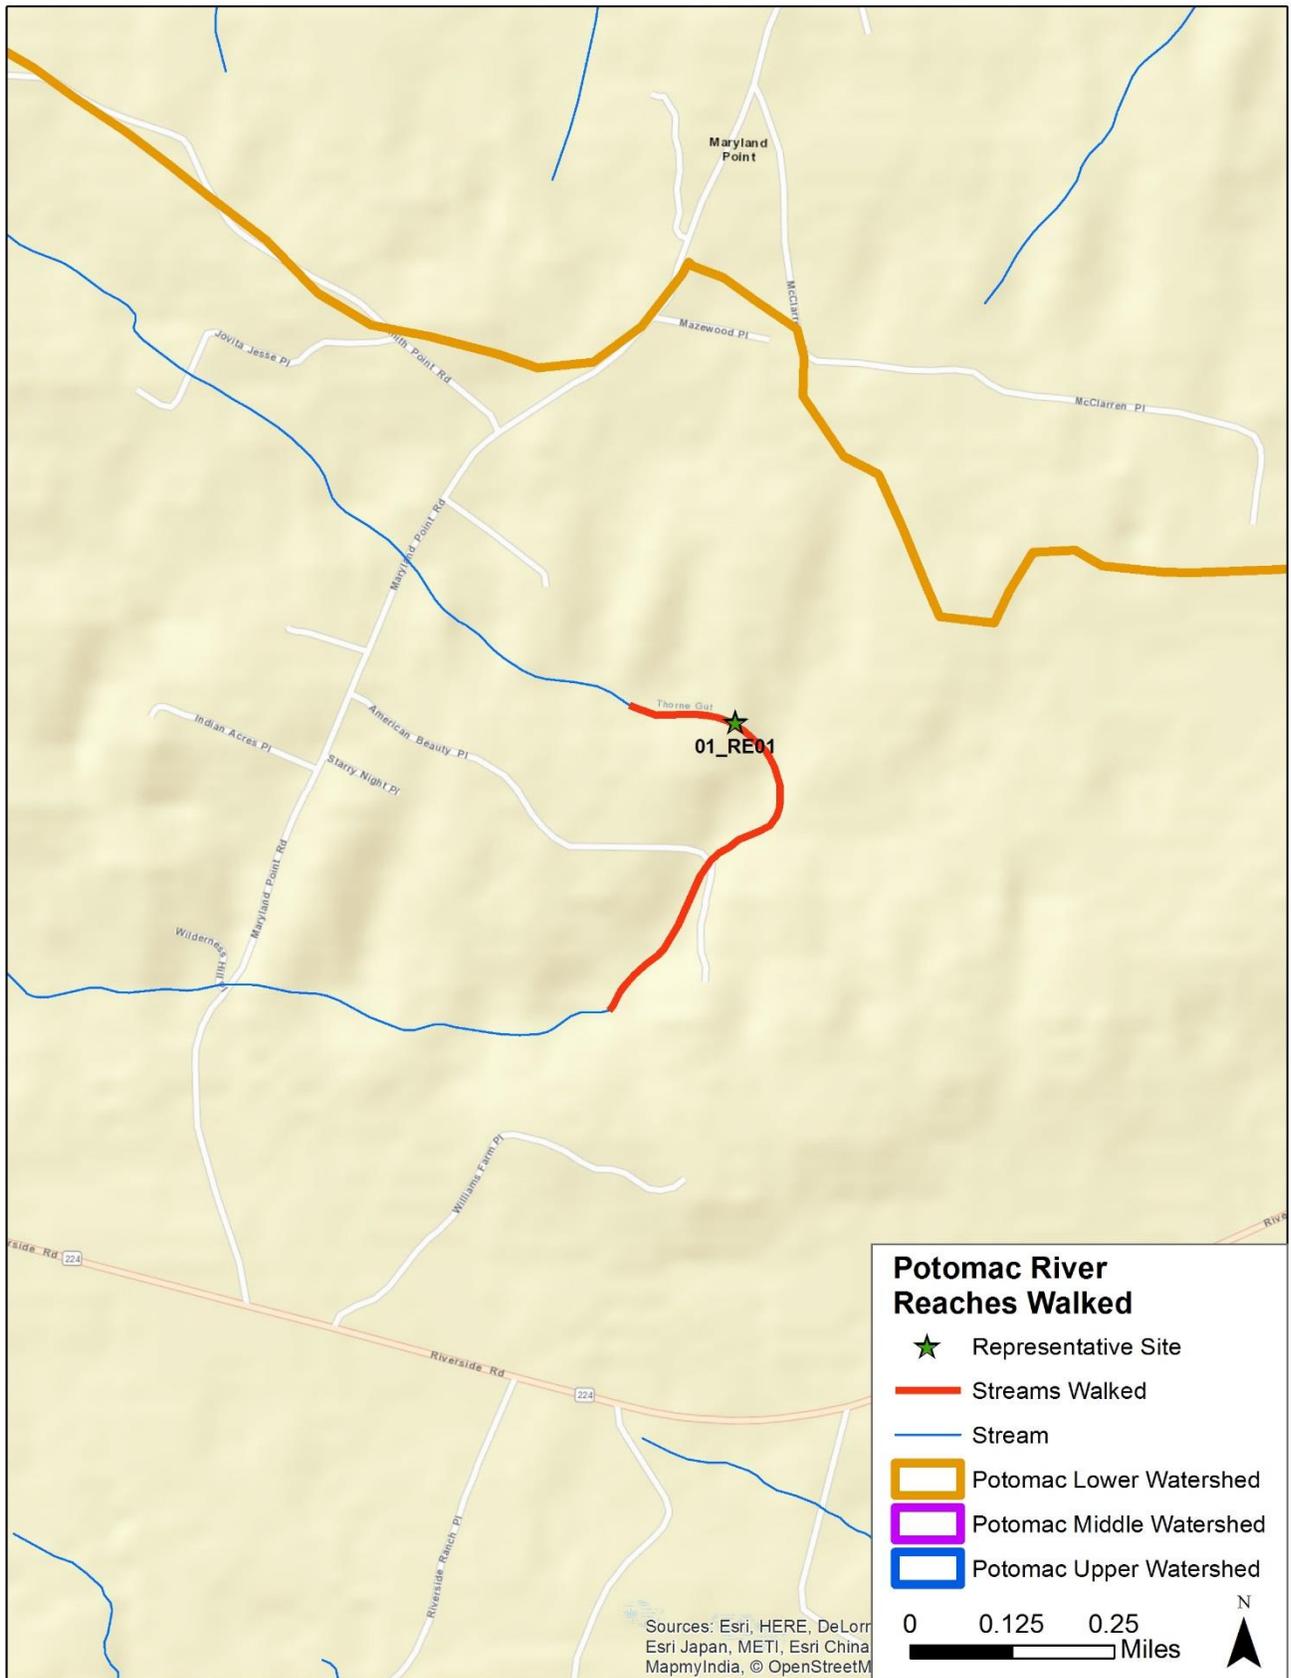
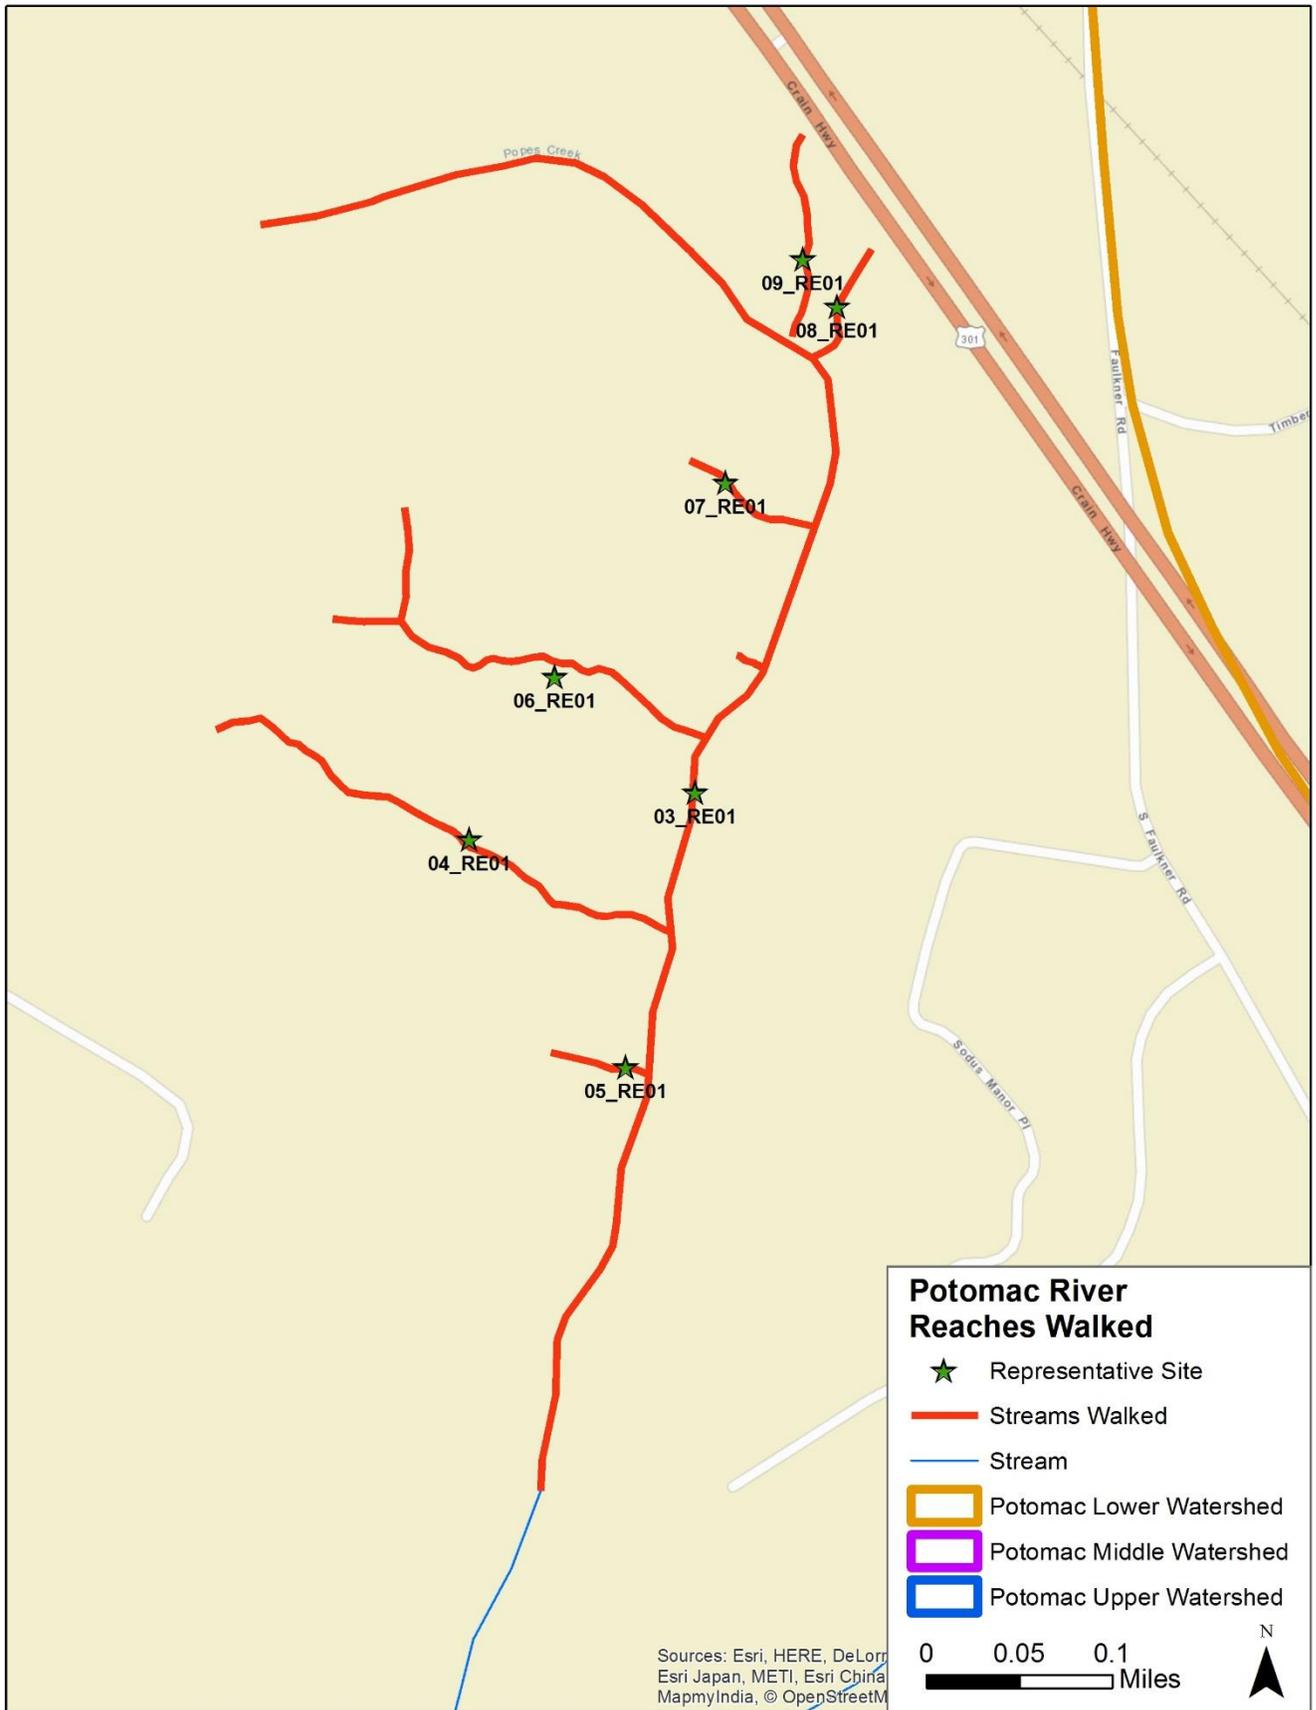
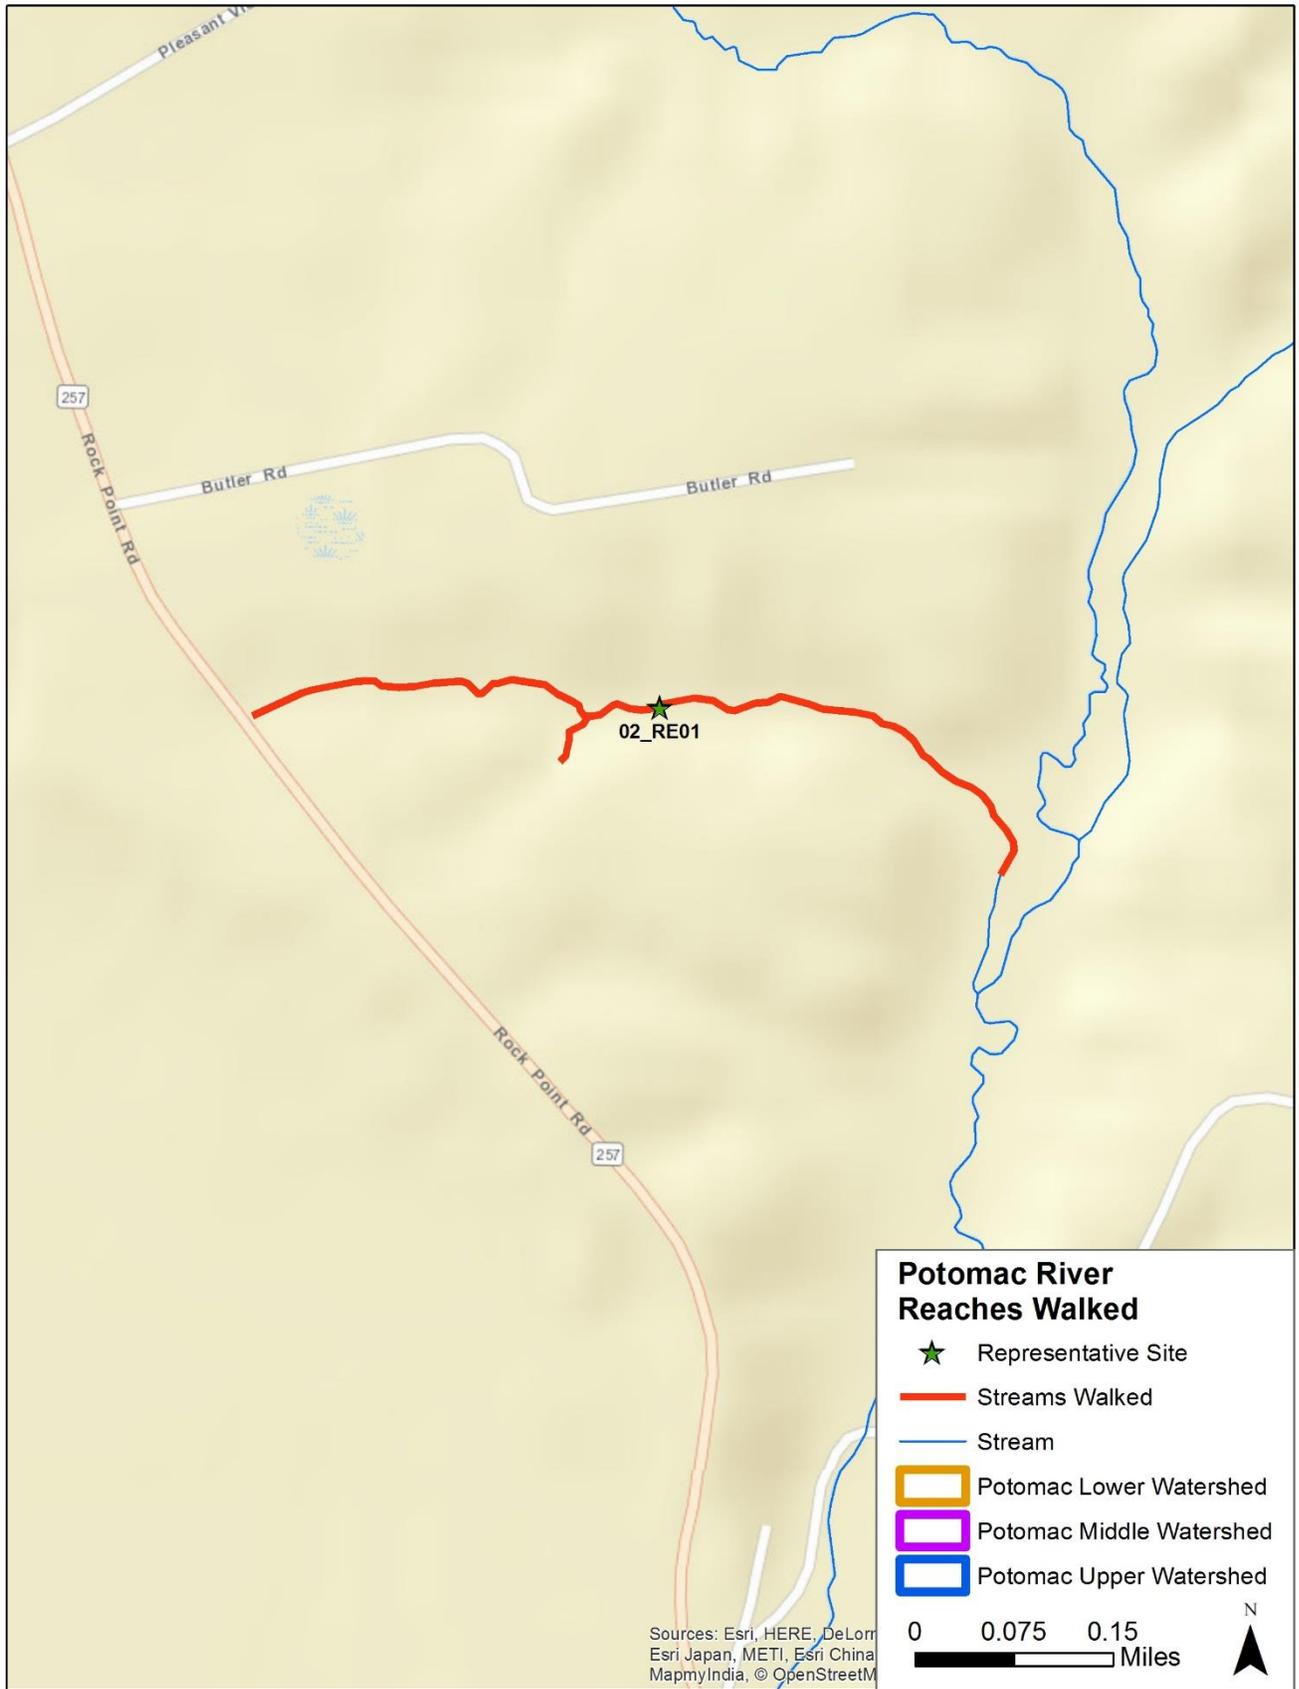
FIGURE 23: POTOMAC MIDDLE WATERSHED STREAM CORRIDOR ASSESSMENT REACHES WALKED AND REPRESENTATIVE SITES, NORTHERN PORTION

FIGURE 24. POTOMAC MIDDLE WATERSHED STREAM CORRIDOR ASSESSMENT REACHES WALKED AND REPRESENTATIVE SITES, SOUTHERN PORTION

FIGURE 25. POTOMAC MIDDLE WATERSHED STREAM CORRIDOR ASSESSMENT REACHES WALKED AND REPRESENTATIVE SITES, WESTERN PORTION

FIGURE 26. POTOMAC LOWER WATERSHED STREAM CORRIDOR ASSESSMENT REACHES WALKED AND REPRESENTATIVE SITES, NORTHERN PORTION

FIGURE 27. POTOMAC LOWER WATERSHED STREAM CORRIDOR ASSESSMENT REACHES WALKED AND REPRESENTATIVE SITES, SOUTHERN PORTION

Field crews walked approximately 5.0 miles of mapped stream channels between May 10 and May 15, 2017; 3.2 miles in the Lower Potomac watershed and 1.8 miles in the Middle Potomac watershed. Figure 23 shows the stream reaches walked by field crews and the location of the representative sites for each reach. Representative sites were selected at locations representative of each stream segment. The general physical habitat condition was assessed at the representative sites using a modified version of the EPA’s Rapid Bioassessment Protocols (Barbour et al., 1999). The assessment includes qualitative ratings for ten habitat parameters as well as information on wetted width, pool, run, and riffle depths, and channel substrate.

Representative points were taken at 13 locations (Figure 23 through Figure 27). Figure 28, below, presents the proportion of reaches in each assessment category for each habitat parameter, giving insight into the types of stream impacts creating the most degradation. In general, the modified qualitative RBP assessment at these sites revealed stream channels dominated by clay, silt, sand and gravel substrates. There were a wide range of scores for riparian vegetation and sediment deposition, ranging from 'poor' to 'optimal', with most of the sites falling within the 'suboptimal' range. Bank condition ranged from 'poor' to 'suboptimal' while bank vegetation ranged from 'poor' to 'optimal'. A majority of sites received a 'suboptimal' score for channel flow status, with scores ranging from 'marginal' to 'optimal'. Velocity depth diversity scores primarily fell within the 'marginal' category, with a few sites within the 'poor' and 'suboptimal' range. The vast majority of sites were unaltered and as a result, most scores for channel alteration fell within the 'optimal' range. Embeddedness, shelter for fish, and benthic substrate scores ranged from 'poor' to 'suboptimal', with most scores within the 'poor' and 'marginal' range.

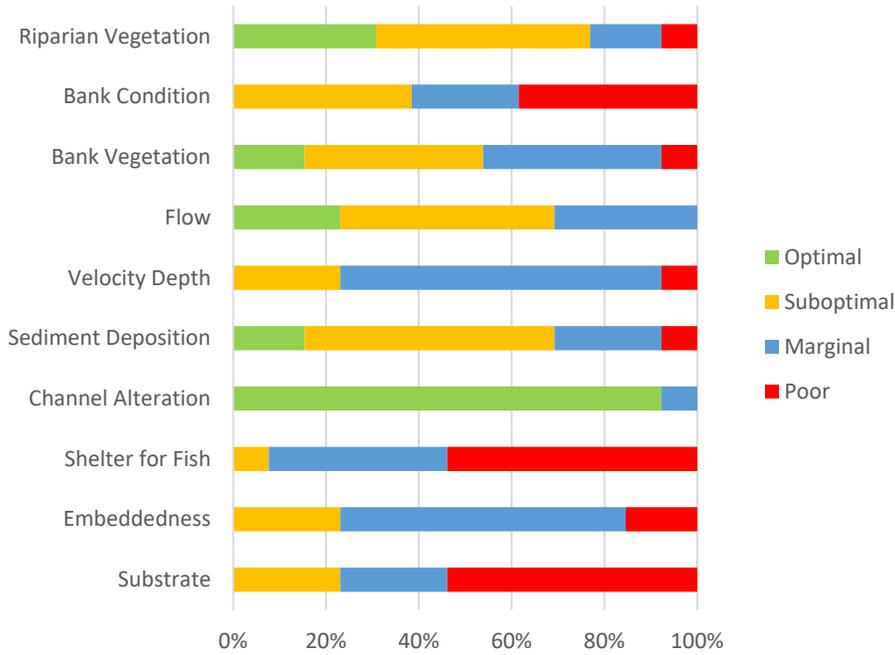
**FIGURE 28: PROPORTION OF REACHES PER ASSESSMENT CATEGORY**

Stream channel erosion is a major factor leading to impaired habitat conditions. Approximately 78% of the total length of streams walked were considered eroded. Widening, headcutting, and downcutting were the erosion processes identified. As the stream channels widen and become incised, the ability to effectively transport sediments (eroded bank material and from runoff over land) is reduced, leading to reduced scores for several habitat parameters including flow, velocity, embeddedness and macroinvertebrate habitat.

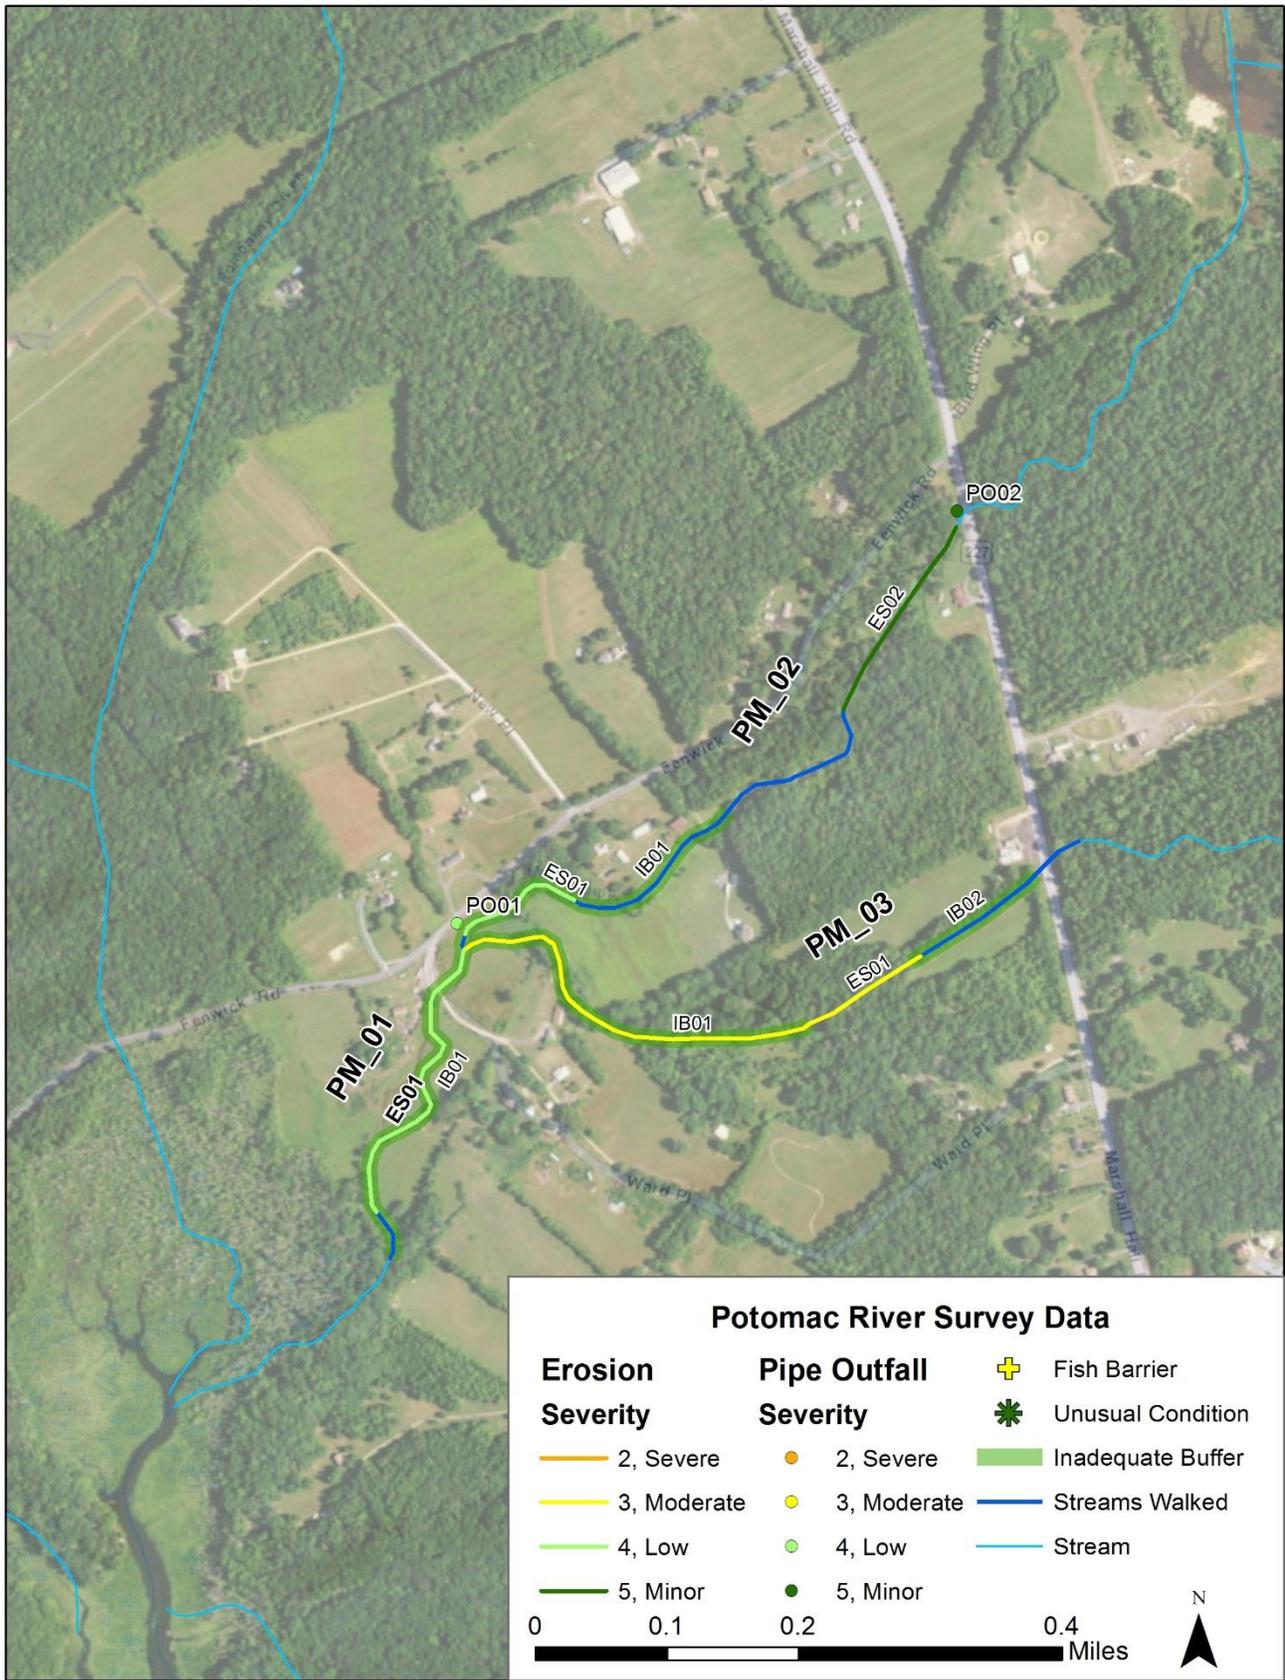
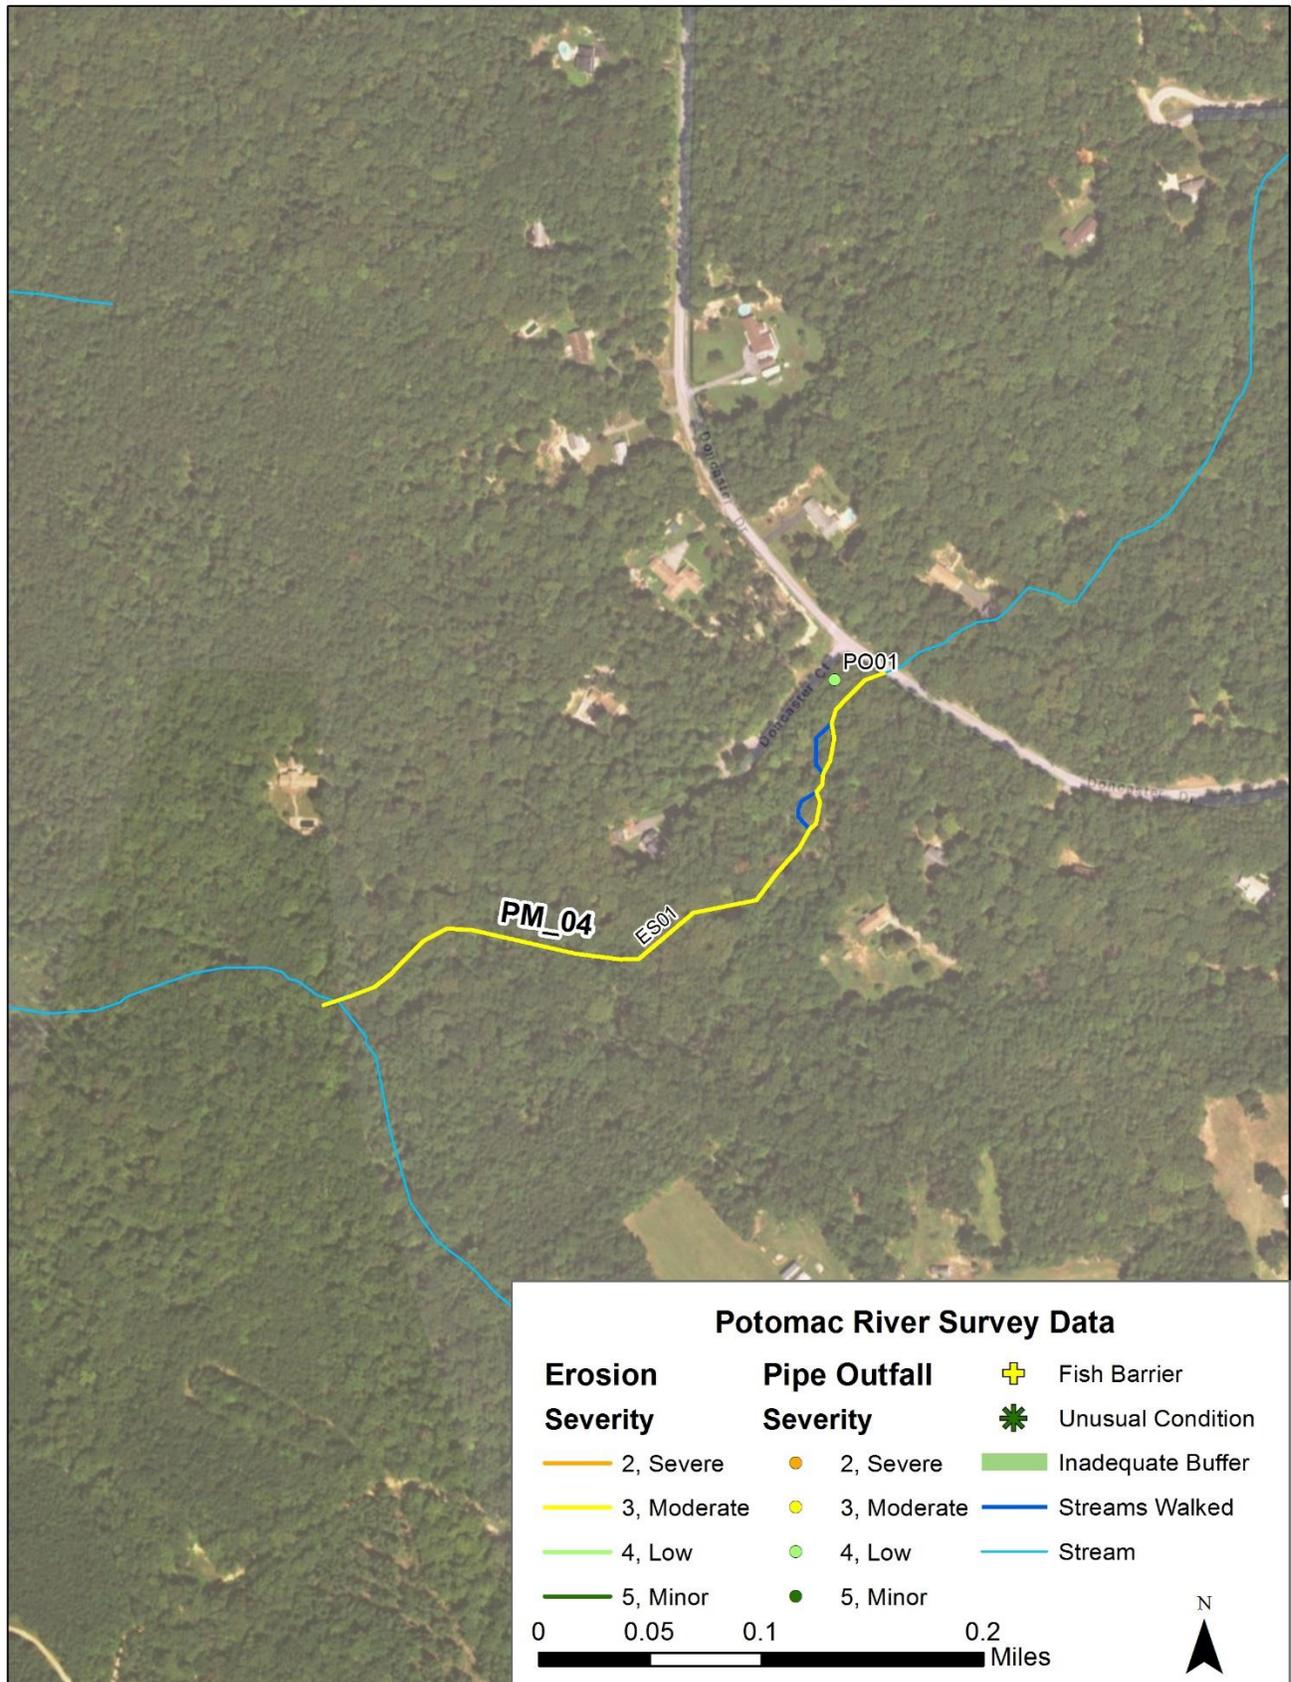
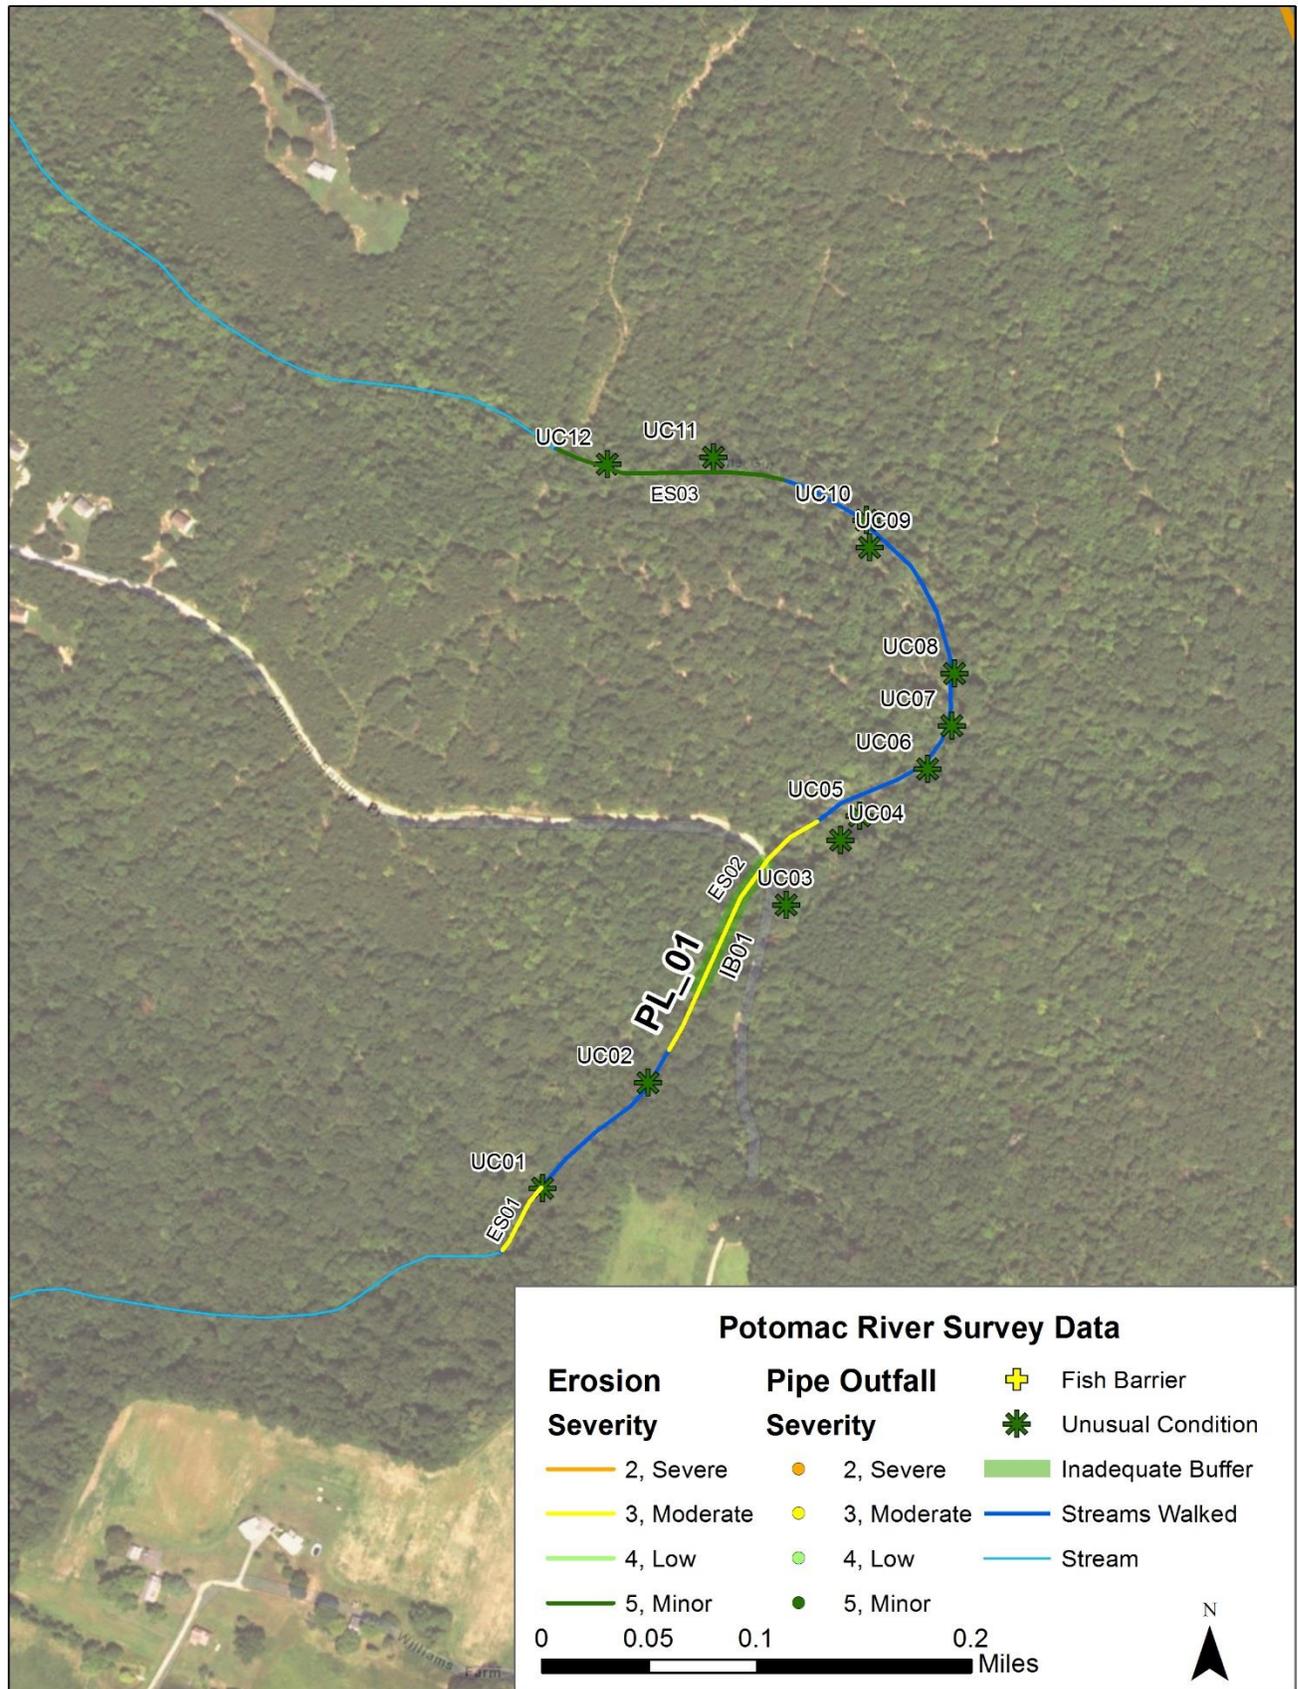
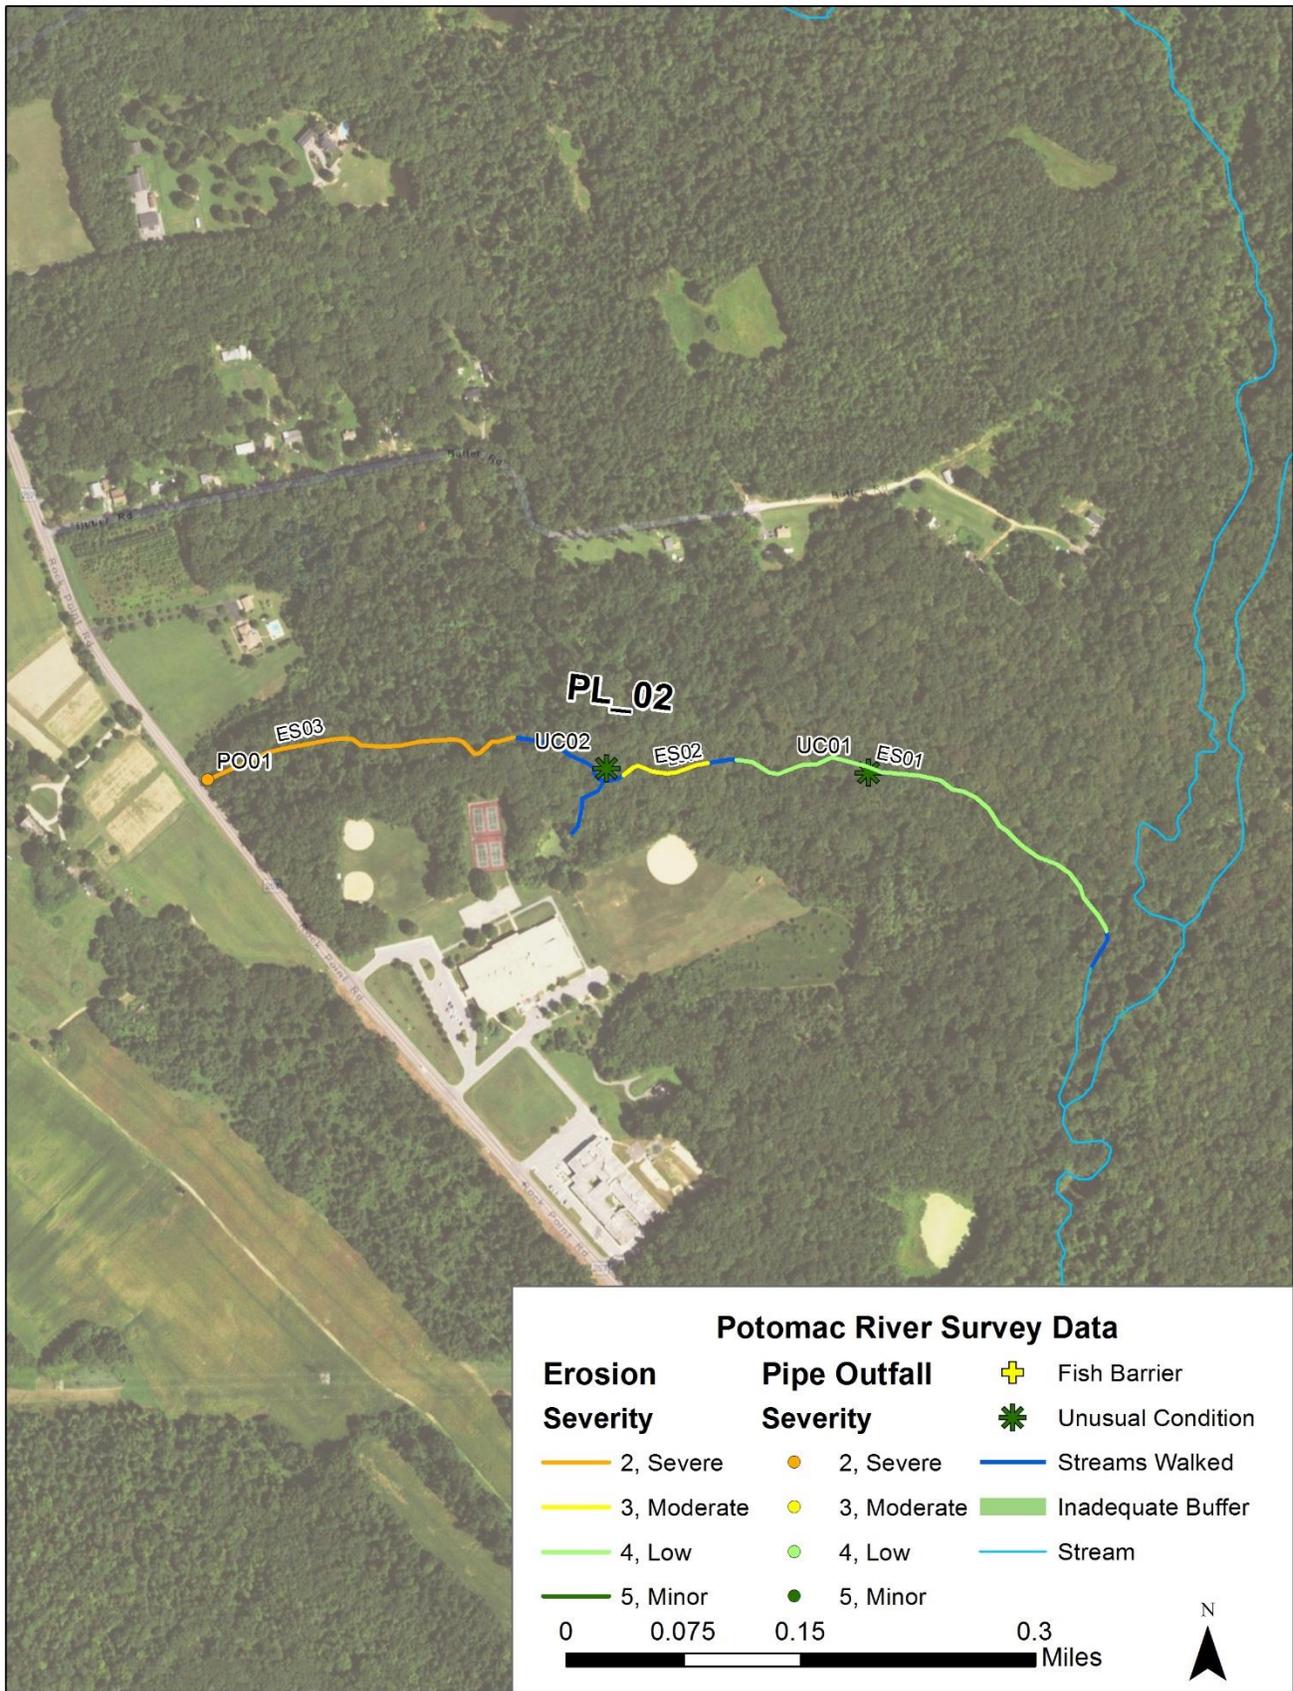
FIGURE 29. SURVEY DATA MAP SHOWING PIPE OUTFALL, EROSION, FISH BARRIER, AND INADEQUATE BUFFER SITES, POTOMAC MIDDLE, NORTHERN PORTION

FIGURE 30. SURVEY DATA MAP SHOWING PIPE OUTFALL, EROSION, FISH BARRIER, AND INADEQUATE BUFFER SITES, POTOMAC MIDDLE, SOUTHERN PORTION

FIGURE 31. SURVEY DATA MAP SHOWING PIPE OUTFALL, EROSION, FISH BARRIER, AND INADEQUATE BUFFER SITES, POTOMAC LOWER, WESTERN PORTION

FIGURE 33. SURVEY DATA MAP SHOWING PIPE OUTFALL, EROSION, FISH BARRIER, AND INADEQUATE BUFFER SITES, POTOMAC LOWER, SOUTHEASTERN PORTION

Twenty erosion sites totaling 3.9 miles were identified. The stream erosion process was identified as widening for eight sites (40%), downcutting for six sites (30%), headcutting for one site (5%), and both downcutting and widening for five sites (25%). While collecting stream erosion data, field crews also attempted to determine the leading possible cause of erosion at each site. The most commonly described possible causes for erosion was landuse change upstream (50%). Other sources include agricultural drainage (25%), pipe outfall (15%), and removal of forest buffer (10%). Three sites were determined to pose a potential threat to an adjacent roadway. Locations of erosion sites can be found in Figure 29 through Figure 34.

Inadequate buffers, defined as buffers less than 50 feet wide from the edge of the stream, were identified at 7 sites, totaling 1.2 miles of inadequate buffers. Approximately 86% of the inadequate buffer length identified was affecting both sides of the stream channel. Agriculture (crops, pasture, old field) was the cause of the inadequate buffer at 86% the sites, while a gravel road accounted for 14% of the inadequate buffer sites. The location of reaches with inadequate buffers is displayed in Figure 29 through Figure 33.

Two pipe outfalls were identified as road crossings, but all other pipe outfalls were associated with stormwater conveyance. Any observed discharge was clear and odorless. Locations and severity of these points are shown in Figure 29 through Figure 33.

There were fourteen unusual condition/comment points identified in the study area. Twelve points were taken to document the location of a beaver dam. One point (PL\_R02\_UC01) was taken to record the presence of a debris jam which was causing a fish barrier and one point (PL02\_UC02) was taken to document an eroded stormwater management pond outfall channel from a pond. The location of the unusual condition points is displayed in Figure 29 through Figure 33.
