# UPPER, MIDDLE, AND LOWER POTOMAC RIVER

## WATERSHED ASSESSMENT

MAY | 2018

KCI TECHNOLOGIES, INC.  
936 RIDGEBROOK ROAD  
SPARKS, MD 21152

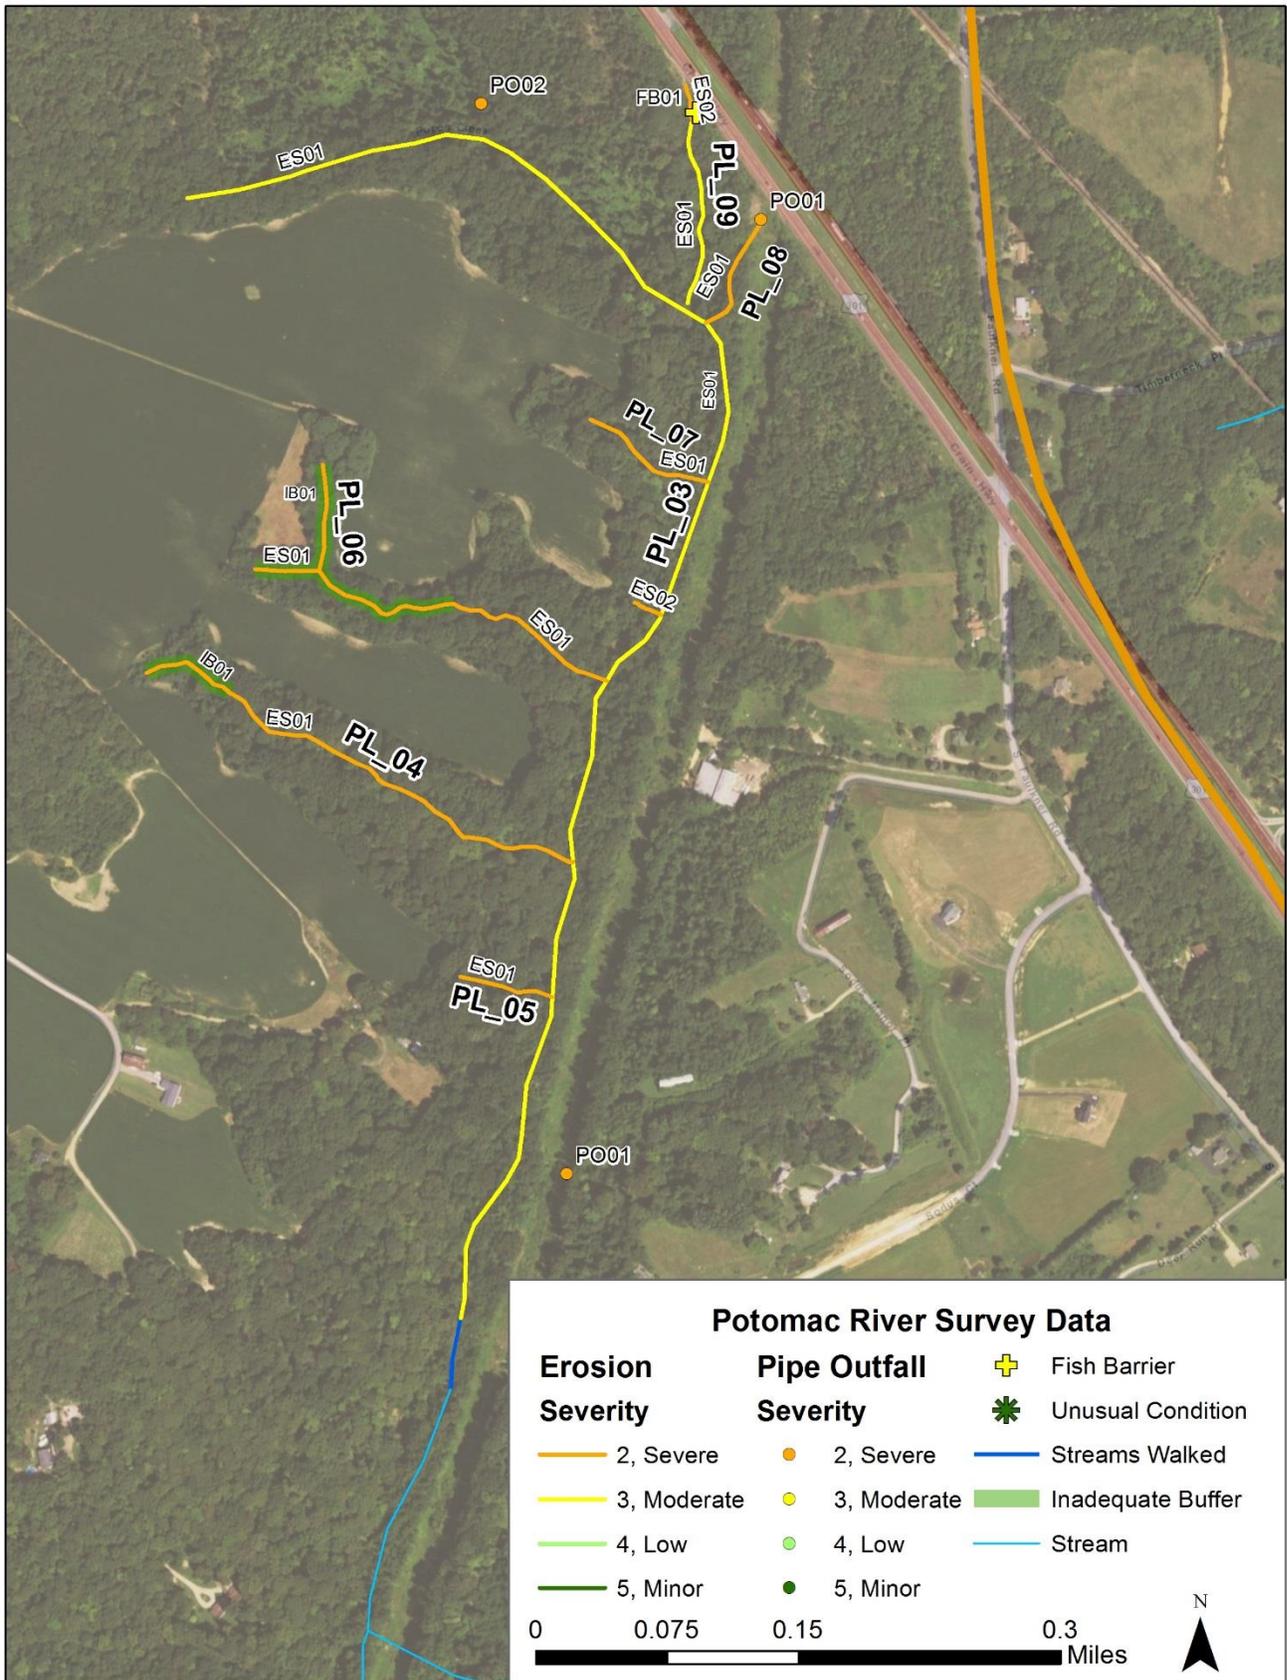
FIGURE 32. SURVEY DATA MAP SHOWING PIPE OUTFALL, EROSION, FISH BARRIER, AND INADEQUATE BUFFER SITES, POTOMAC LOWER, NORTHEASTERN PORTION

Twenty erosion sites totaling 3.9 miles were identified. The stream erosion process was identified as widening for eight sites (40%), downcutting for six sites (30%), headcutting for one site (5%), and both downcutting and widening for five sites (25%). While collecting stream erosion data, field crews also attempted to determine the leading possible cause of erosion at each site. The most commonly described possible causes for erosion was landuse change upstream (50%). Other sources include agricultural drainage (25%), pipe outfall (15%), and removal of forest buffer (10%). Three sites were determined to pose a potential threat to an adjacent roadway. Locations of erosion sites can be found in Figure 29 through Figure 34.

Inadequate buffers, defined as buffers less than 50 feet wide from the edge of the stream, were identified at 7 sites, totaling 1.2 miles of inadequate buffers. Approximately 86% of the inadequate buffer length identified was affecting both sides of the stream channel. Agriculture (crops, pasture, old field) was the cause of the inadequate buffer at 86% the sites, while a gravel road accounted for 14% of the inadequate buffer sites. The location of reaches with inadequate buffers is displayed in Figure 29 through Figure 33.

Two pipe outfalls were identified as road crossings, but all other pipe outfalls were associated with stormwater conveyance. Any observed discharge was clear and odorless. Locations and severity of these points are shown in Figure 29 through Figure 33.

Only one fish barrier was observed during the survey. The barrier was associated with the downstream side of a road crossing pipe culvert. The culvert was elevated approximately 36 inches from the downstream pool and received a severity rating of 'moderate'. The location and severity of the fish barrier is displayed in Figure 32.

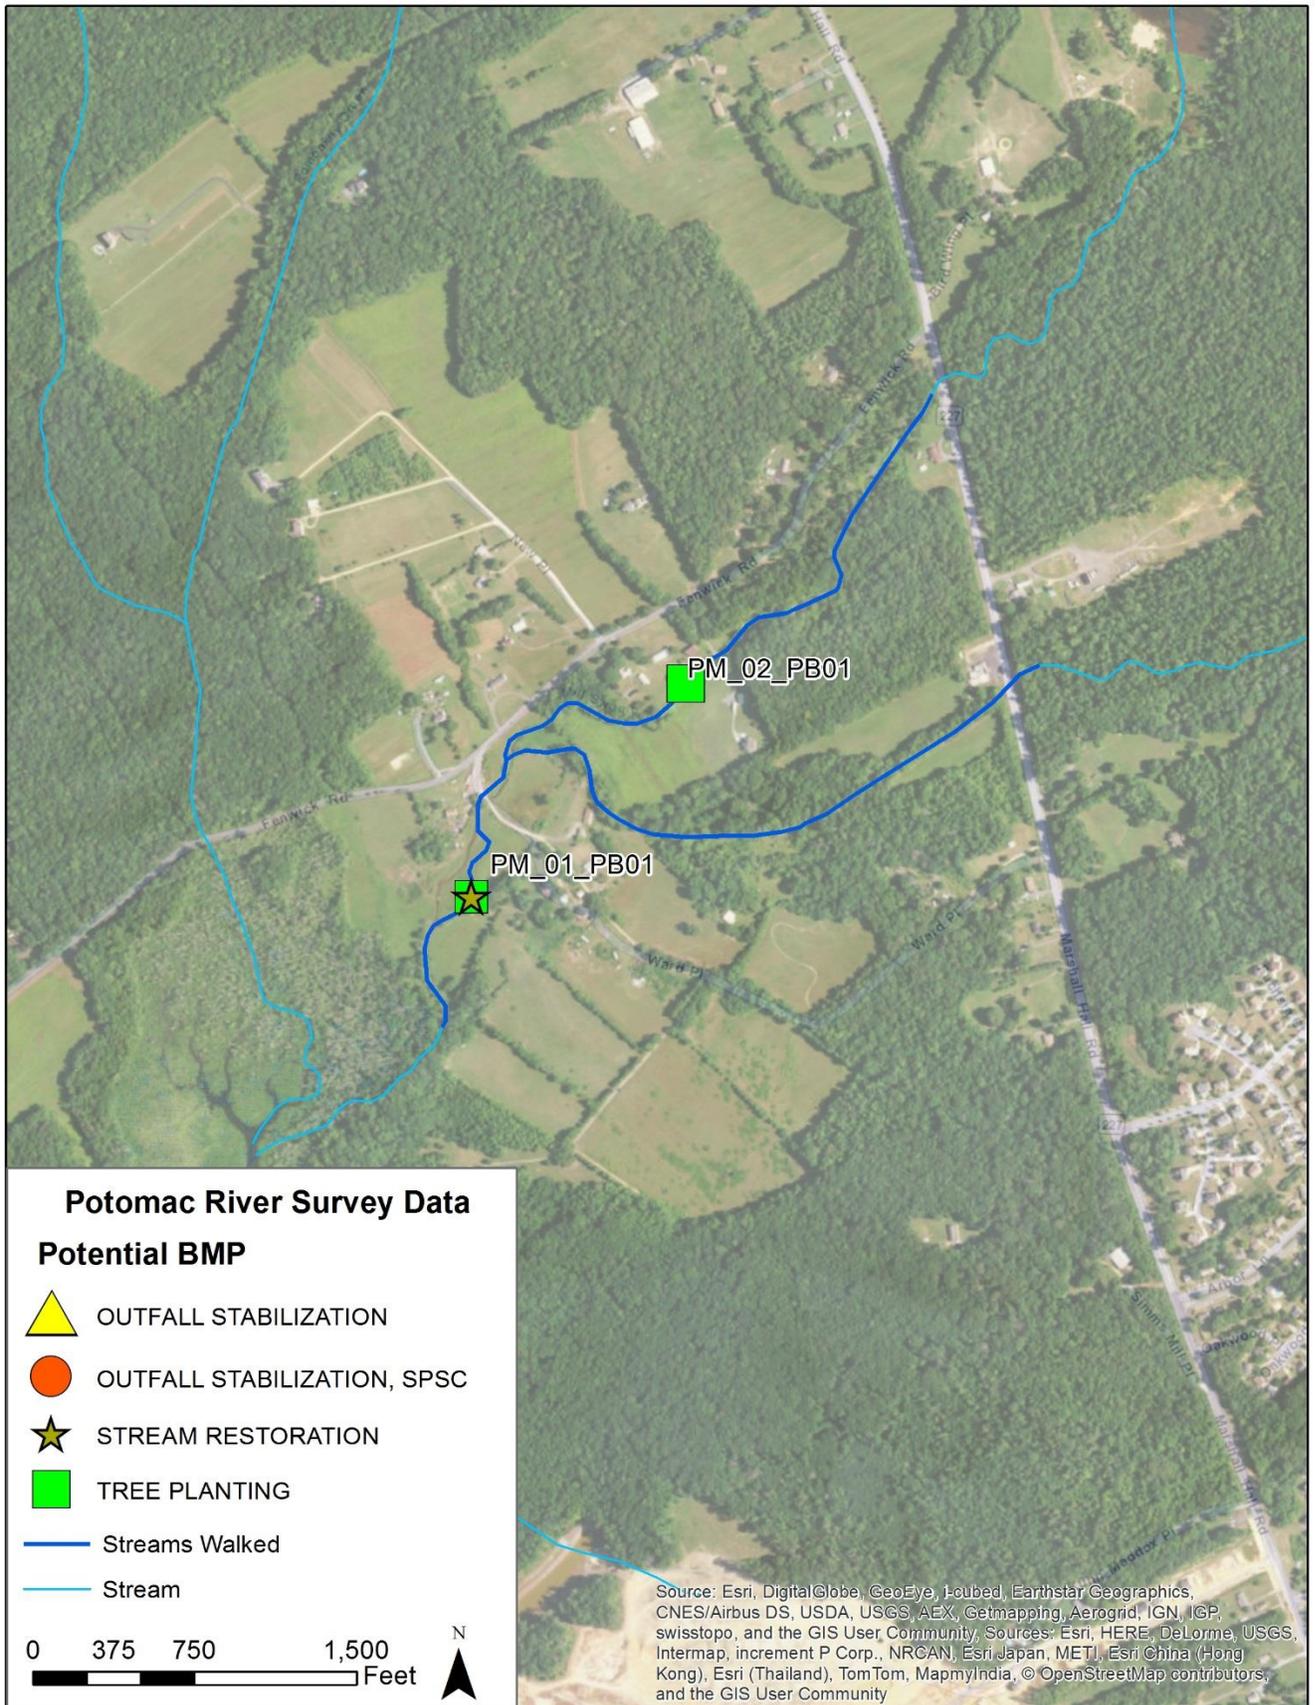
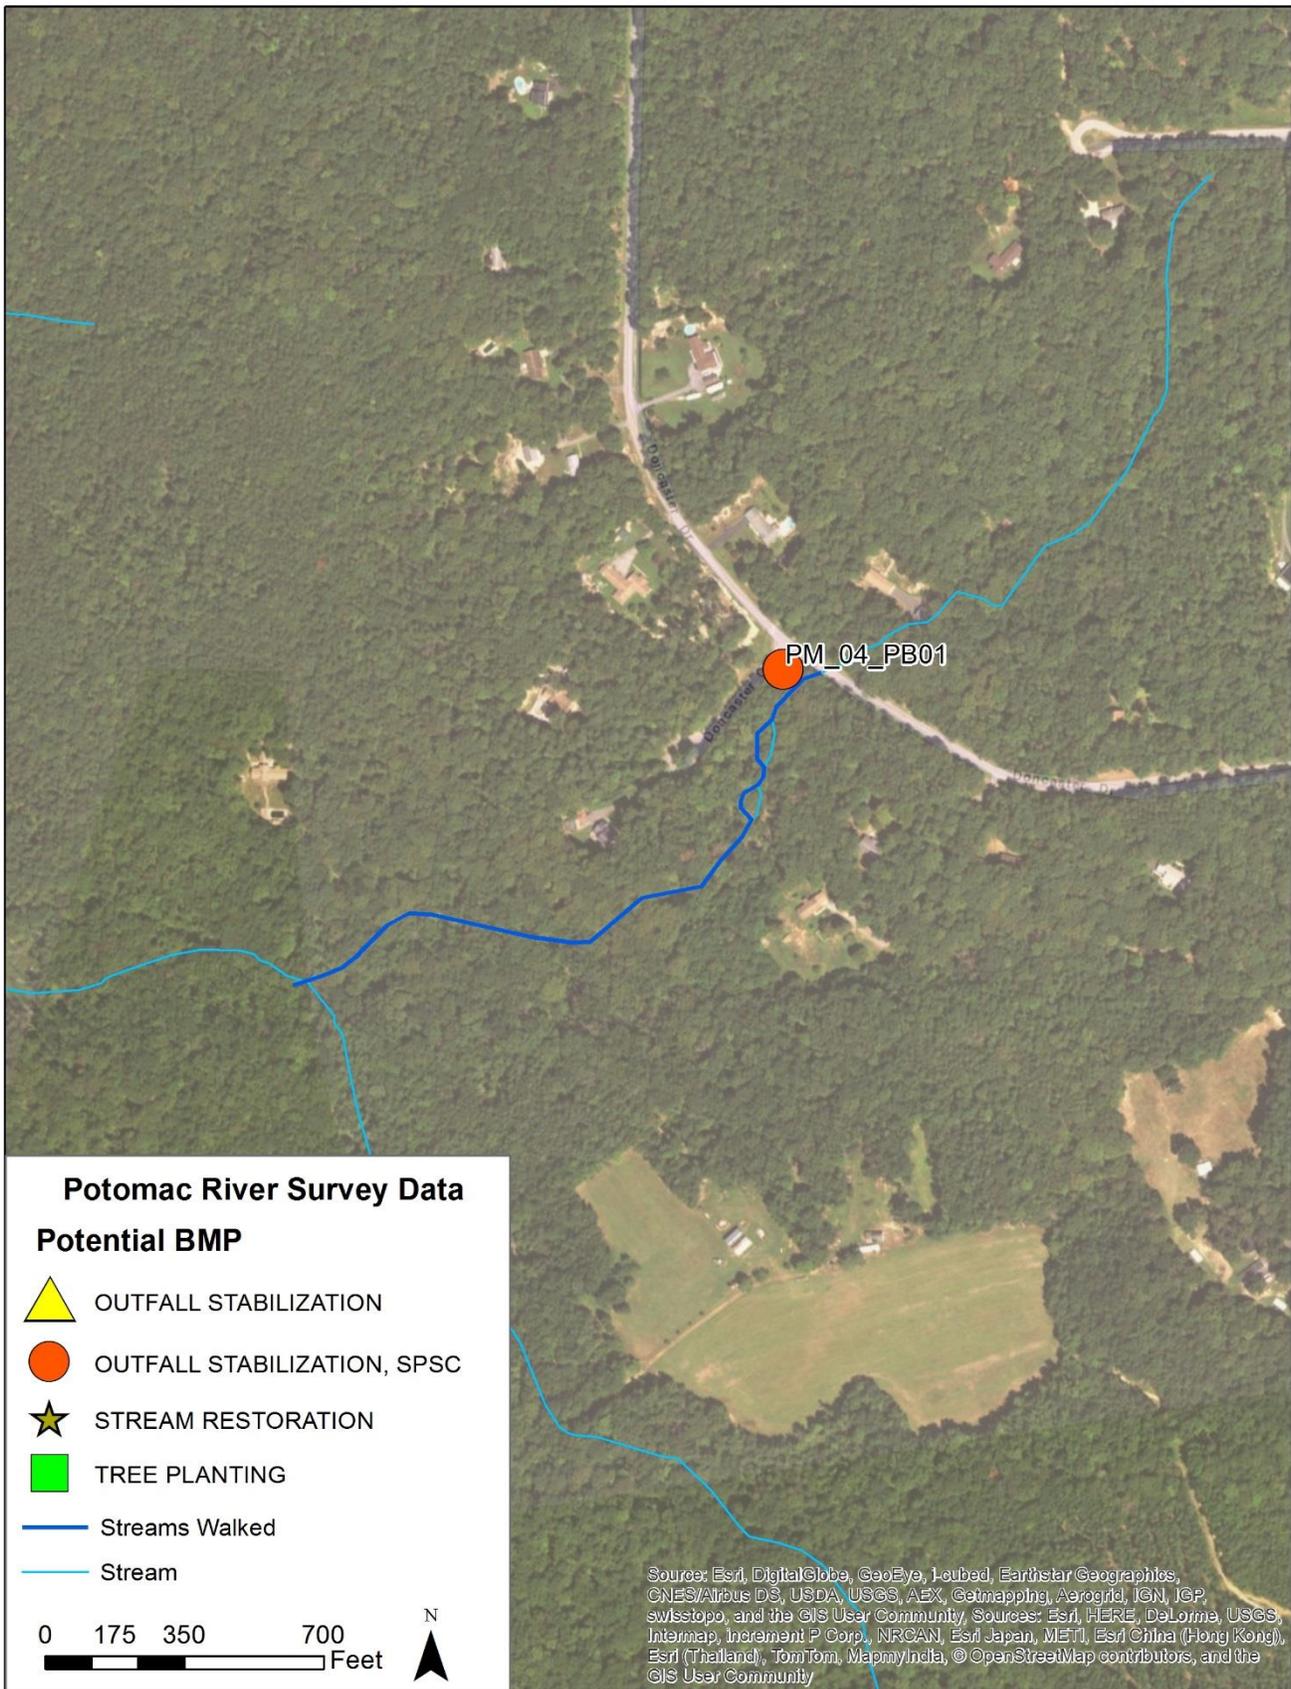
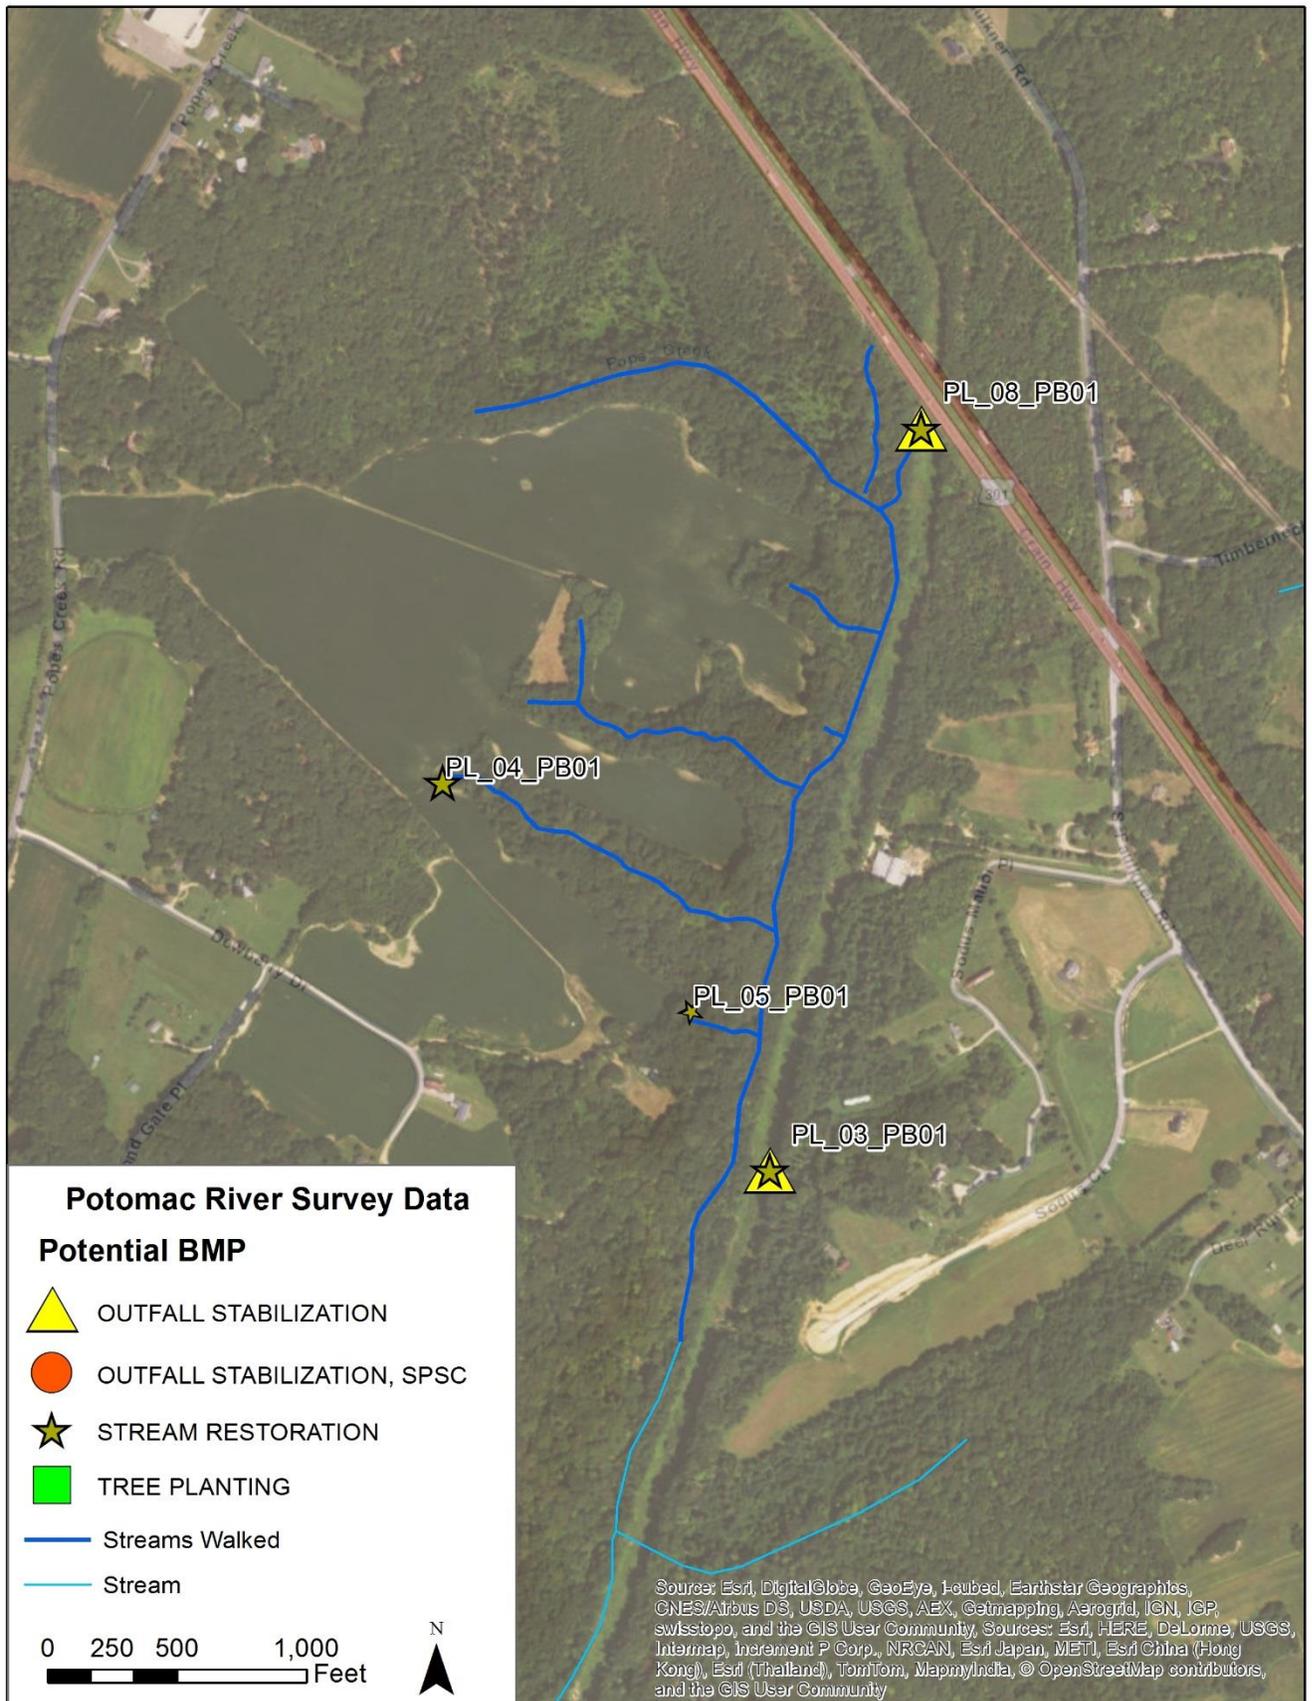
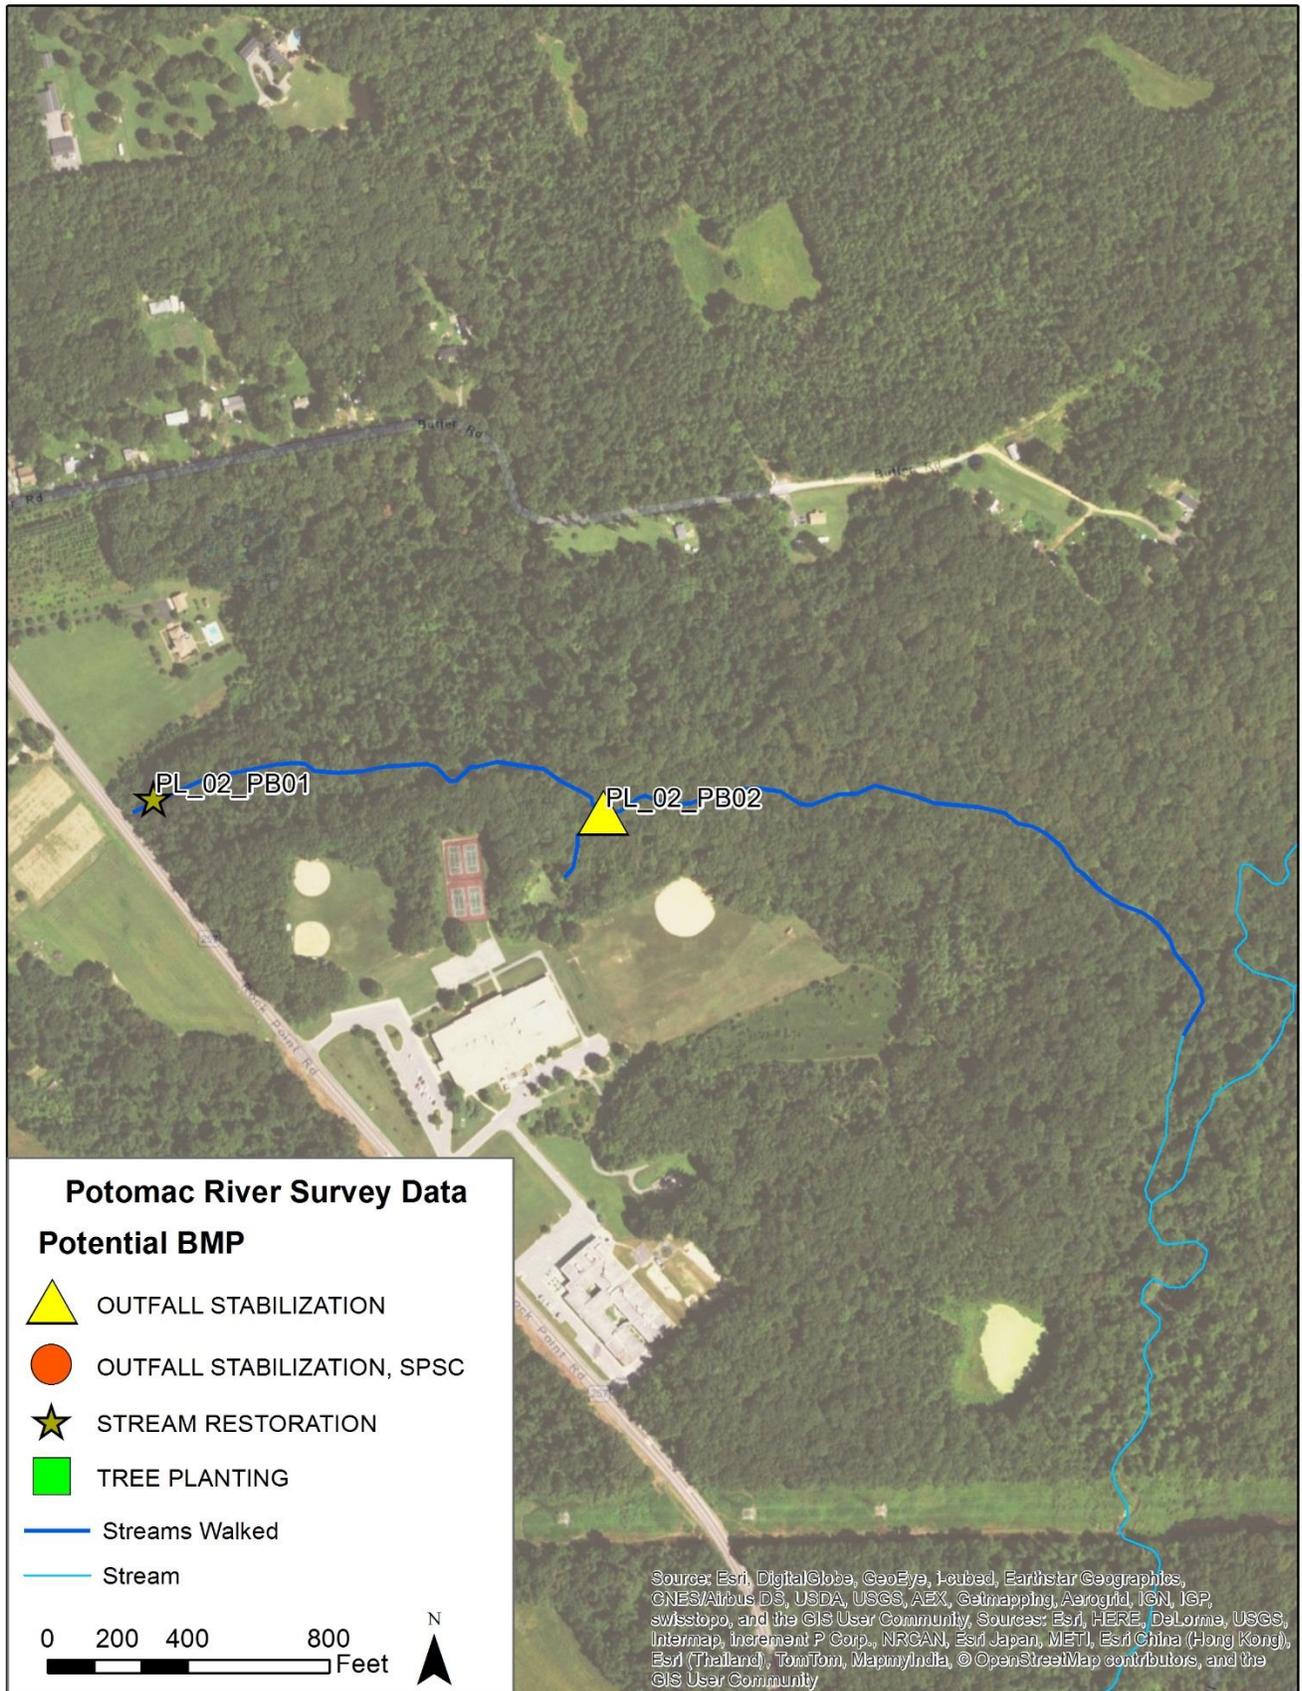
Nine initial potential improvement sites were identified during the SCA fieldwork. Recommended BMP types include, riparian buffer enhancement (two sites), stream restoration/outfall stabilization (six sites), and SPSC/outfall stabilization (two sites). More than one BMP type was suggested at one site. The locations of these preliminary sites as well as the primary BMP type are displayed in Figure 34 through Figure 37. These projects were further expanded and are presented in the following section.

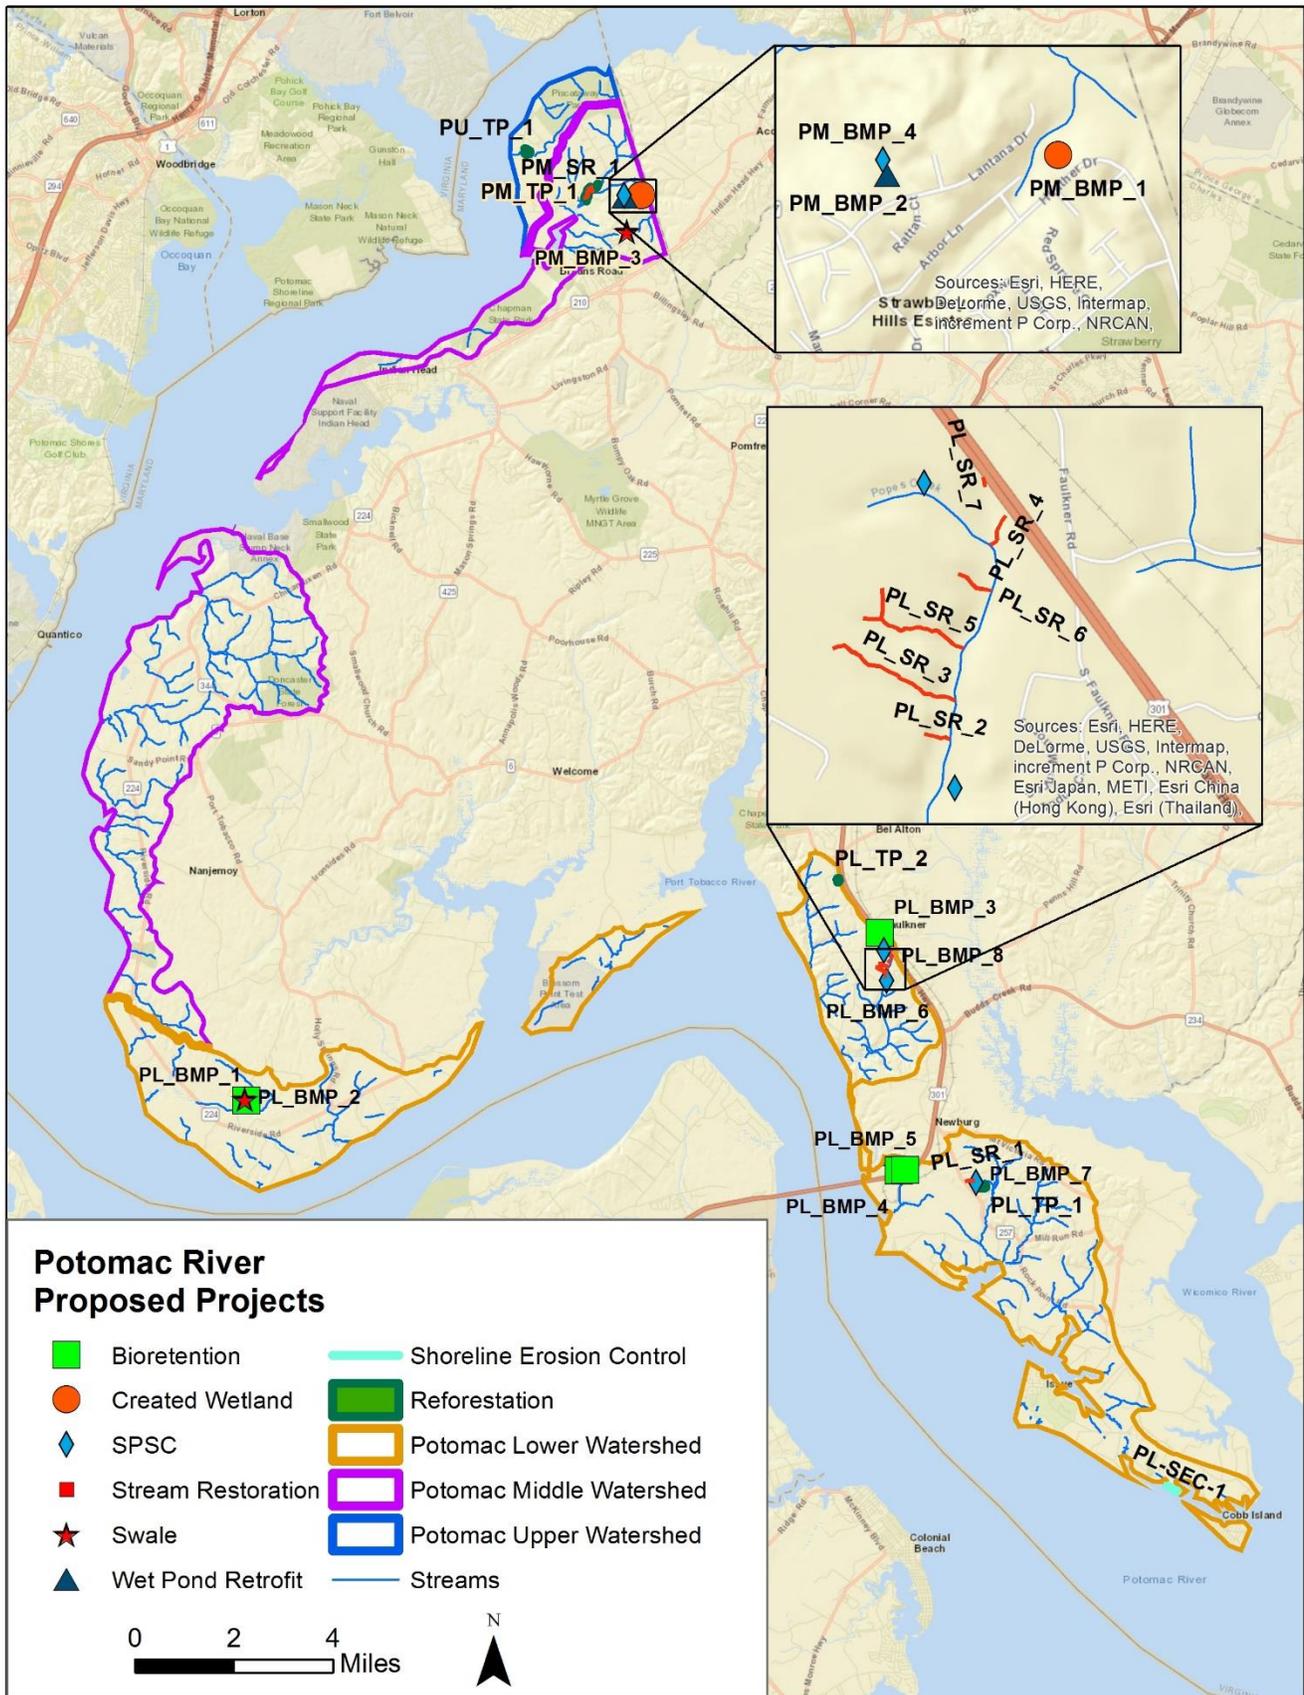
FIGURE 38: LOCATION OF POTOMAC RIVER WATERSHED POTENTIAL WATER QUALITY IMPROVEMENT PROJECTS- LEVEL 9 PROJECTS IDENTIFIED IN THIS WATERSHED ASSESSMENT

Mapping of the site specific structural practices are included in Figure 38. Tables presenting cost, load reduction, and impervious credit associated with each of the proposed projects are included in each section below.

The BMP facility types that were identified include bioretention, dry swale, created wetland, step pool storm conveyance, and wet pond retrofit. Table 18 below includes a brief discussion of the existing site conditions and the proposed site improvements. Table 19 contains a summary of the impervious area treated by the proposed BMP types. BMP locations are displayed in Figure 38.

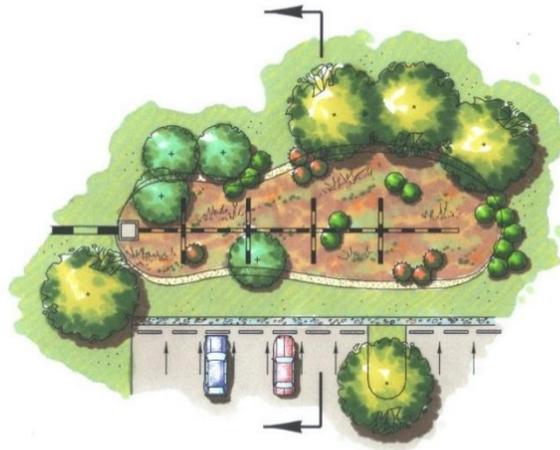
Bioretention areas generally consist of a stone diaphragm, filter fabric, filter media, landscaping, and an underdrain system. The stone diaphragm reduces the velocity of the runoff from the impervious surface that is entering the facility and also removes suspended material that may clog the filter media. The underdrain system is a perforated pipe system that collects the water that has filtered through the permeable media and transports it to a downstream open channel or connects into a nearby storm drain.

**Plan view of bioretention area**

The landscaping in a bioretention facility is also very important. The plants chosen are native plant species that are tolerant of standing water. A wide variety of trees, shrubs, and herbaceous plants are selected for varying levels of vegetative uptake, for encouragement of various wildlife species, and for improved aesthetics. The permeable soil in the bioretention area is approximately 2.5 feet to 4 feet deep with 3 inches of mulch above it.

The ponding within the bioretention area is typically 6 inches to 12 inches. There is generally a catch basin or weir provided within the ponding area that is used for overflow when the ponding area reaches its maximum volume.

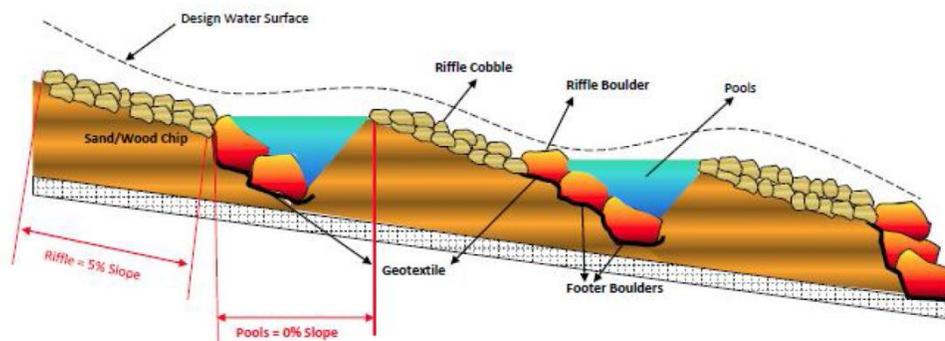
An SPSC system consists of alternating pools and riffle channels. The length of the pools is typically twice the length of the riffles and a minimum of 18 inches deep. The maximum length of the riffle structures is typically eight feet so as not to build excessive energy. Also, an SPSC segment used for water quality should not exceed 5% in longitudinal slope. If the overall slope exceeds five percent, boulder cascades may be utilized to traverse the grade. All unarmored sides of the pool are laid at no steeper than 3H:1V. In the event the connecting stream is incised, boulders are used to construct an in-stream weir.

**Profile for Regenerative Stormwater Conveyance System (source: Anne Arundel County, 2011)**

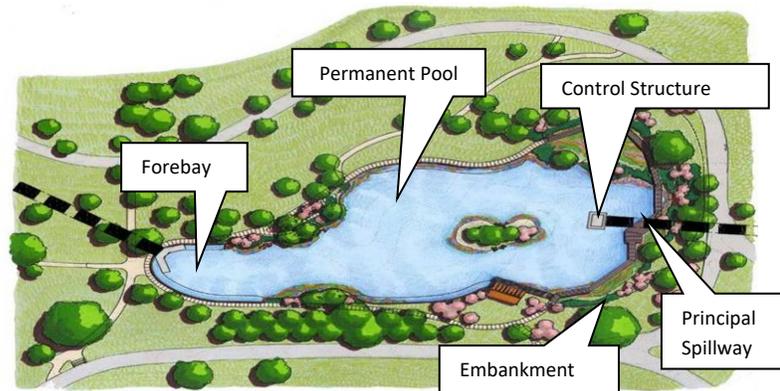
A wet pond typically consists of a forebay, embankment, control structure, principal spillway, and a permanent pool. The forebay is small pool located at the inflow of a pond and is designed to allow coarse sediment to settle out of the water column before it flows into the main body of the pond. The embankment, which is typically designed to confine the 100-year storm, contains a clay core to minimize seepage from the upstream side to the downstream side. The principal spillway runs through the embankment and is the primary means for flow to leave the pond. The control structure regulates the level of water within the facility. It has openings set at specific elevations, the lowest of which controls the depth of water in the pond. The permanent pool is the elevation of water that remains in the facility, maintained by the control structure.

Plan view of wet pond

Typically a safety bench is installed just above the permanent pool elevation around the perimeter of the pond. Approximately 18 inches below the water surface is typically an aquatic bench that is required to be put in for wetland planting to improve aesthetics and vegetative uptake of nutrients. The aquatic bench should extend to a depth of 18 inches below the permanent pool elevation. The combined minimum width of these two benches is 15 feet.

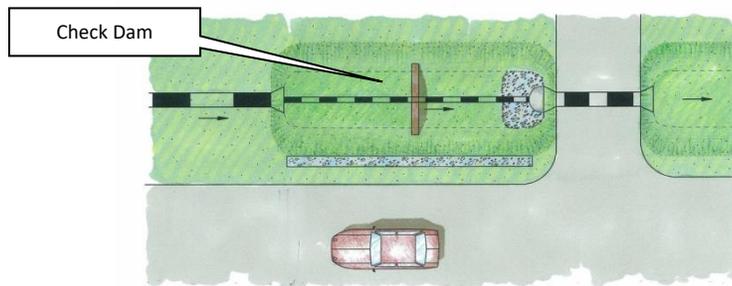
A dry swale contains filter material, an underdrain system, and check dams. The filter material is typically 2.5 feet of permeable soil underlain by a gravel bed surrounding an underdrain system consisting of a perforated pipe. The pipe conveys the filtered water to the downstream channel or a local storm drain.

A check dam is a small dam used within the channel to temporarily pool water, which promotes deposition of sediment, increases filtration through the filter media, and reduces flow velocities. Check dams allow channels to have a longitudinal slope of up to 4% and still provide WQv with non-erosive flow velocities.

**Plan view of Dry Swale**

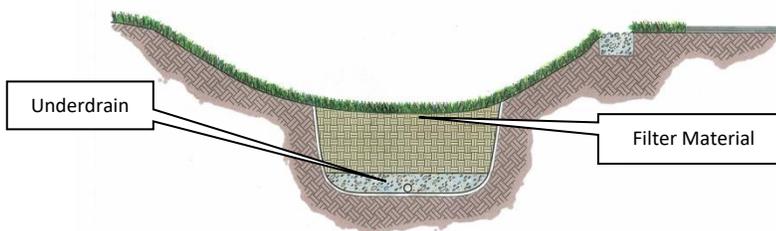
The side slopes of a dry swale are typically designed to be flatter than 3:1. The vegetative cover usually consists of grass with some riprap at swale inlets and outlets. The bottom width of the dry swale is between two feet and eight feet and the maximum ponding depth is 18 inches.

**Cross section of Dry Swale**

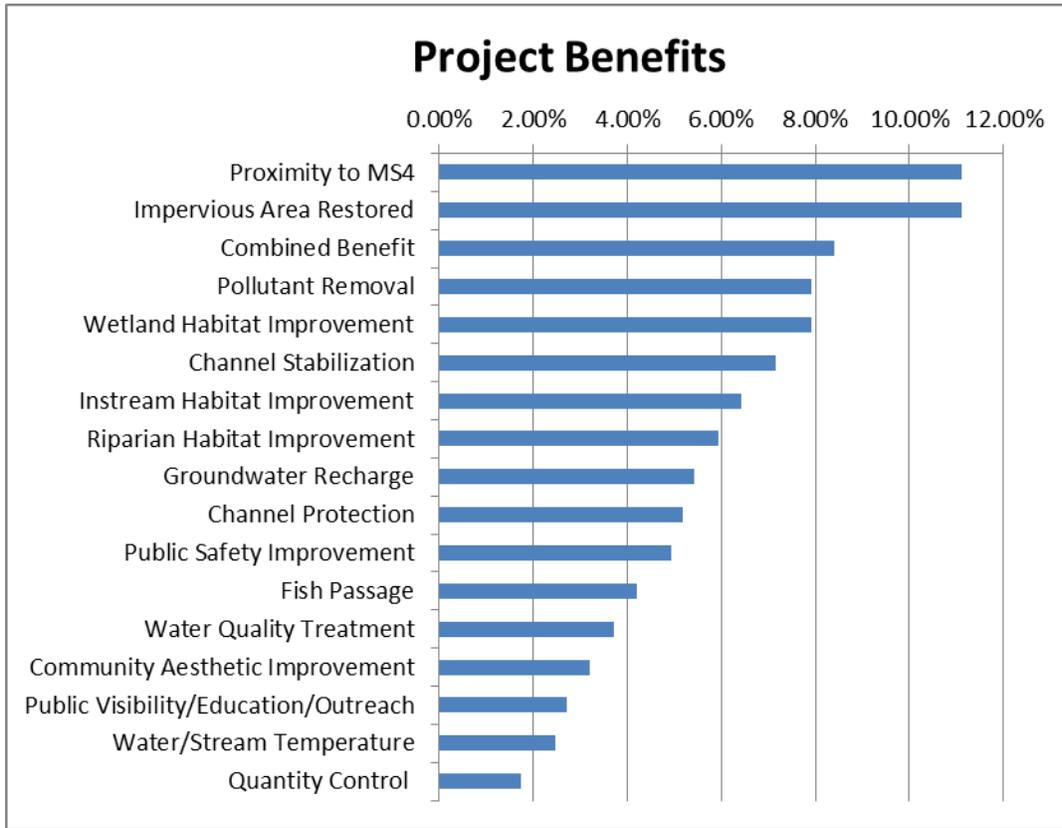
Figure 1: Project Benefits Metric

Each metric was analyzed by the project team by comparing pairs of metrics to evaluate which has greater importance. The project team included representatives from Charles County Department of Planning and Growth Management. Each metric is evaluated individually against all of the other metrics and the evaluator selects one by one, which metric has greater importance. The results are tabulated for each metric category (benefits, constraints, costs). Metrics with the greatest number of selections represent those that were felt overall to be the most important. Results are presented in Figures 1-3.
