MATTAWOMAN CREEK

WATERSHED ASSESSMENT

MAY | 2016

KCI TECHNOLOGIES, INC.

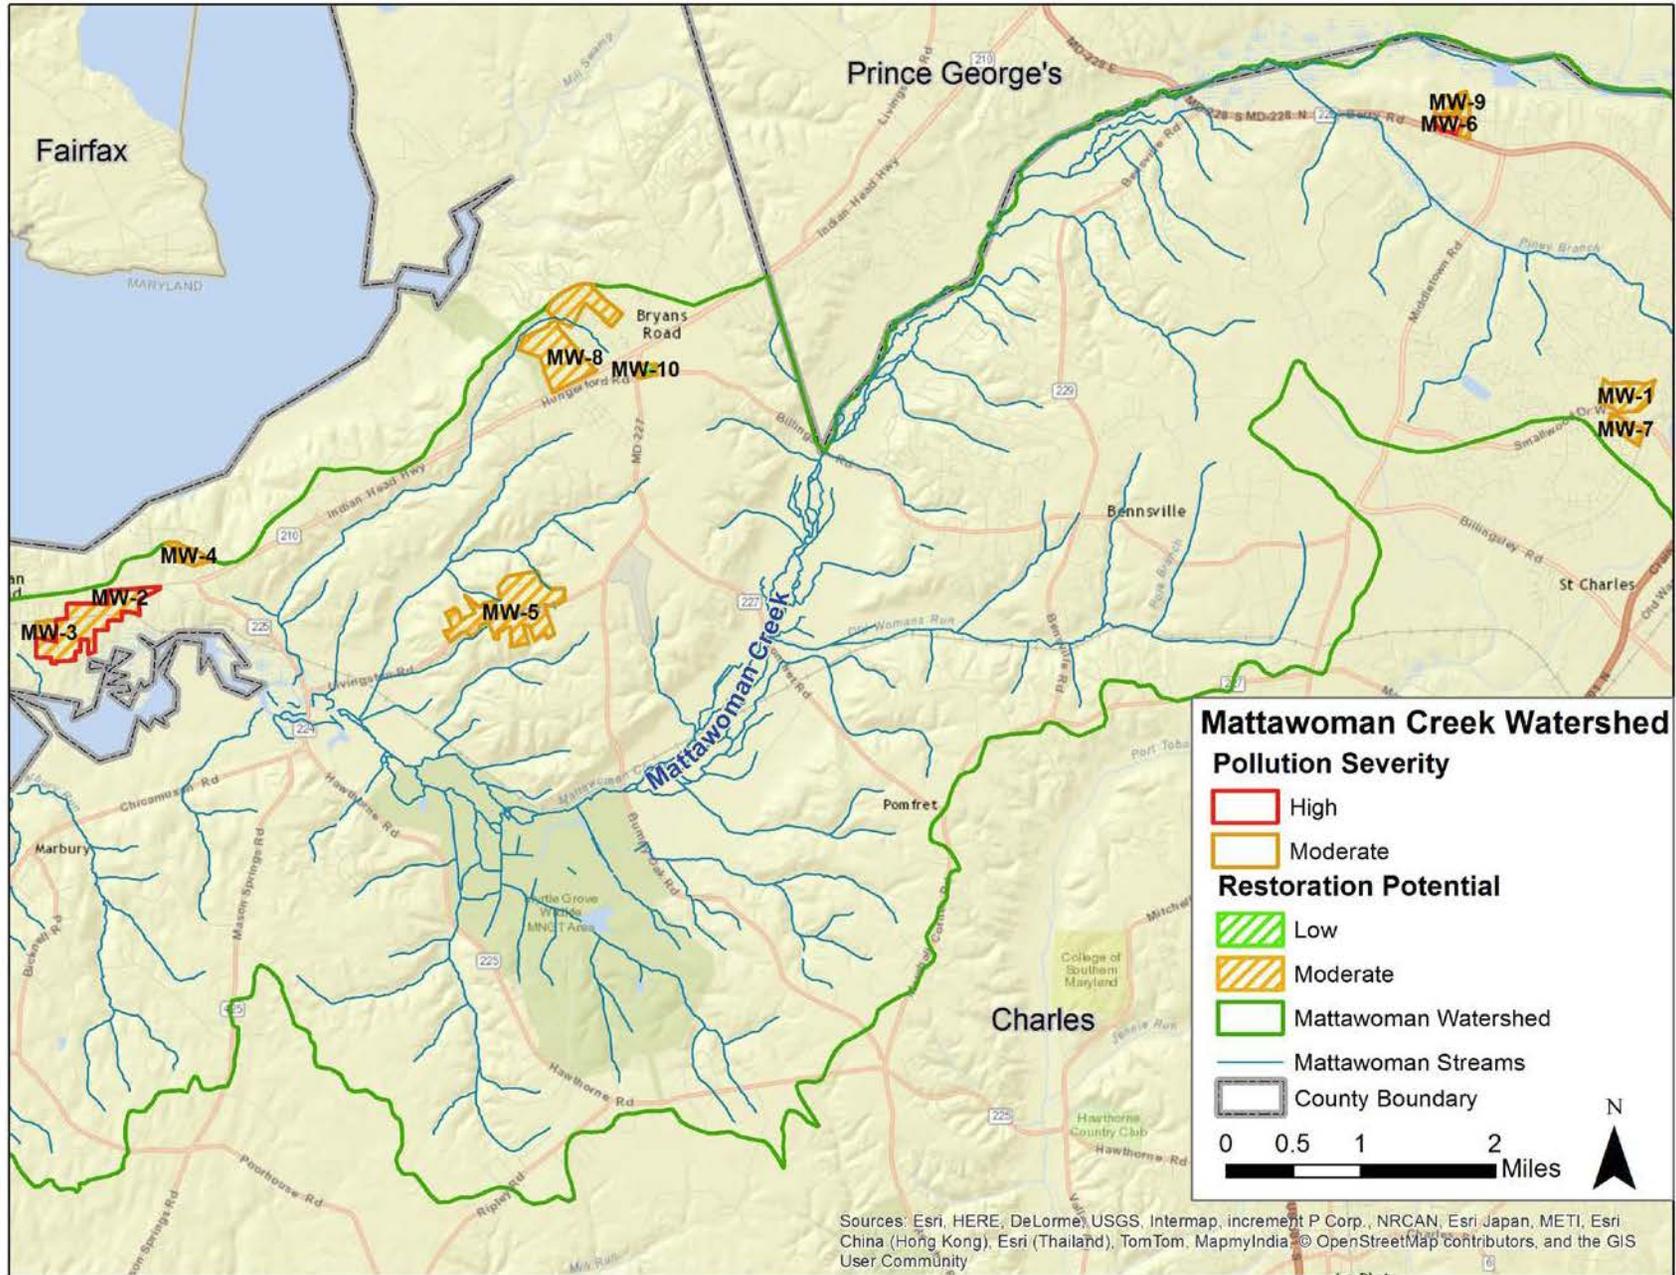
FIGURE 3: NEIGHBORHOOD SOURCE ASSESSMENT RESULTS

Of the 10 neighborhoods assessed, only two (Indian Head and Somerset) received a ‘high’ pollution severity rating due to the potential for nutrient, bacteria, sediment, and oil and grease pollution (Table 6). All other neighborhoods received a “moderate” pollution severity rating.

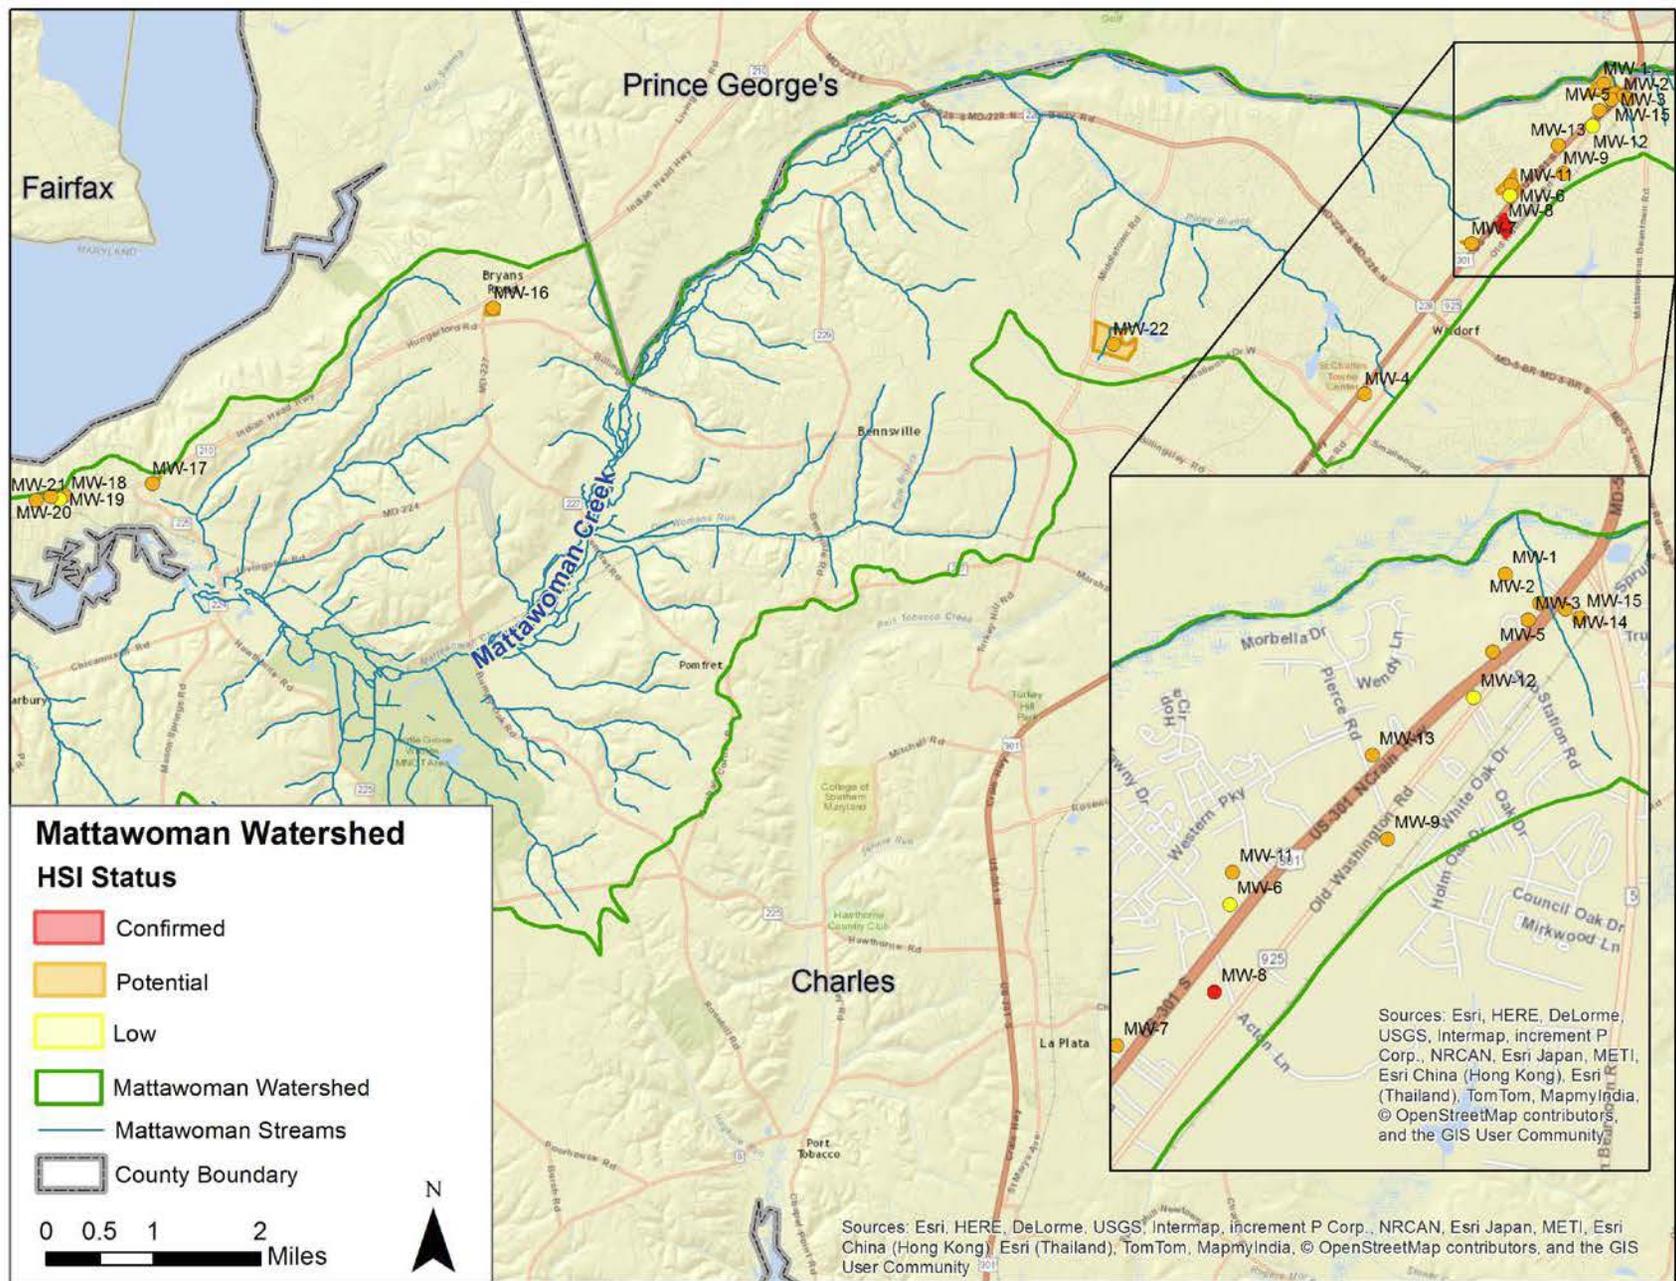
FIGURE 4: HOT SPOT INVESTIGATION RESULTS

A total of 21 sites were investigated in the Mattawoman Creek watershed (Figure 4). The location, general description, and common operations (i.e., vehicle operations, outdoor materials, waste management, physical plant, turf/landscaping) of each site investigated are presented in Table 7. A complete record of HSI data is included in Appendix B.

Of the 21 sites investigated, only one (MW-8) was designated 'confirmed' as having high potential for discharging pollutants into stormwater runoff (Table 7). A total of 17 locations were designated as 'potential' hotspots, while the remaining three sites were considered 'low' potential. It was recommended that a review of the storm water pollution prevention plan is scheduled at 12 sites (55%). Specific recommendations for each site can be found in Table 7.

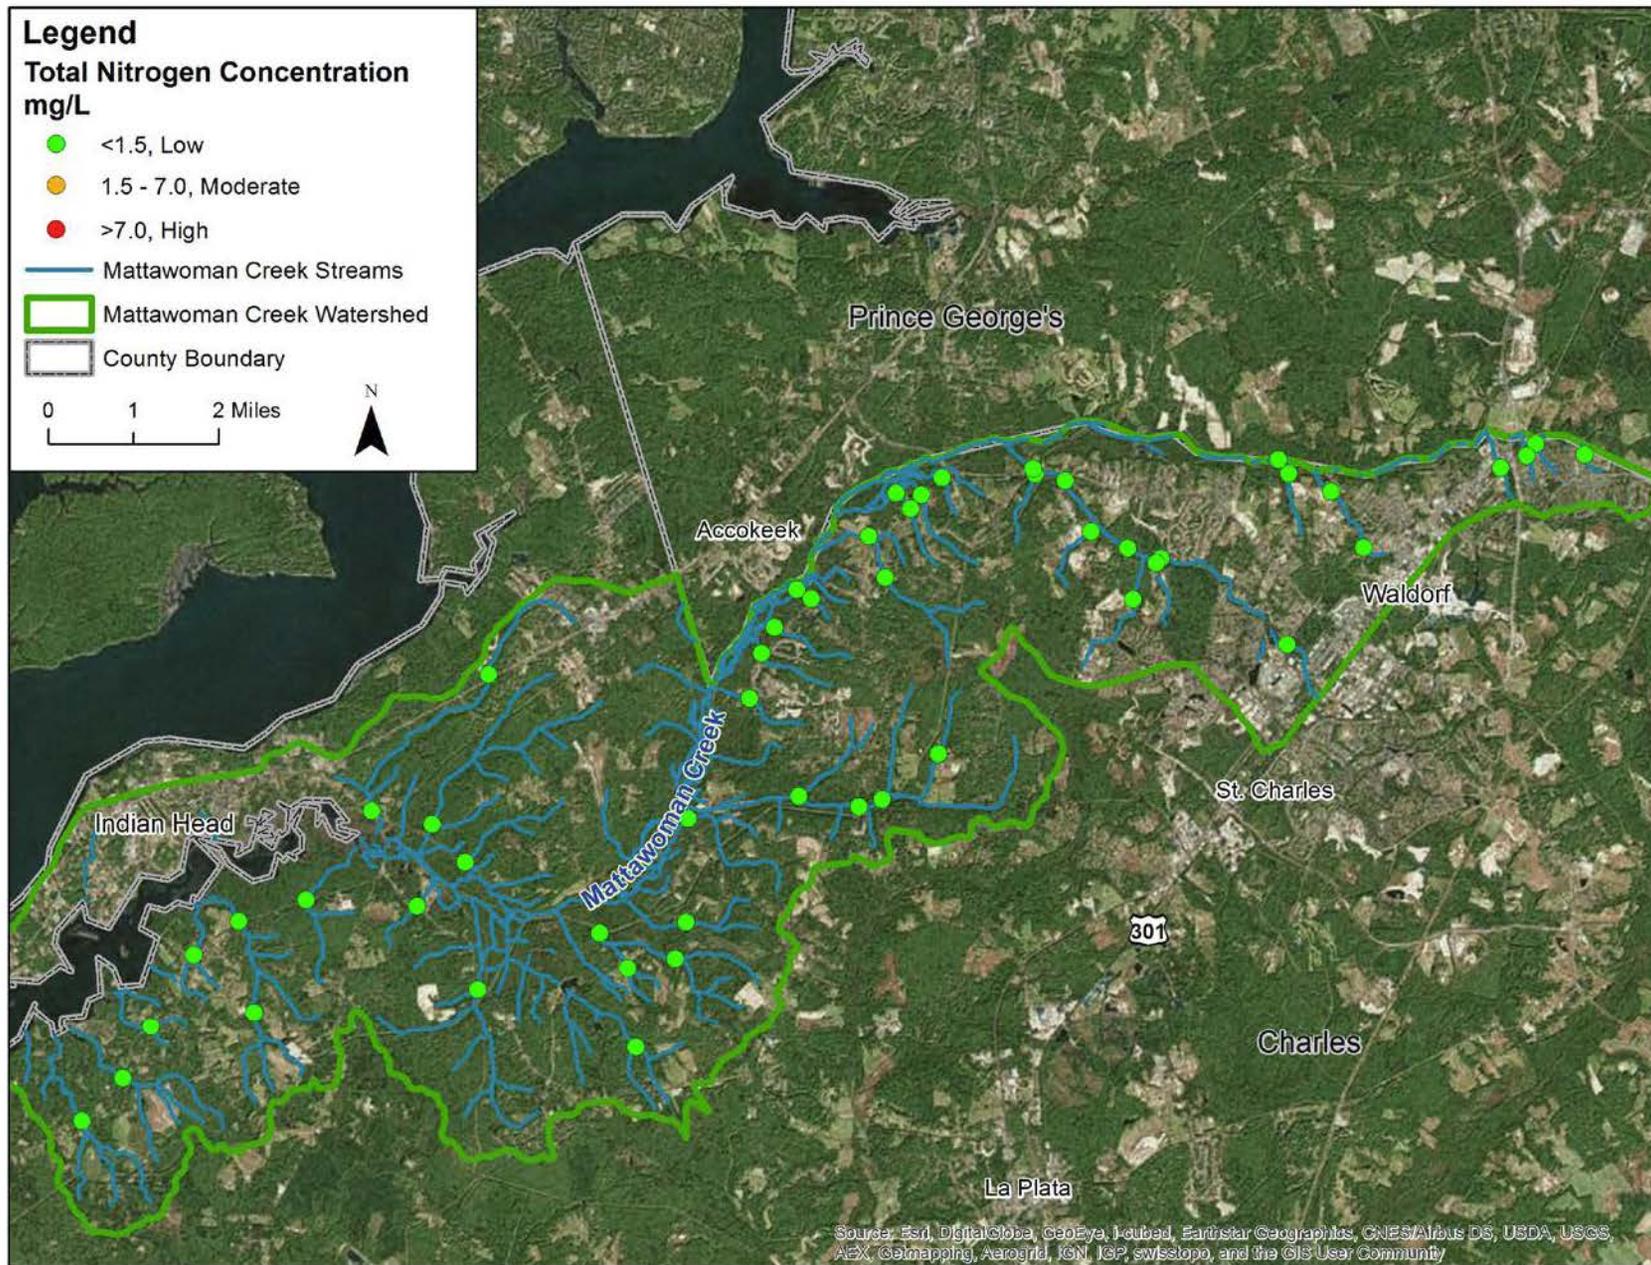
FIGURE 6: SYNOPTIC WATER QUALITY SURVEY SAMPLING RESULTS: TOTAL NITROGEN CONCENTRATION

Total nitrogen concentrations were low in all subwatersheds (Figure 6 and Table 11). Nitrate/nitrite concentrations were moderate in three subwatersheds (Figure 12 and Table 11). Baseline concentrations were found in the remaining subwatersheds (Figure 7 and Table 11). Instantaneous nitrate/nitrite yields were moderate in only one subwatershed and baseline in the remaining subwatersheds (Figure 7 and Table 11).

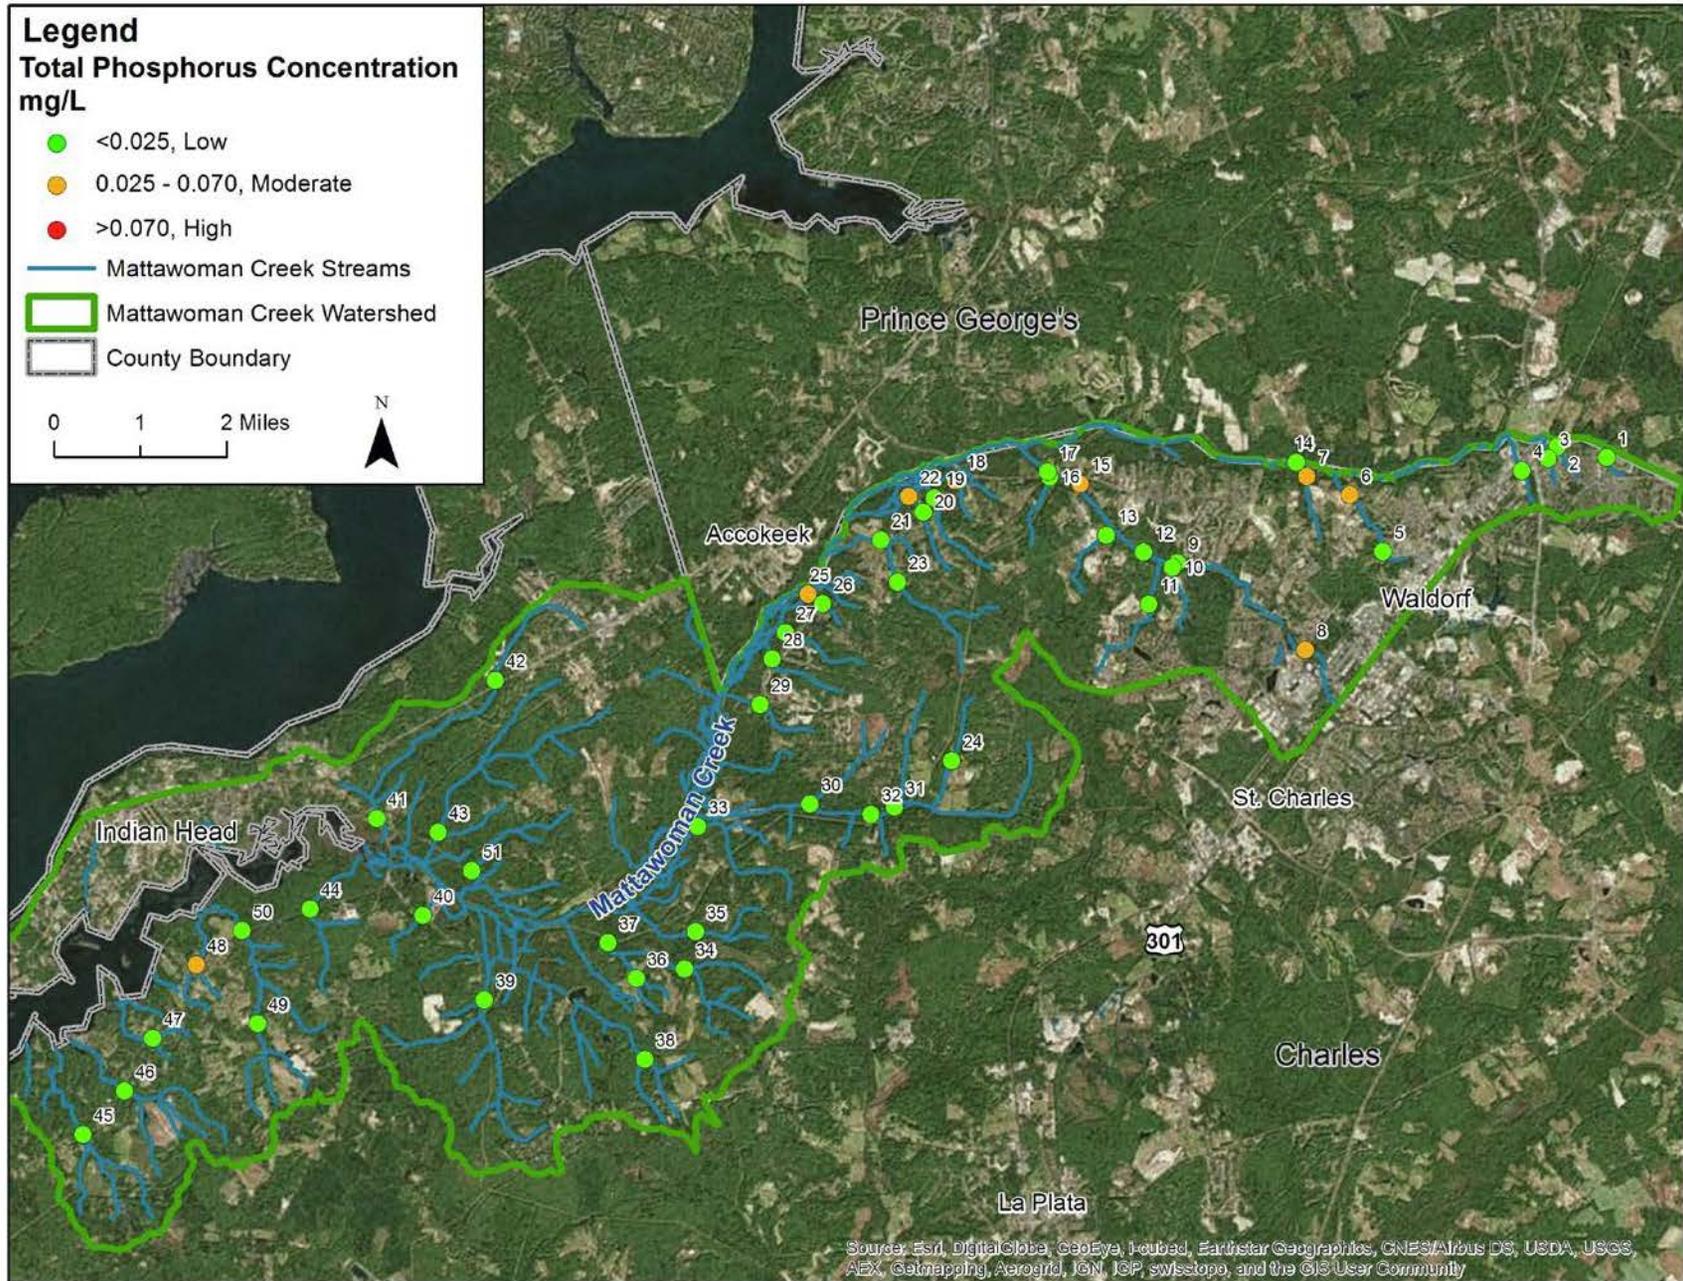
FIGURE 8: SYNOPTIC WATER QUALITY SURVEY SAMPLING RESULTS: TOTAL PHOSPHORUS CONCENTRATION

Total phosphorus concentrations were moderate in eight subwatersheds, and low in the remaining subwatersheds (Figure 8 and Table 11). Excessive concentrations of orthophosphate were found in 16 subwatersheds, which had values ranging from 0.005 mg/L to 0.400 mg/L (Figure 9 and Table 11). Moderate concentrations were found in 34 subwatersheds, however half the detection limit for orthophosphate (0.005) falls between the baseline and moderate ratings, therefore the 32 subwatersheds that were below the detection limit should be considered to have baseline levels.

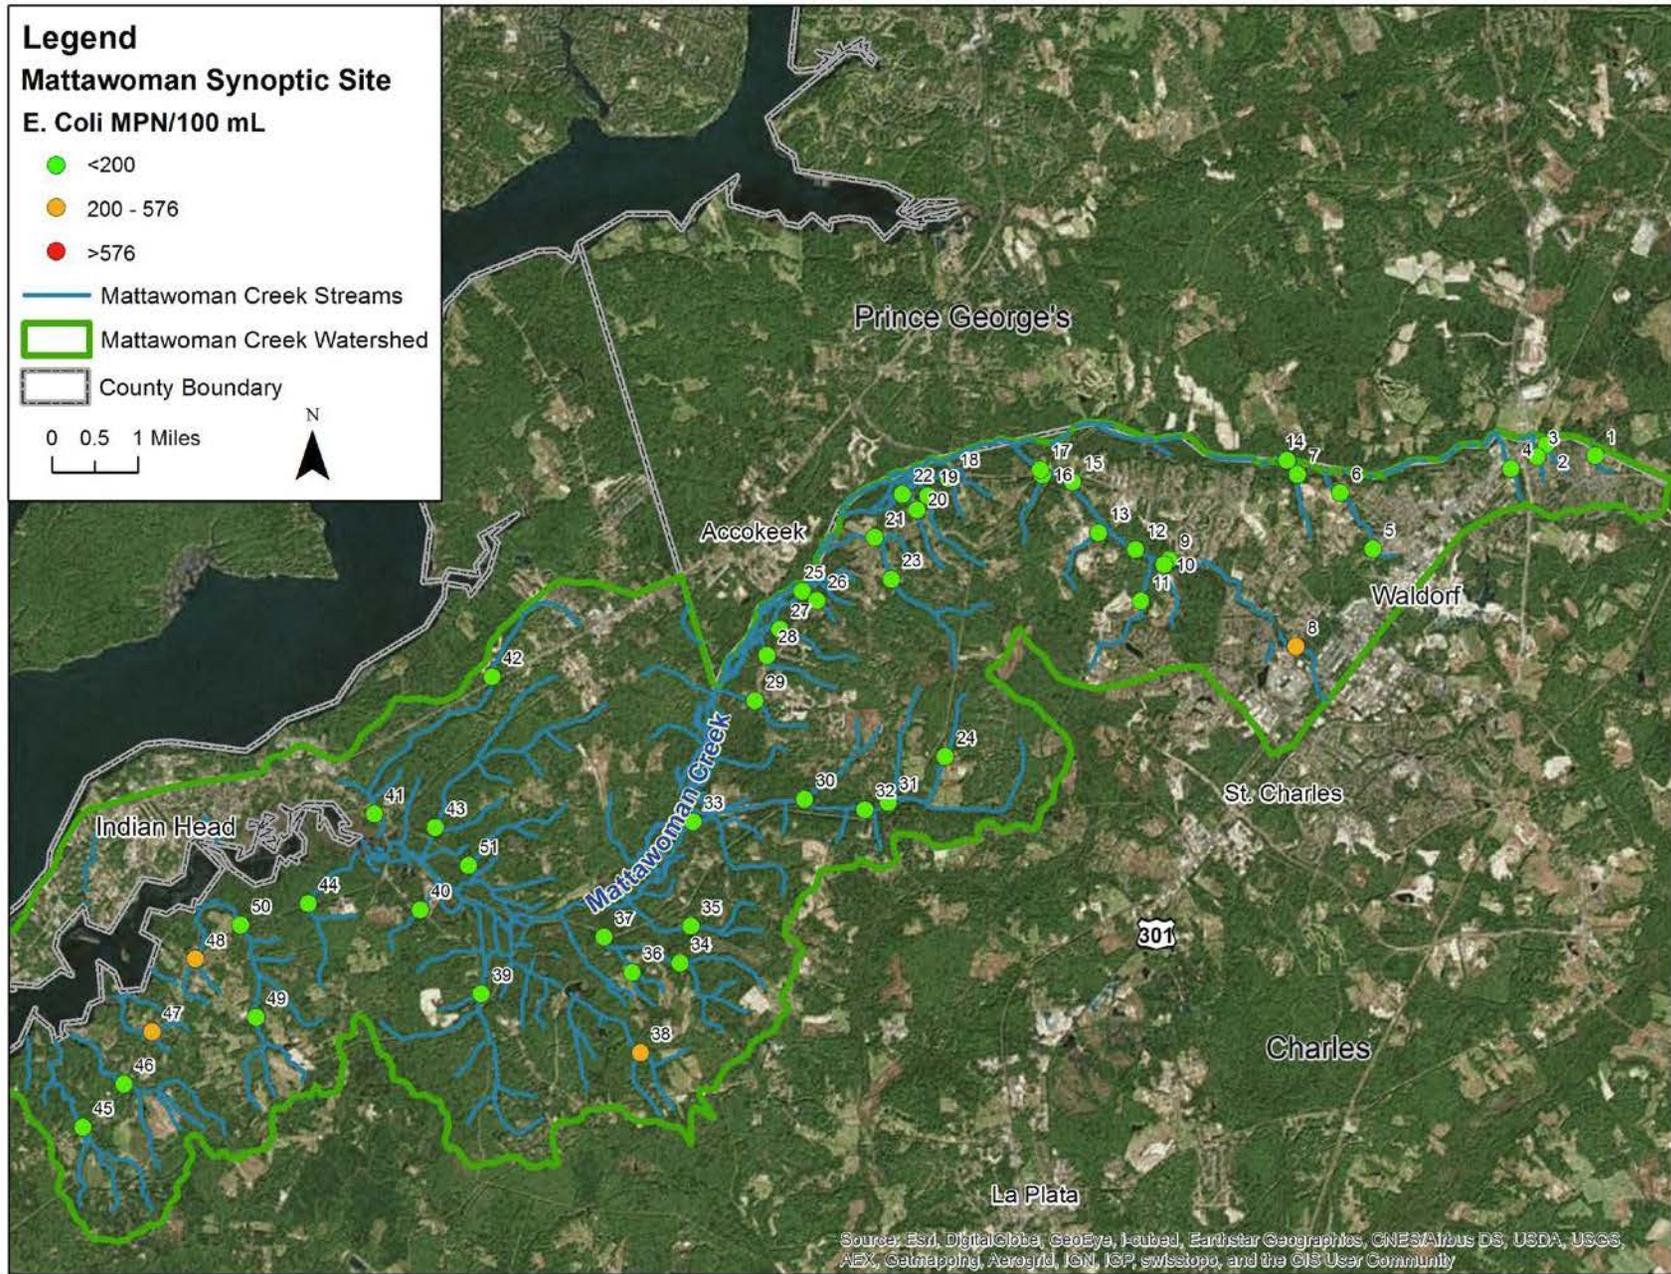
FIGURE 10: SYNOPTIC WATER QUALITY SURVEY SAMPLING RESULTS: BACTERIA

Elevated bacteria levels (*E. coli* > 576 mpn/100 ml; mpn = most probable number) were not found at any sites, however four subwatersheds had levels exceeding the standard for water contact recreation of 200mpn/100 ml (Figure 10 and Table 11).

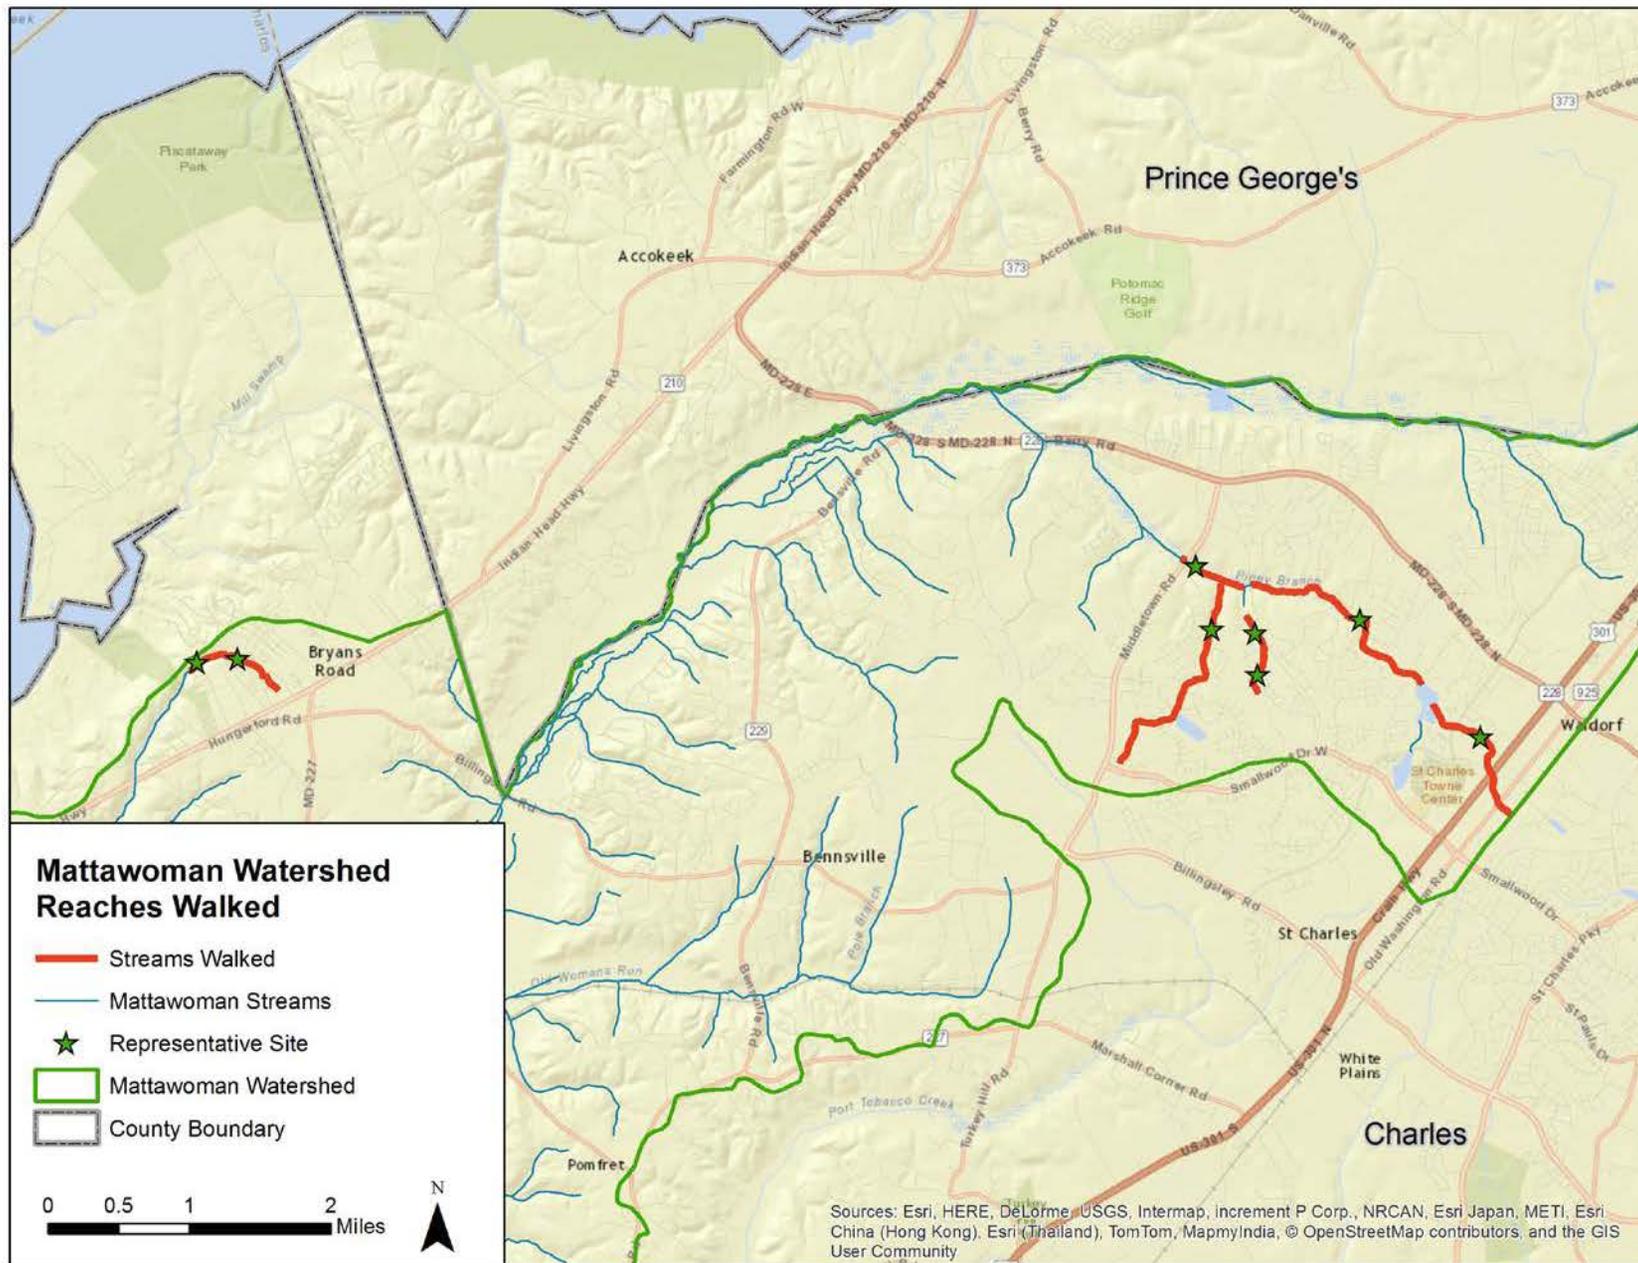
FIGURE 11: MATTAWOMAN CREEK WATERSHED STREAM CORRIDOR ASSESSMENT REACHES WALKED AND REPRESENTATIVE SITES

Field crews walked approximately 6.3 miles of mapped stream channels between April 21 and 24, 2015. Figure 11 shows the stream reaches walked by field crews and the location of the representative sites for each walked reach. Erosion sites, pipe outfalls, and buffer breaks were the most widespread and frequent problems identified. The total number of points identified and ranked by severity in each watershed can be found in Table 12. The majority of points were categorized as moderate to minor severity. Only one point received a rating of “very severe,” while 12 received a rating of “severe”. A more detailed discussion of each data point type follows. A complete dataset is included as Appendix C.

Representative points were taken at 8 locations (Figure 11). Figure 12, below, presents the proportion of reaches in each assessment category for each habitat parameter, giving insight into the types of stream impacts creating the most degradation. In general, the modified qualitative RBP assessment at these sites revealed stream channels dominated by sand and gravel substrates. None of the stream reaches assessed were rated “poor” for riparian and bank vegetation, but ratings ranged from “marginal” to “optimal”. Stream reaches with channel alteration were generally in good condition and no reaches receiving a “poor” or “marginal” rating. There was moderate sediment deposition throughout the study area, with only one site rated “poor”. Channel flow status was good throughout the study area. Both velocity/depth diversity and shelter for fish were found to be “suboptimal” at all of the reaches assessed. Benthic substrate was generally rated “suboptimal” throughout majority of the reaches.

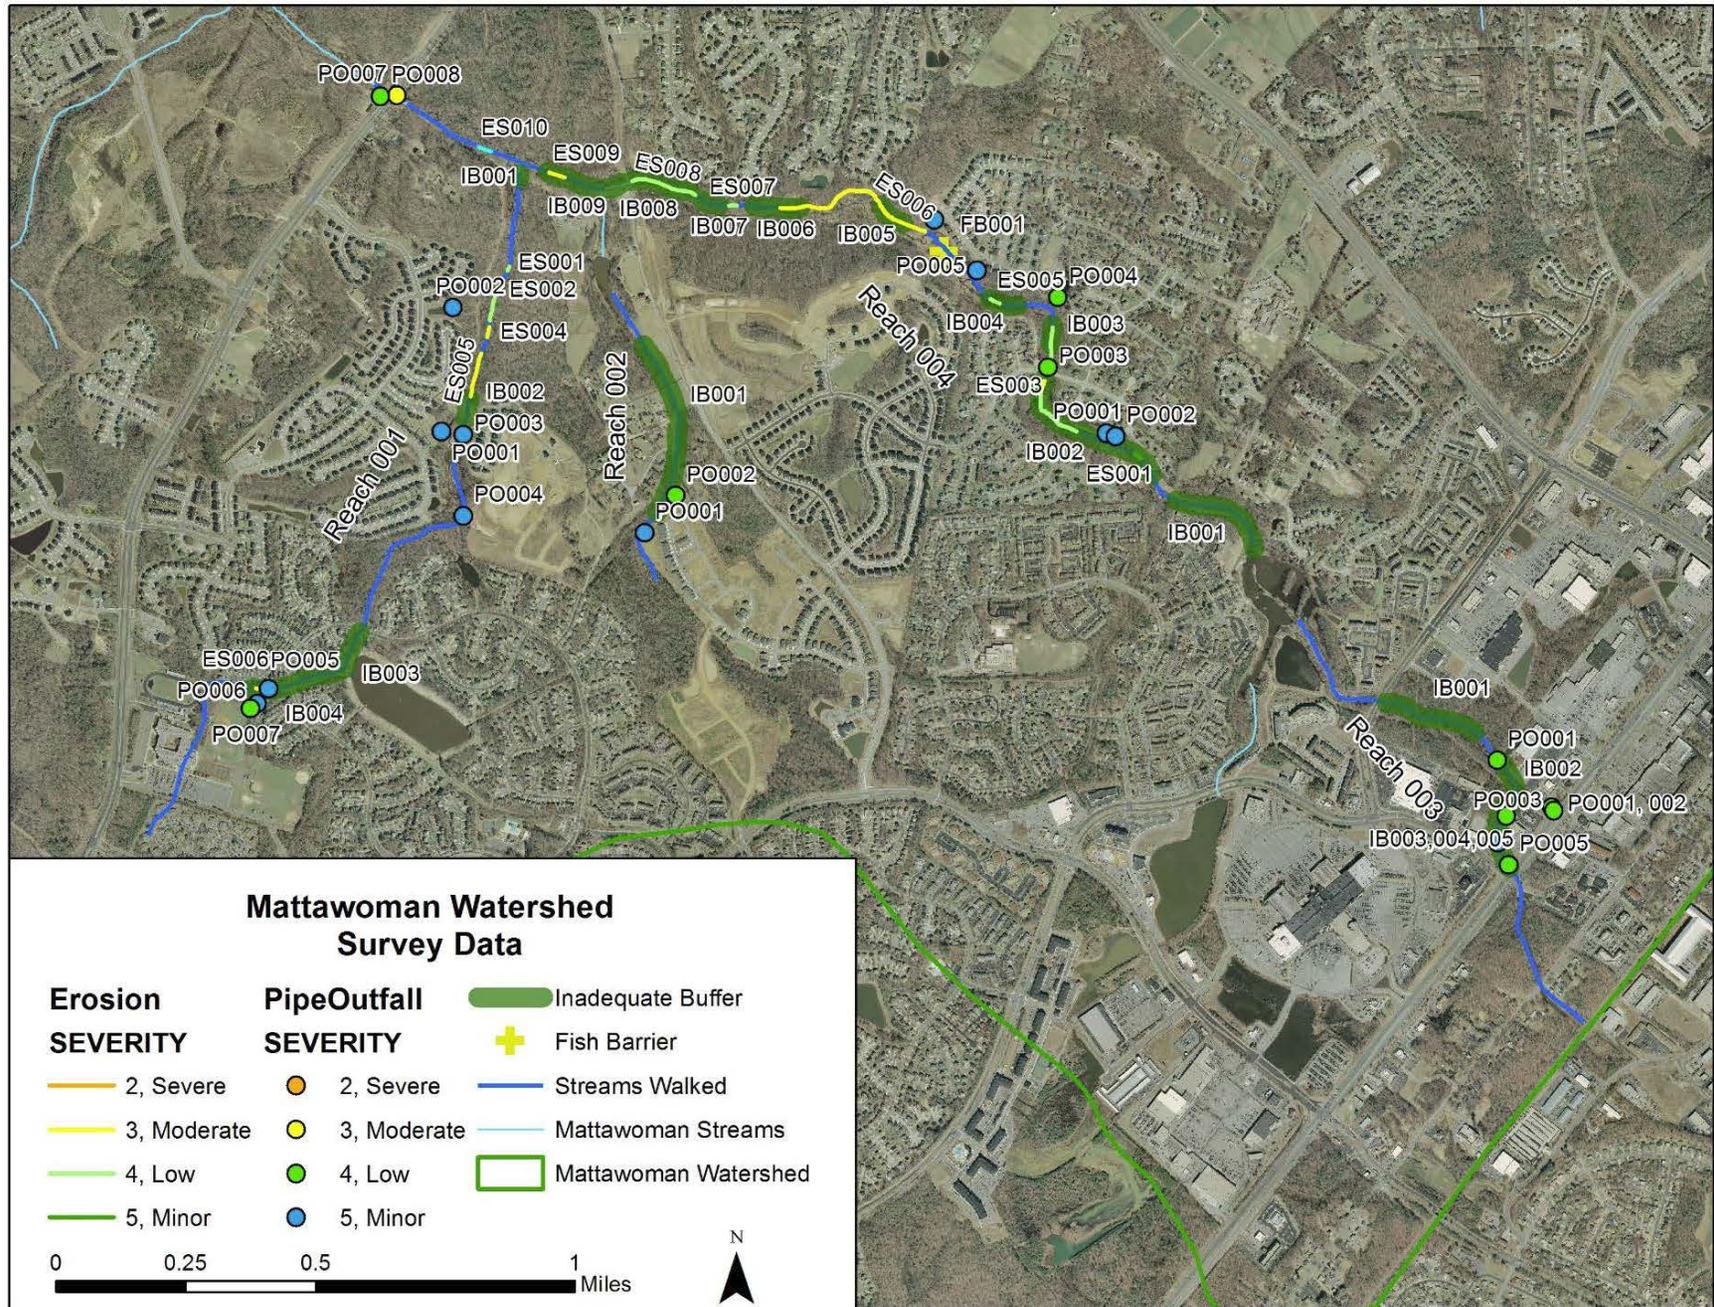
FIGURE 13: SURVEY DATA MAP SHOWING PIPE OUTFALL, EROSION, FISH BARRIER, AND INADEQUATE BUFFER SITES, EASTERN REACHES

Twenty erosion sites totaling 1.4 miles were identified. The stream erosion process was identified as widening for 90% of sites, headcutting for 5%, downcutting for 5%. While collecting stream erosion data, field crews also attempted to determine the leading possible cause of erosion at each site. These potential causes included: an upstream road crossing, bends and slopes in the stream channel, upstream land use changes, and pipe outfalls. The most commonly described possible causes for erosion was landuse change upstream (75%), followed by bend at steep slope (10%). No sites presented an immediate threat to infrastructure. Locations of erosion sites can be found in Figure 13 and Figure 14.

Inadequate buffers, defined as buffers less than 50 feet wide from the edge of the stream, were identified at 23 sites, totaling 4.2 miles of inadequate buffers for both right and left bank combined. Approximately 65% of the inadequate buffer length identified was affecting both sides of the stream channel. Crop fields, lawn, and sewer easement were the most commonly identified types of land use where the stream buffer was found to be deficient. The location of reaches with inadequate buffers is displayed in Figure 13 and Figure 14.

Twenty-seven pipe outfall points were located and assessed. Approximately 88 percent of the outfalls received severity ratings of either “low” or “minor,” indicating that they typically do not have dry weather discharges nor appear to be causing localized erosion. A total of two outfalls were rated as “moderate”, one was rated “severe” and no outfalls were rated “very severe” due to localized erosion impacts. All of the pipe outfalls were associated with stormwater conveyance, and any observed discharge was clear and odorless, with the exception of two sites with medium brown discharge and one site with an orange color. Locations and severity of these points is shown in Figure 13 and Figure 14. Pipe outfalls with severity scores less than moderate are displayed, but not labeled.

Only one fish barrier was observed during the survey and was identified as a beaver dam. The barrier received a severity rating of “moderate” and the beaver dam was causing a 36 inch drop in elevation. The location and severity of the fish barrier is displayed in Figure 13.

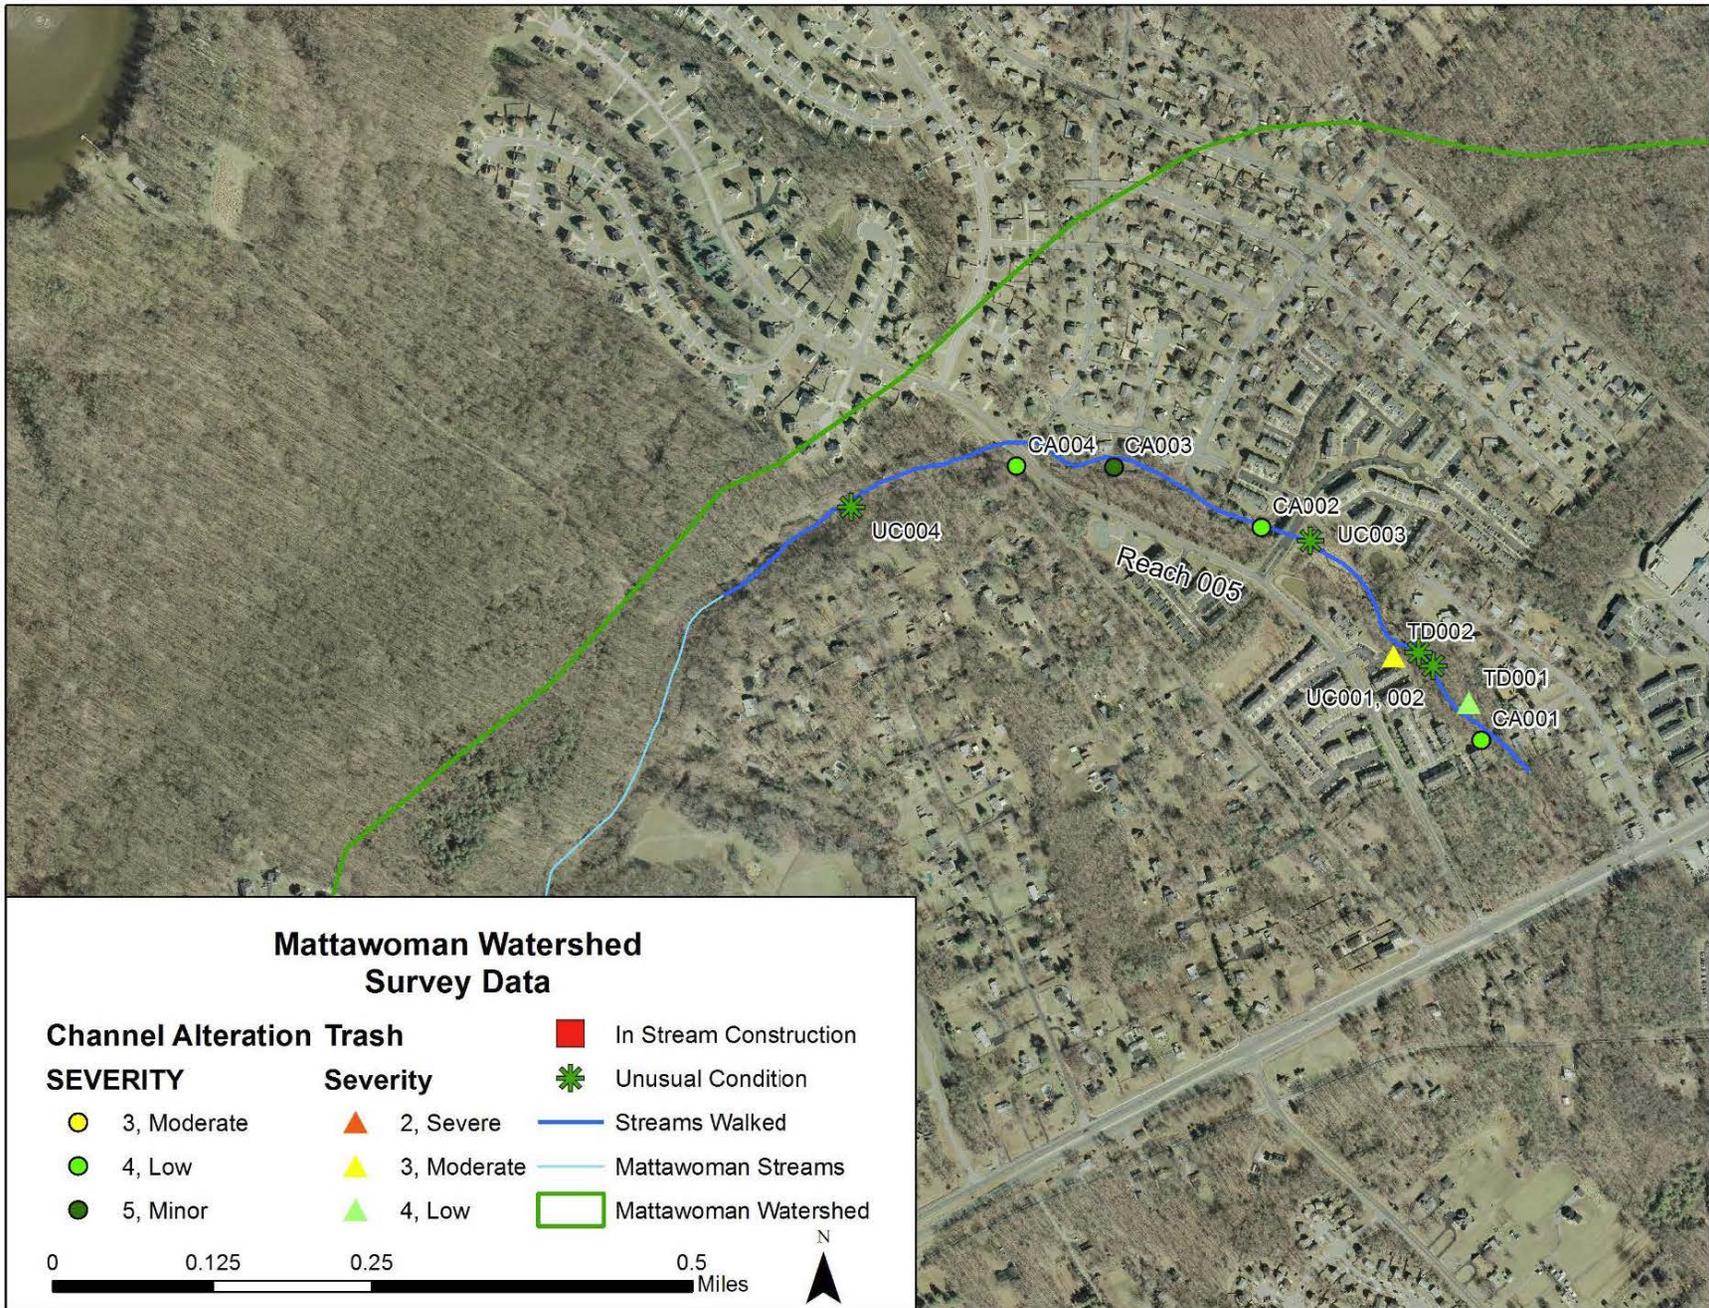
FIGURE 16: SURVEY DATA MAP SHOWING CHANNEL ALTERATION, TRASH DUMPING, IN STREAM CONSTRUCTION, AND UNUSUAL CONDITION SITES, WESTERN REACHES

Channel alteration impacts were found at 18 sites, totaling approximately 1,907 feet in length. All channel alteration locations had a severity rating of “low” to “moderate” and were primarily associated with rip rap stabilization efforts. Six of the sites were located at a road crossing. Locations of channel alteration sites can be found in Figure 15 and Figure 16.

A total of seven trash dumping sites were also identified. One site was rated “severe”, three sites were rated as “moderate”, and 3 sites were rated as “low” severity. Only two of the sites could not be cleaned up by volunteers due to the presence of large metal pieces of trash. Point locations and severity scoring of unusual conditions and trash sites can be seen in Figure 15 and Figure 16.

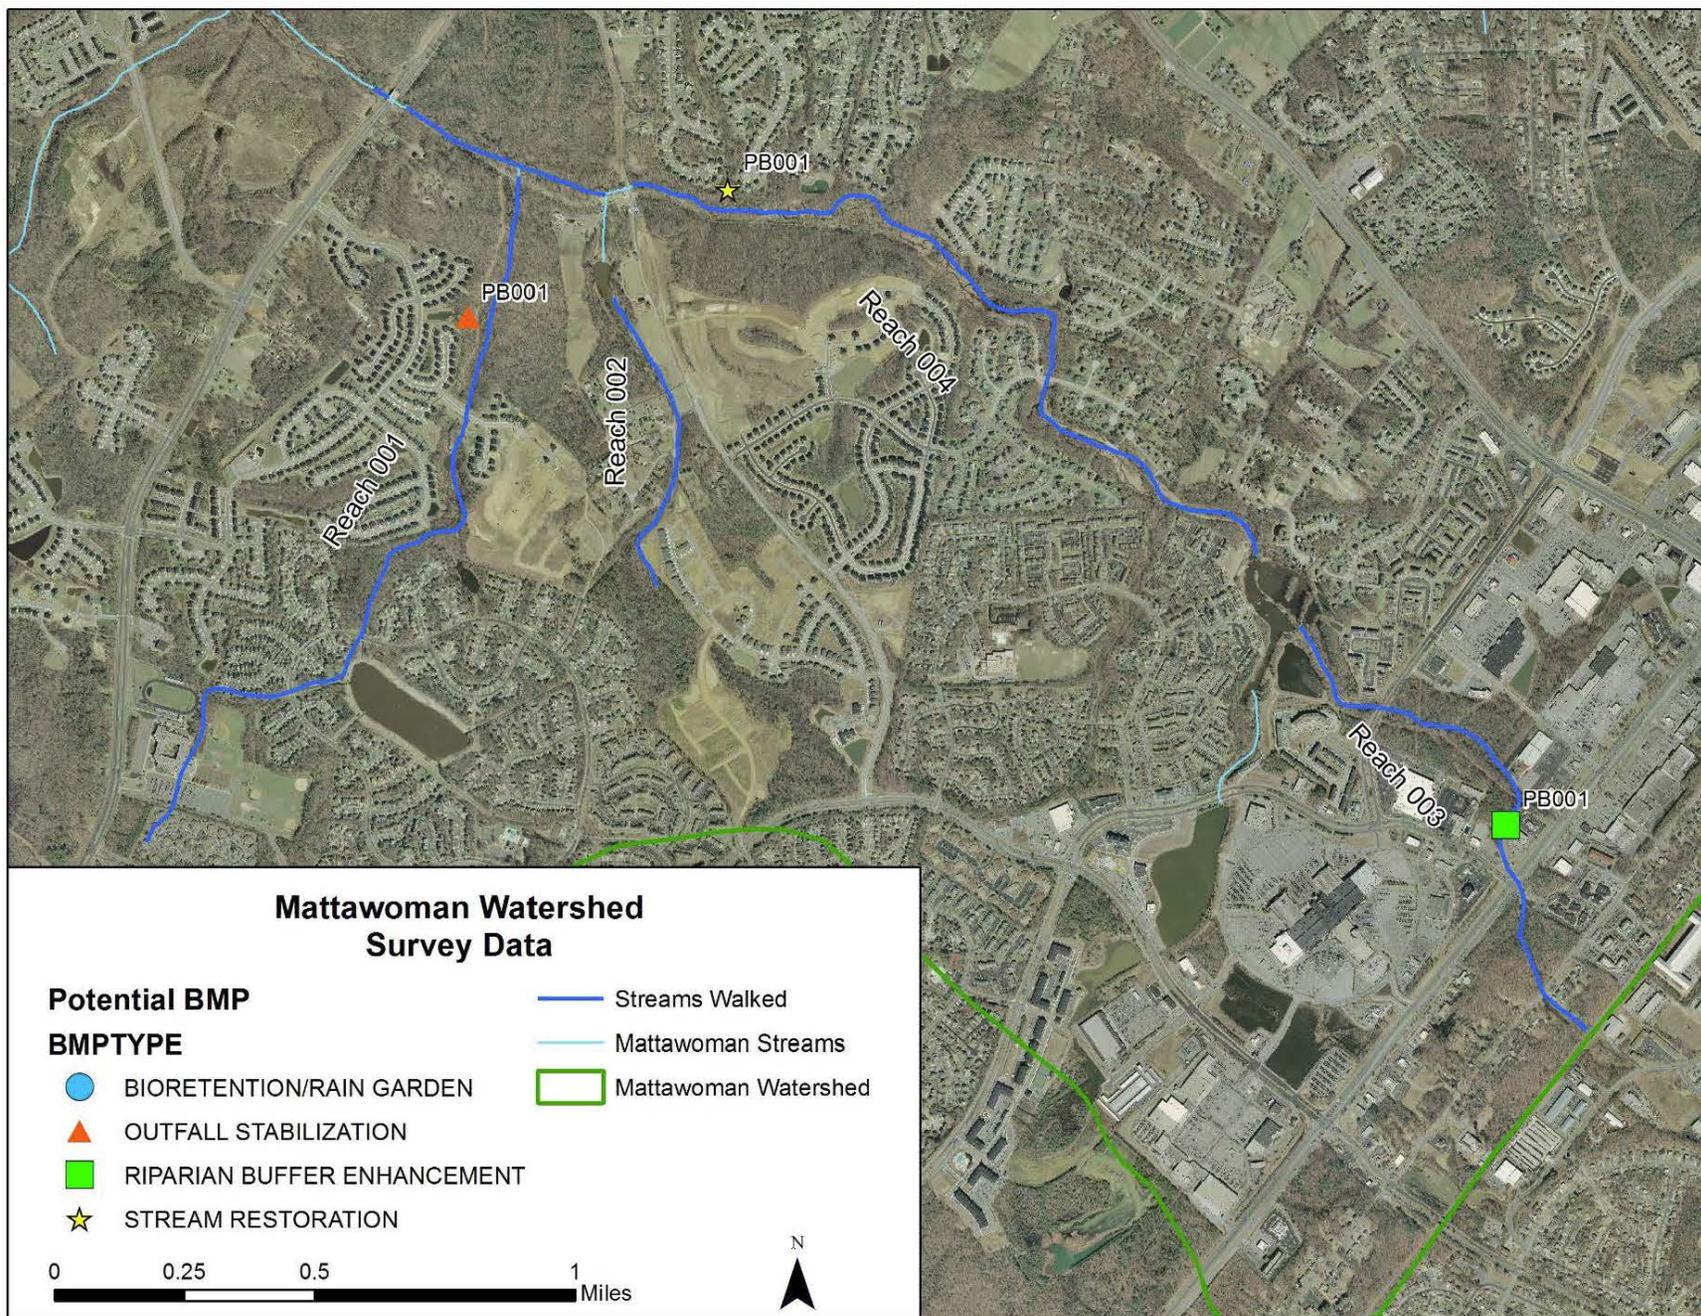
FIGURE 17: SURVEY DATA MAP SHOWING POTENTIAL BMP LOCATIONS, EASTERN REACHES

Seven initial potential improvement sites were identified during the SCA fieldwork. Multiple improvements were recommended for one site. Recommended BMP types include outfall stabilization (3 sites), riparian buffer enhancement and wetland restoration (1 site), stream restoration (2 sites), and bioretention/raingarden (1 site). The locations of these preliminary sites as well as the primary BMP type are displayed in Figure 17 and Figure 18. These projects were further expanded and are presented in the following section.
