MATTAWOMAN CREEK

WATERSHED ASSESSMENT

MAY | 2016

KCI TECHNOLOGIES, INC.

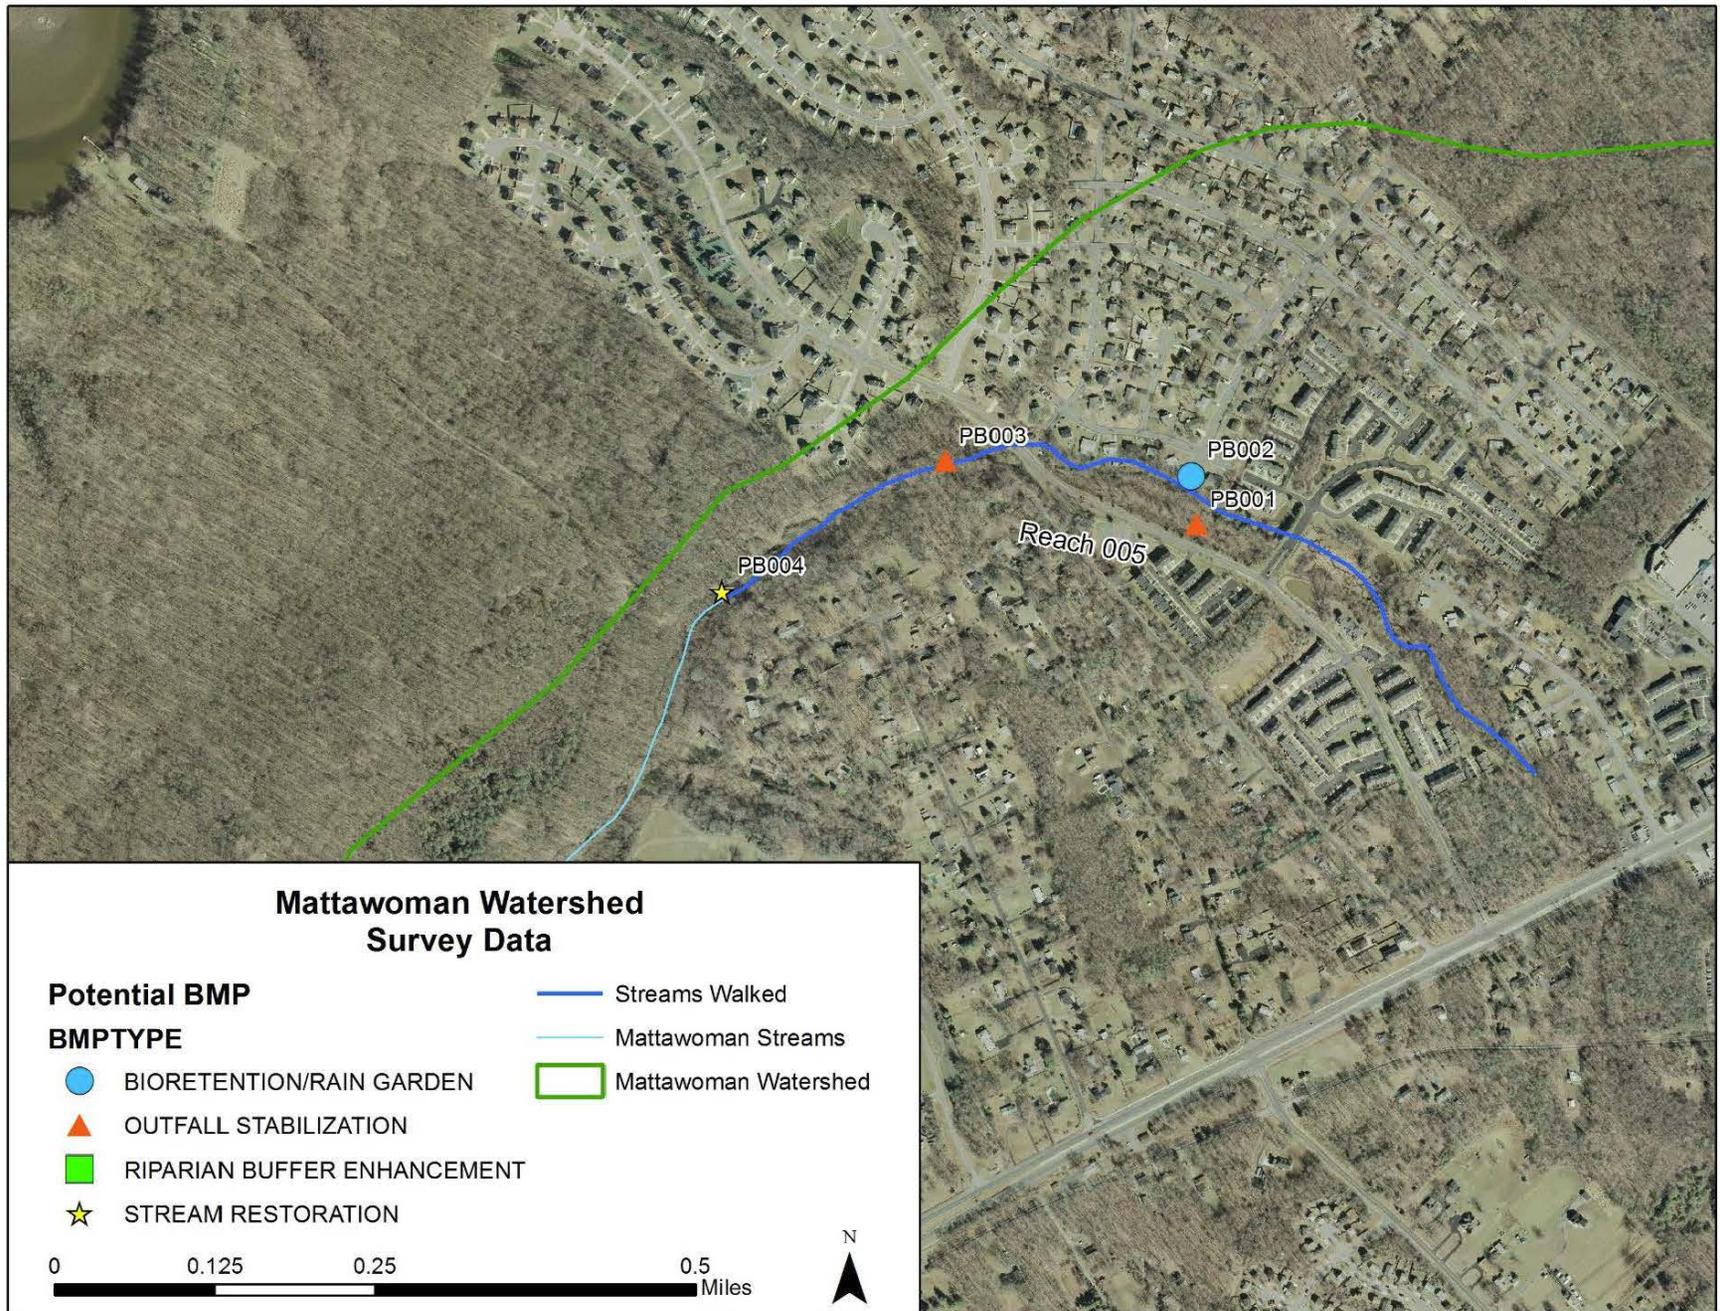
FIGURE 18: SURVEY DATA MAP SHOWING POTENTIAL BMP LOCATIONS, WESTERN REACHES

Seven initial potential improvement sites were identified during the SCA fieldwork. Multiple improvements were recommended for one site. Recommended BMP types include outfall stabilization (3 sites), riparian buffer enhancement and wetland restoration (1 site), stream restoration (2 sites), and bioretention/raingarden (1 site). The locations of these preliminary sites as well as the primary BMP type are displayed in Figure 17 and Figure 18. These projects were further expanded and are presented in the following section.

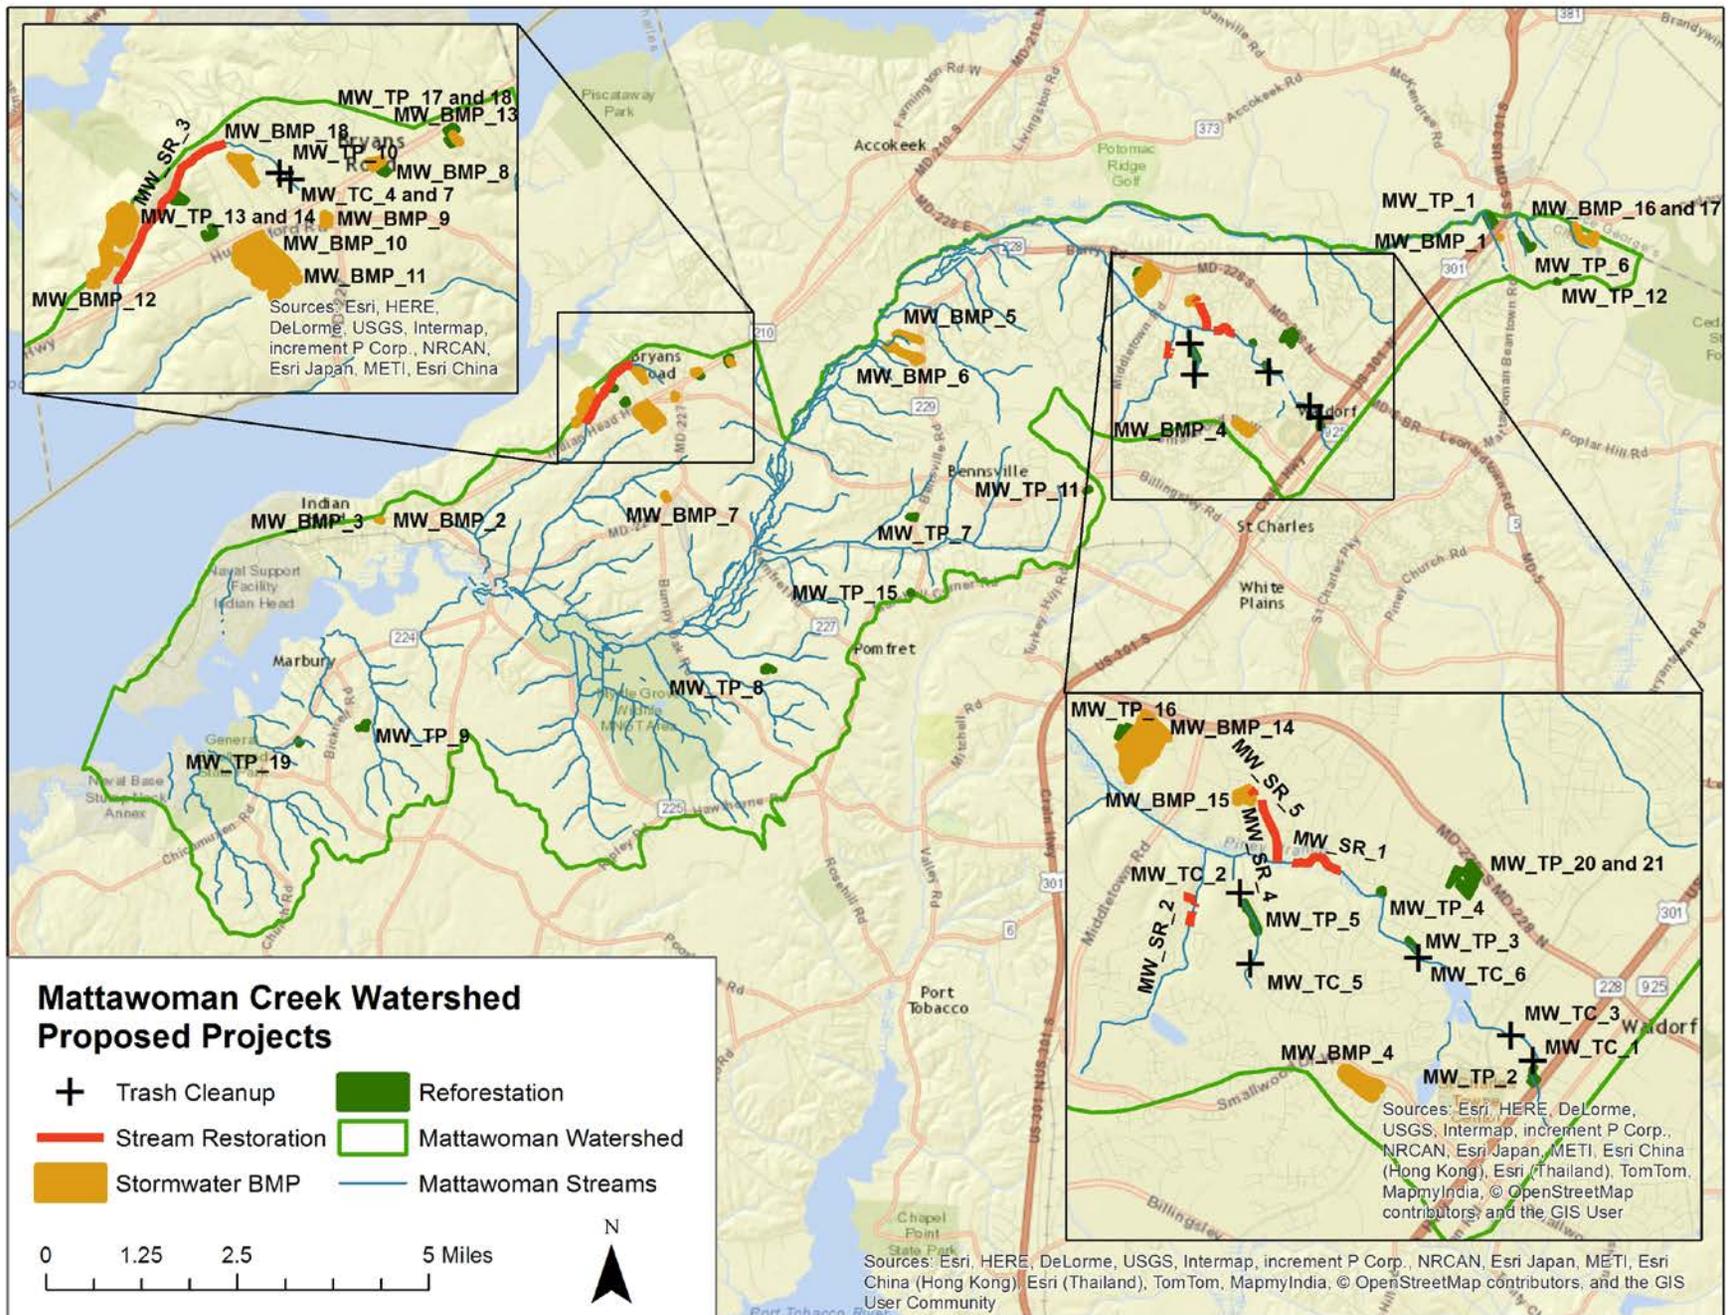
FIGURE 19: LOCATION OF MATTAWOMAN CREEK WATERSHED POTENTIAL WATER QUALITY IMPROVEMENT PROJECTS

Mapping of the site specific structural practices are included in Figure 19. Tables presenting cost, load reduction, and impervious credit associated with each of the proposed projects are included in each section below.

The BMP facility types that were identified include created wetland, infiltration basin, step pool storm conveyance systems, bioretention, and wet ponds. Table 17 below includes a brief discussion of the existing site conditions and the proposed site improvements. Table 18 contains a summary of the impervious area treated by the proposed BMP types. BMP drainage areas are displayed in Figure 19.

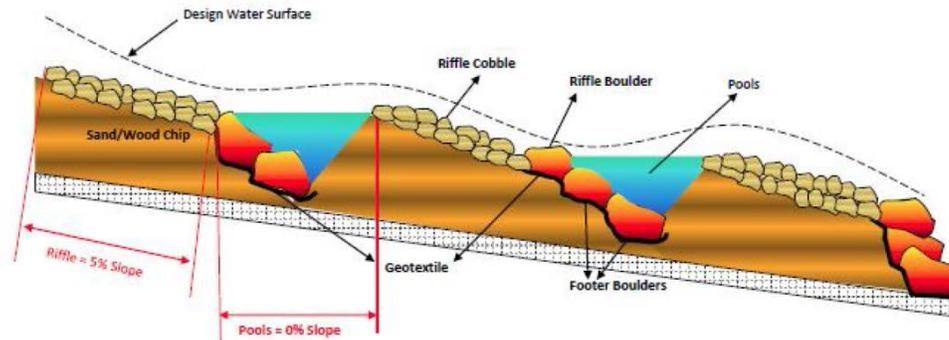
An SPSC system consists of alternating pools and riffle channels. The length of the pools is typically twice the length of the riffles and a minimum of 18 inches deep. The maximum length of the riffle structures is typically eight feet so as not to build excessive energy. Also, an SPSC segment used for water quality should not exceed 5% in longitudinal slope. If the overall slope exceeds five percent, boulder cascades may be utilized to traverse the grade. All unarmored sides of the pool are laid at no steeper than 3H:1V. In the event the connecting stream is incised, boulders are used to construct an in-stream weir.

Profile for Regenerative Stormwater Conveyance System (source: Anne Arundel County, 2011)

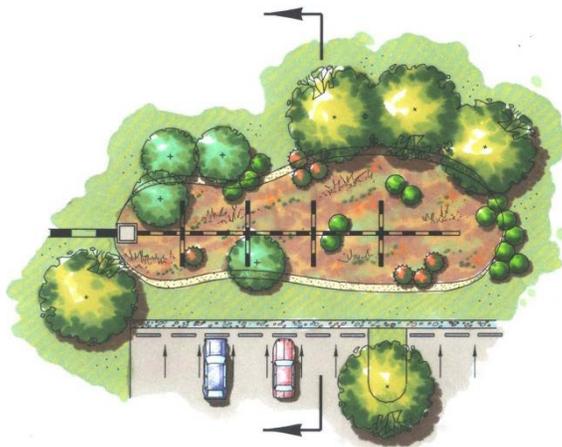
Bioretention areas generally consist of a stone diaphragm, filter fabric, filter media, landscaping, and an underdrain system. The stone diaphragm reduces the velocity of the runoff from the impervious surface that is entering the facility and also removes suspended material that may clog the filter media. The underdrain system is a perforated pipe system that collects the water that has filtered through the permeable media and transports it to a downstream open channel or connects into a nearby storm drain.

Plan view of bioretention area

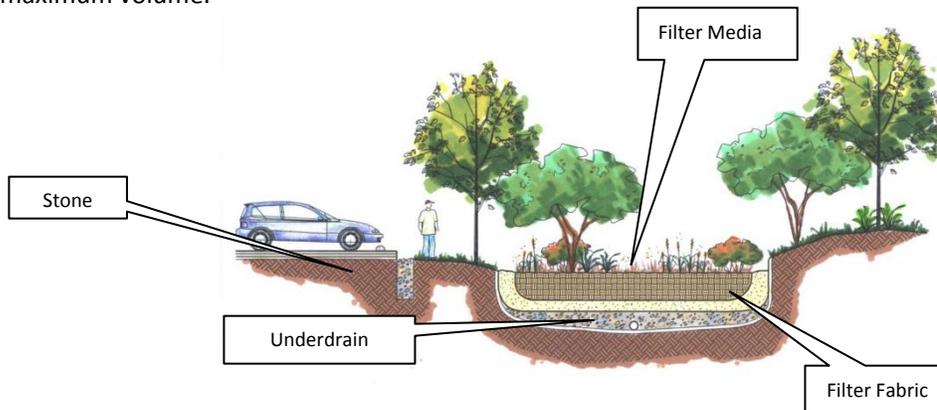
The landscaping in a bioretention area is also very important. The plants chosen are native plant species that are tolerant of standing water. A wide variety of trees, shrubs, and herbaceous plants are selected for varying levels of vegetative uptake, for encouragement of various wildlife species, and for improved aesthetics. The permeable soil in the bioretention area is approximately 2.5 feet to 4 feet deep with 3 inches of mulch above it.

The ponding within the bioretention area is typically 6 inches to 12 inches. There is generally a catch basin or weir provided within the ponding area that is used for overflow when the ponding area reaches its maximum volume.

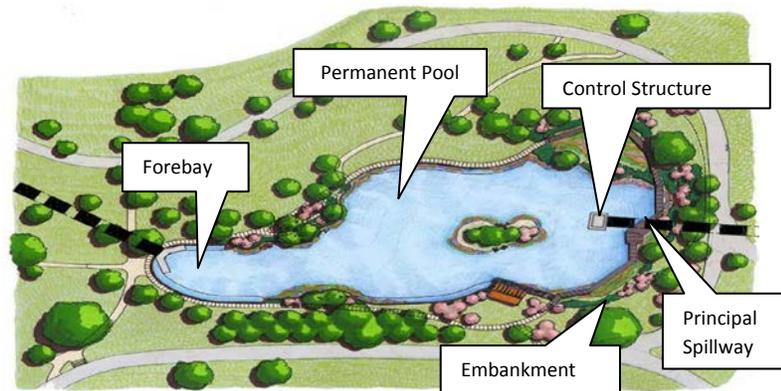
A wet pond typically consists of a forebay, embankment, control structure, principal spillway, and a permanent pool. The forebay is small pool located at the inflow of a pond and is designed to allow coarse sediment to settle out of the water column before it flows into the main body of the pond. The embankment, which is typically designed to confine the 100-year storm, contains a clay core to minimize seepage from the upstream side to the downstream side. The principal spillway runs through the embankment and is the primary means for flow to leave the pond. The control structure regulates the level of water within the facility. It has openings set at specific elevations, the lowest of which controls the depth of water in the pond. The permanent pool is the elevation of water that remains in the facility, maintained by the control structure.

Plan view of wet pond

Typically a safety bench is installed just above the permanent pool elevation around the perimeter of the pond. Approximately 18 inches below the water surface is typically an aquatic bench that is required to be put in for wetland planting to improve aesthetics and vegetative uptake of nutrients. The aquatic bench should extend to a depth of 18 inches below the permanent pool elevation. The combined minimum width of these two benches is 15 feet.
