**NPDES ANNUAL REPORT  
JULY 2012 - JUNE 2013**

Charles County Government  
Department of Planning and Growth Management

CHARLES COUNTY, MARYLAND  
MUNICIPAL SEPARATE STORM SEWER DISCHARGE PERMIT

02-DP-3322 (MD0068365)

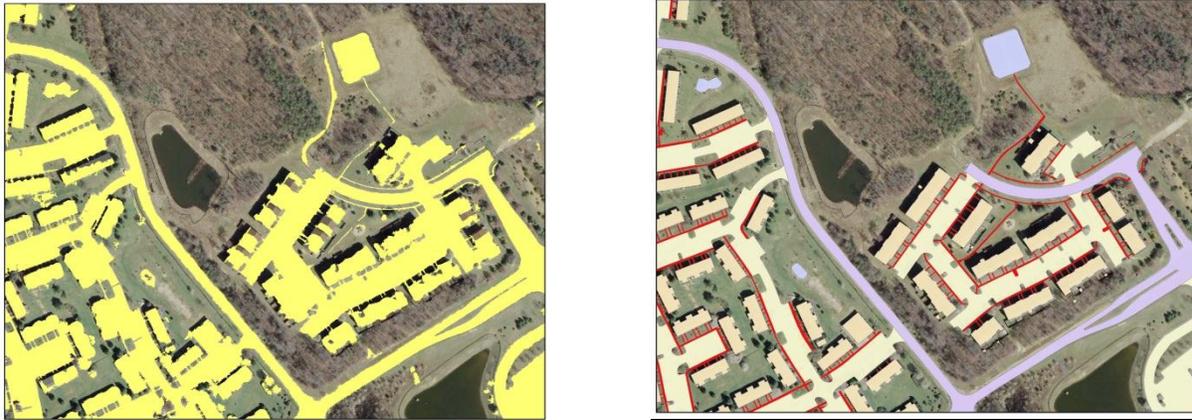
The first application of the actual impervious surface was used to generate an average impervious area for single family lots in the county, referred to as Equivalent Residential Unit, and actual impervious surface coverage for non-residential parcels for use in evaluating the alternate methods of applying the stormwater remediation fee, as required by State law.

Figure 1: Impervious Surface Delineation - Feature Analyst (left) and Actual Impervious (right)

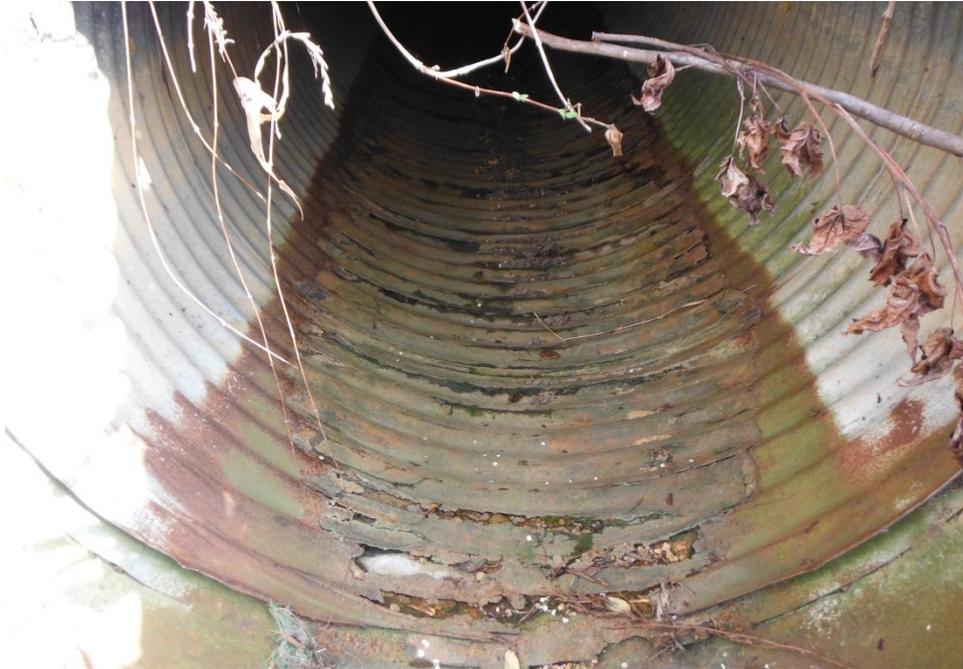
Outfall #14, #31, #33, #78, #106, #178, and #206 were all corrugated metal pipes contained significant metal corrosion with major perforations or missing inverts. Moderate to severe erosion was occurring at Outfall #14, #18, #106, and #112. Outfall #106 was reported with severe erosion and CMP corrosion in 2008 and 2011.

*Outfall #14 Culvert before Repair, 2013*

Outfall #	Description of Issue(s)	County Tracking	Status
#2	Turbid discharge from upstream SWM pond due to berm failure	RFA 130480	SWM pond repair complete 9/2013
#14	Metal corrosion and erosion	Roads Division	Repairs July 2013 (Photos below)
#18	High concentration of nitrate, severe channel erosion	Capital Services Division	Erosion and collapsing pipe repaired October 2013 (Photos below)
#26	High levels of detergent	RFA 130643	90 Day Compliance Letter
#31	Metal corrosion	RFA 130648	Investigation on ownership of facility.
#33	Metal corrosion	RFA 130647	90 Day Compliance Letter – 3/10/14

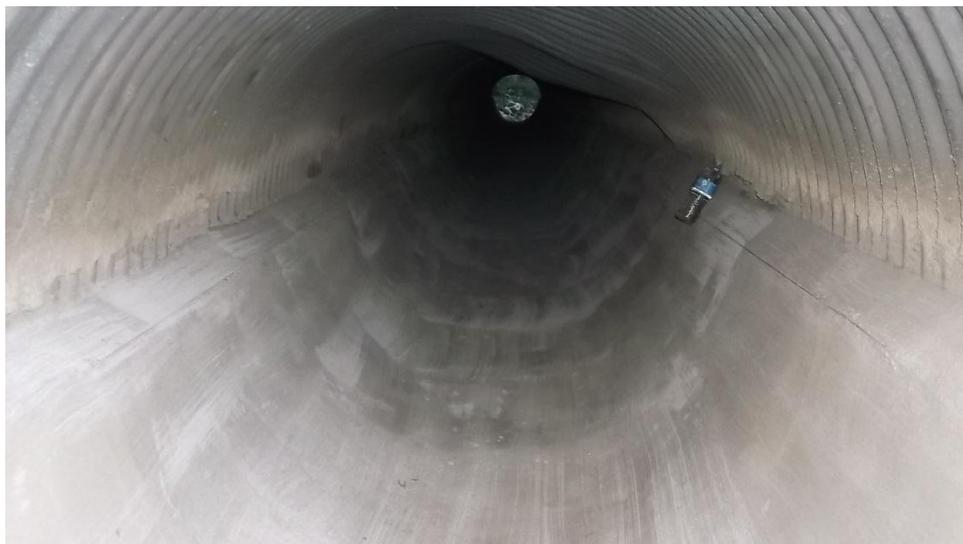
*Outfall #14 Culvert after Repair with Shotcrete, 2013*

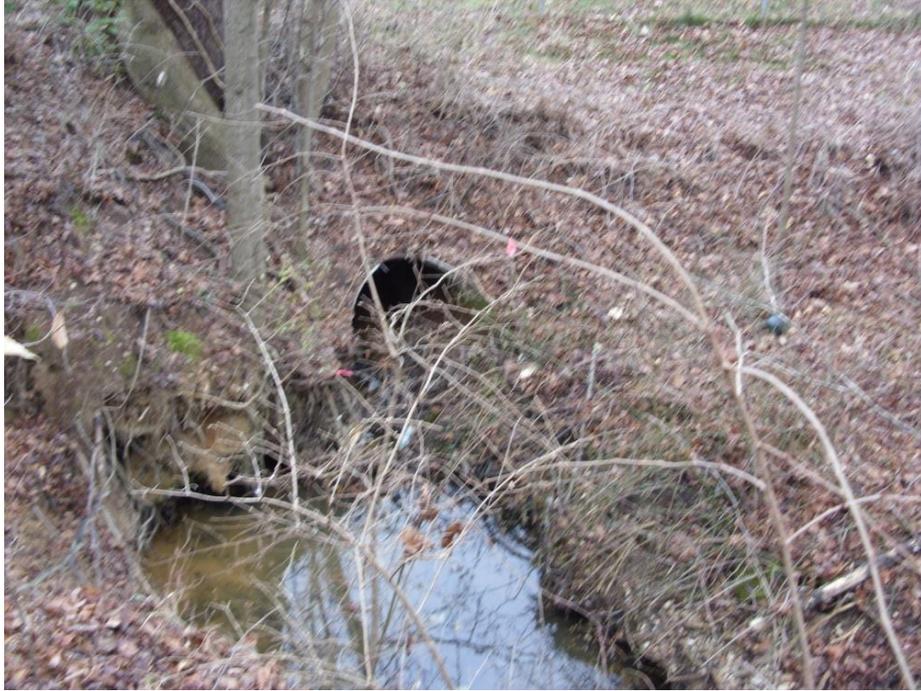
*Outfall #18 Culvert before Repair, 2013*

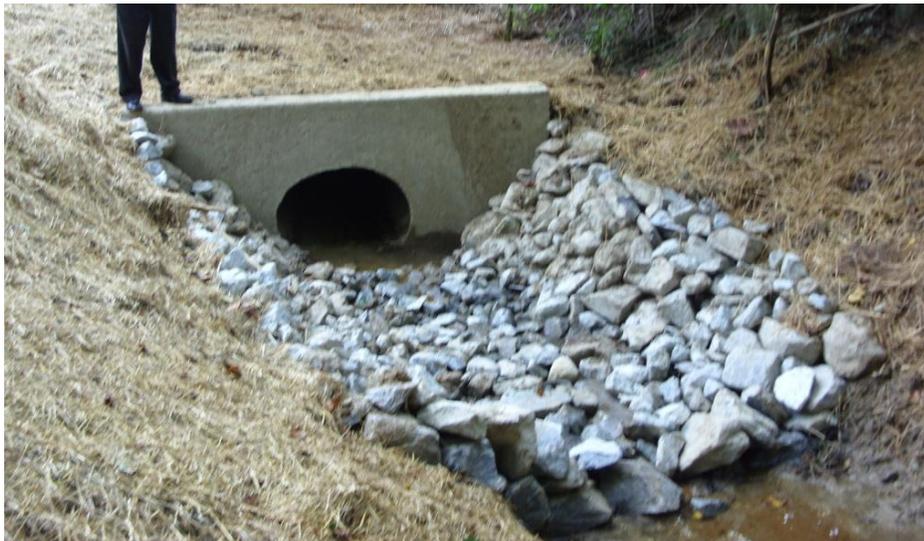
*Outfall #18 New End Section and Weir Wall, with Approx. 148 Linear Feet of Existing Metal Culvert Lined with Concrete and Joints Repaired, 2013*

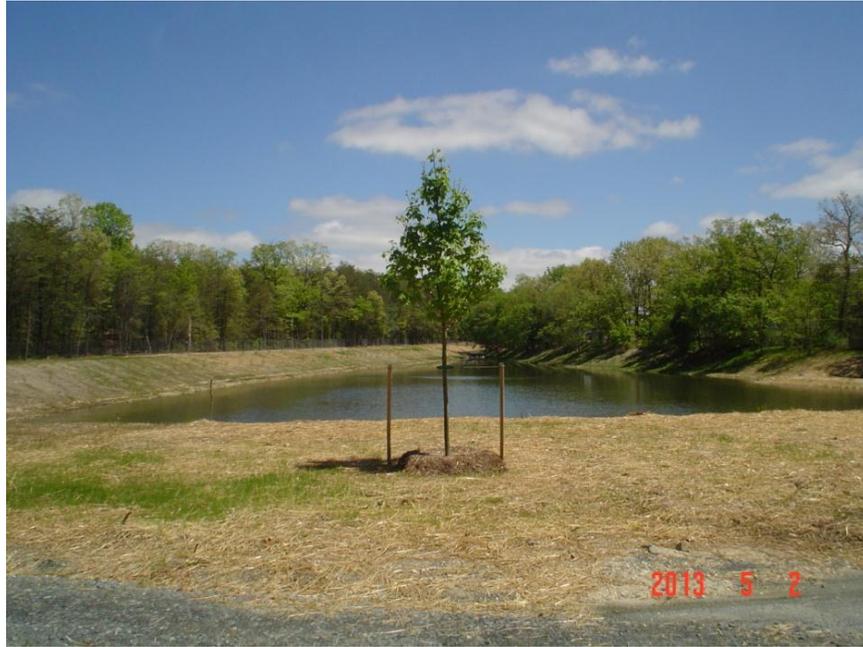
The gravel wetland facility is proposed in the Pinefield Civic Association open space along Temi Drive at the lowest elevation. Obtaining access and easement agreements with the Civic Association is still ongoing through 2013. Following is a graphic of the proposed facility.

*Pinefield Watershed Restoration Project - Completed*

In 2012, Vista Design, Inc. completed a watershed restoration concept for an additional portion of Pinefield called Temi Drive that will reroute drainage from a corroded steel pipe and eroded outfall, to a gravel wetland that will provide water quality treatment for approximately 18 acres of untreated impervious area. In 2013 engineering of the gravel wetland began under County permit VCI 130063. The engineering plans are currently at 90% completion of design.

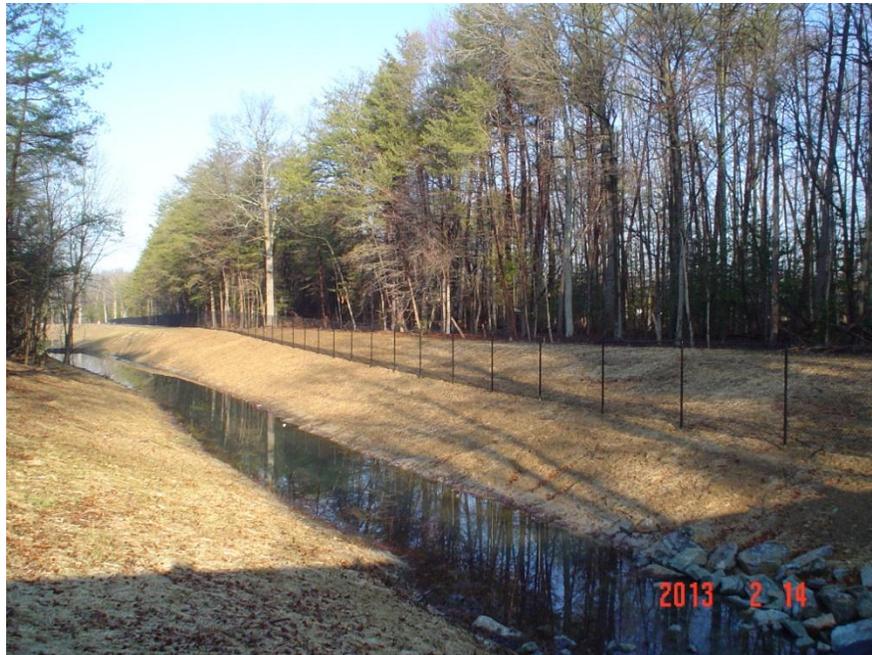
*Pinefield Watershed Restoration Project - Completed*

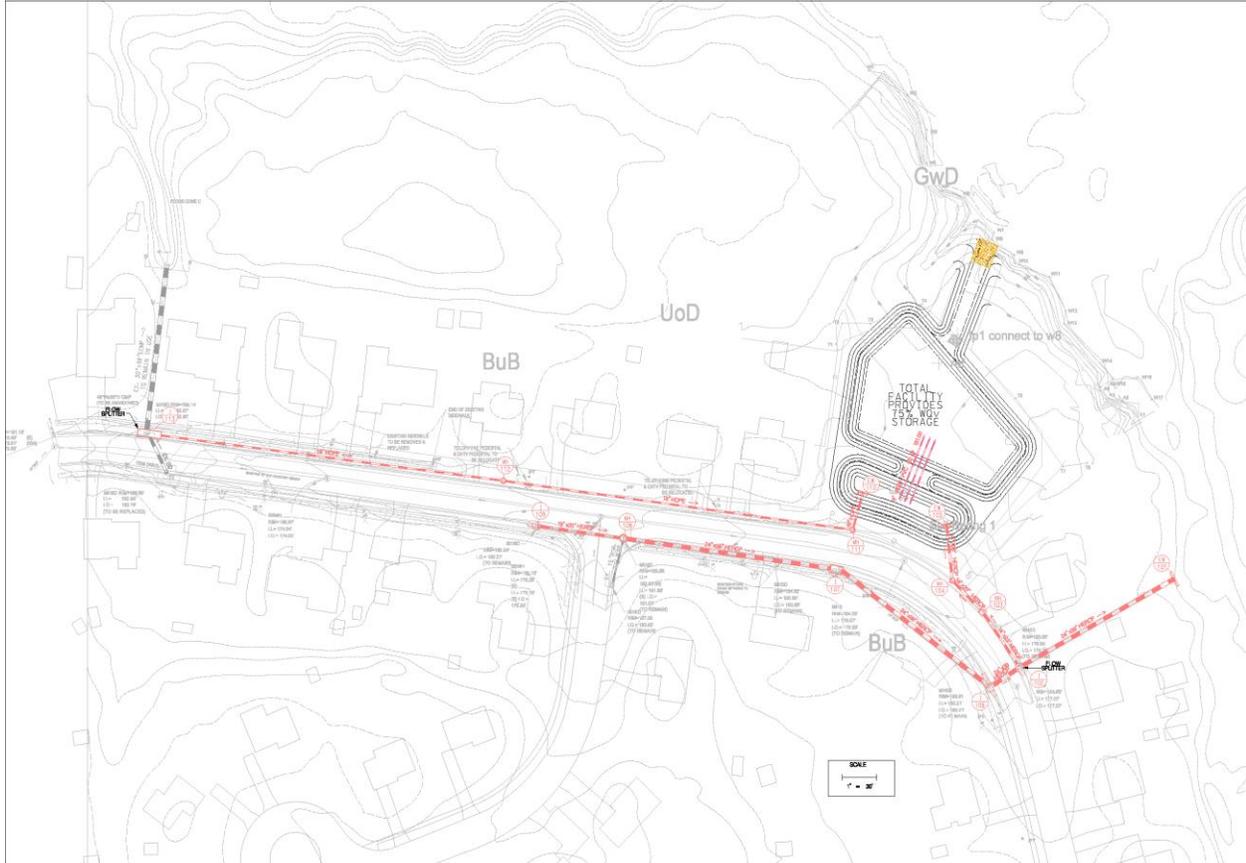
*Temi Drive Watershed Restoration Project*

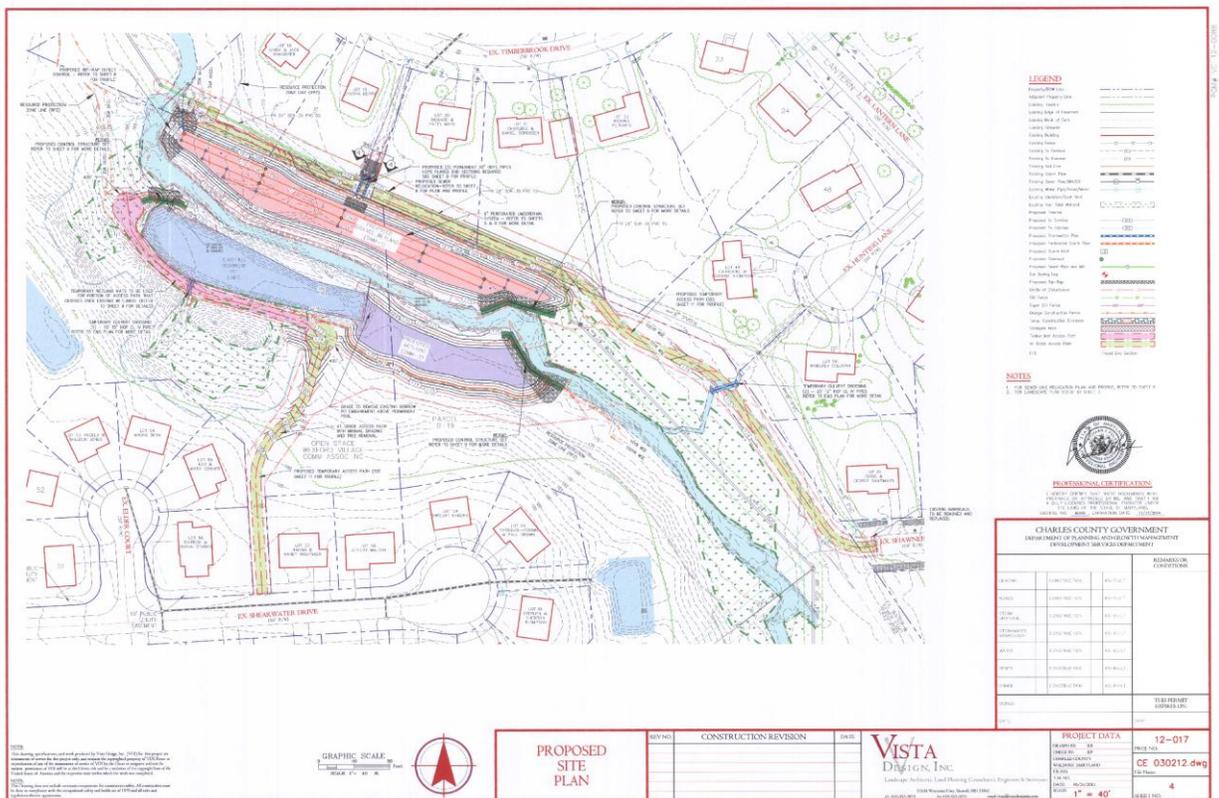
Staff and the consultant met with Maryland Department of the Environment (MDE) regarding the regional stormwater concept, which MDE supported. A large submerged gravel wetland and wetland facility was under design during the 2013 permit year. The facility is being designed to treat over 40 acres of untreated impervious area from areas near Route 301. Minimum disturbance to the existing stream is proposed. In 2013, the permit is 100% complete with the Charles Soil Conservation District and MDE approval is imminent. There is a small list of easements to be acquired prior to the project being constructed. Additional delays to construction include the necessary engineering to reroute a sewer line from running through the center of the proposed facility, which had not been known to exist in the area. Designing and rerouting the sewer line around the proposed facility began in 2012. Final permitting and construction is anticipated in 2014. Following is a graphic of the Acton Hamilton project.

Acton Hamilton Watershed Restoration Project

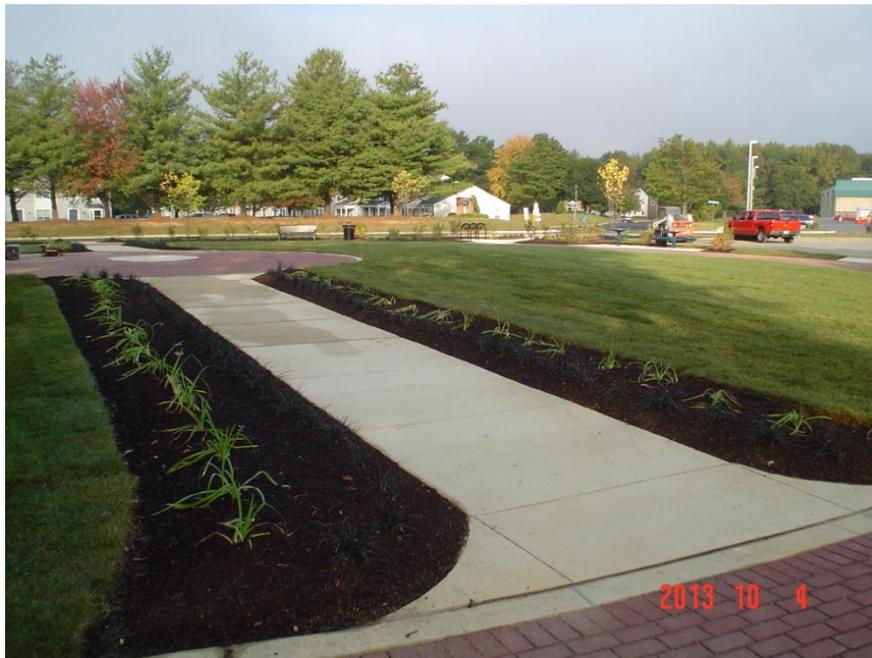
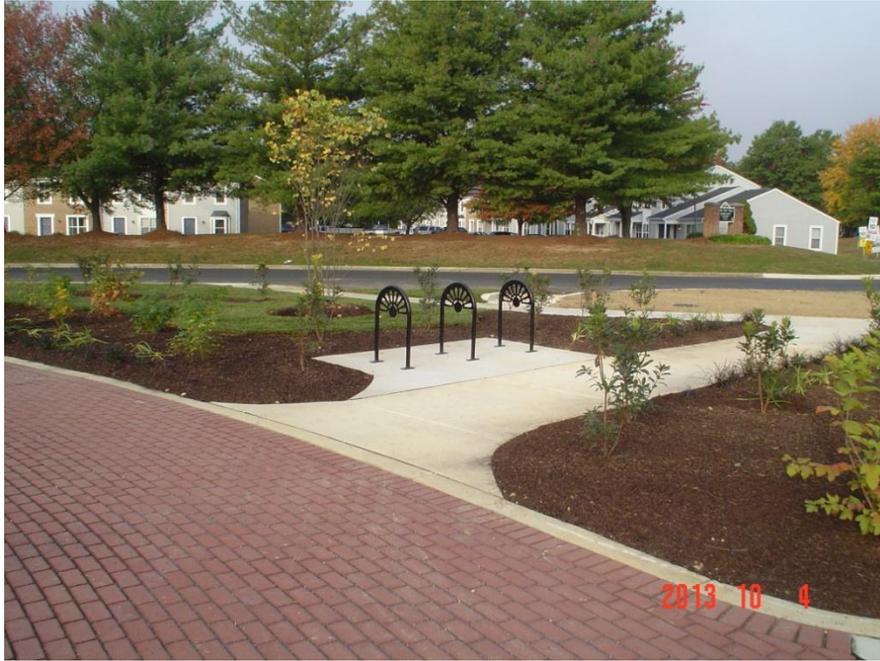
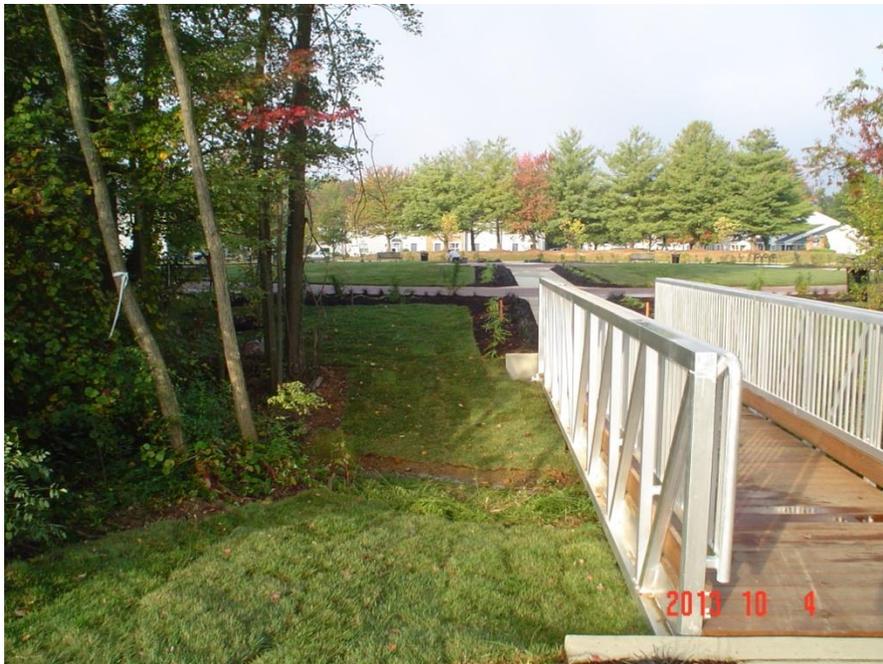
The Bryans Road Town Common includes underground detention pond for treating runoff from the shopping center parking area, and a dry swale along Matthews Road that treats the roadway and a portion of the rooftop of the shopping center. Additional features include landscape islands to delineate traffic lanes through the parking area, pedestrian linkages (including a bridge) from senior housing to nearby restaurants, and new underground drainage infrastructure to the facility. In June 2012 the construction of Bryans Road NPDES project was bid under RFP 12-15 and in August 2012 was awarded to Sandy Excavating, Inc. Construction began in the fall of 2012 and completed in October 2013. Photos of the construction and placement of the underground arches can be found in the 2012 NPDES Annual Report. Following are photos of the completed project.

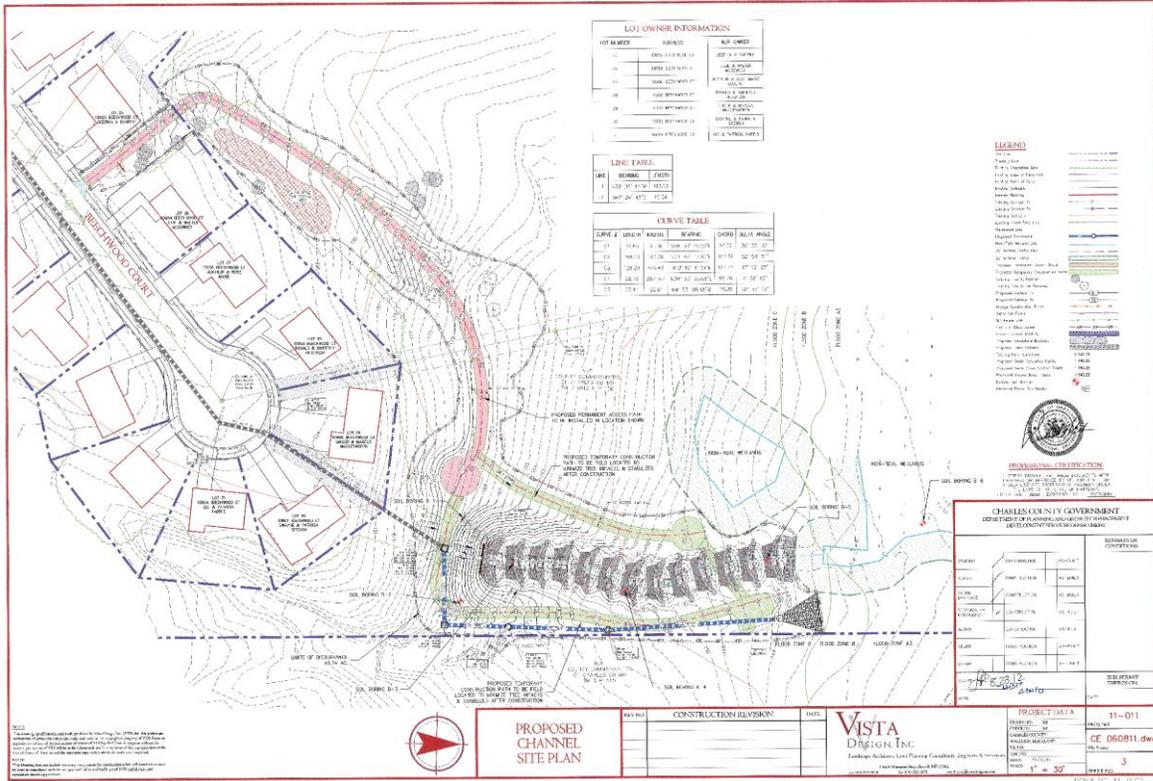
Fox Run NPDES project was issued a construction permit to treat over 9 acres of untreated impervious area in the neighborhood of Fox Run. This project also improves issues with the outfall pipe and severe erosion at the outfall channel was well. The project has been designed as a step pool storm conveyance stream restoration project. No right-of-way is needed. The project was publicized under Invitation to Bidders (ITB) 13-24 in May 2013. A contract was awarded to Reliable Contracting in the amount of \$823,015. Notice to Proceed was issued on September 10, 2013 and the project is currently under construction. Below is a graphic of the step pool conveyance system to be built.

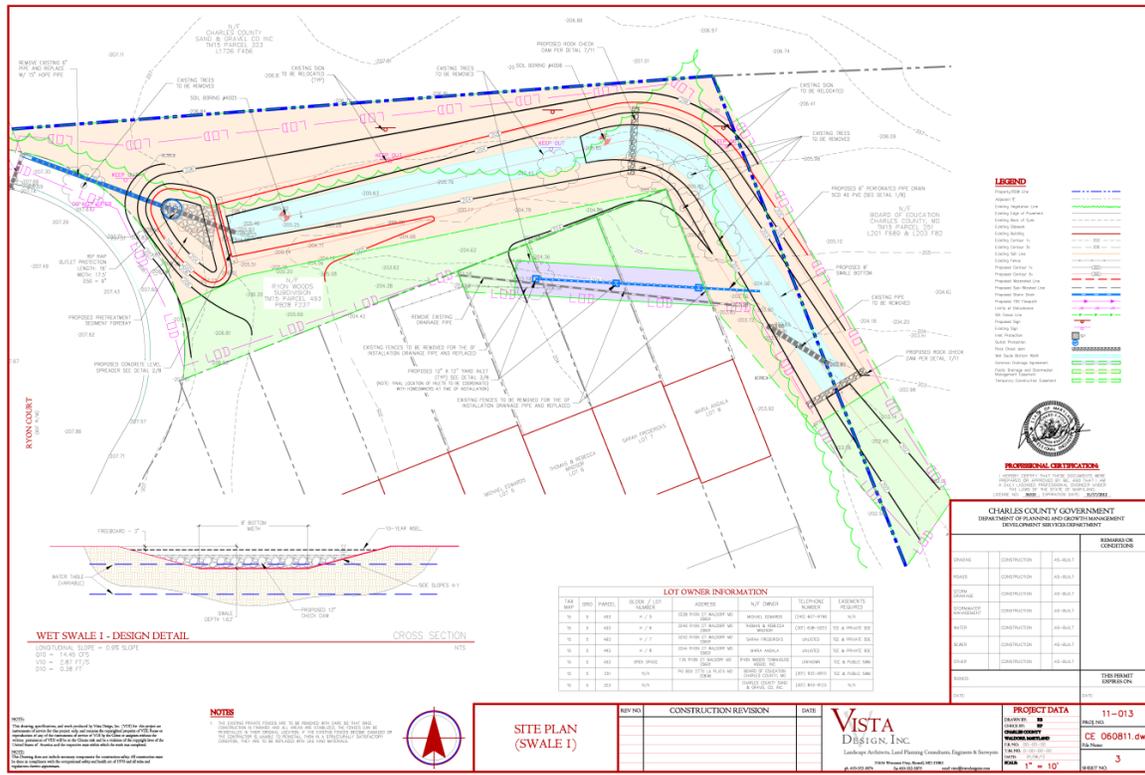
Ryon Woods NPDES project (VCI 110099) was designed to treat over 1 acre of untreated impervious area and also correct serious drainage issues for the neighborhood of Ryon Woods. The project consists of two separate grass swales with check dams designed for water quality. In addition, drainage was redirected from homeowners' yards.

Right of way acquisitions were completed early in 2013. In September 2013, a purchase order was awarded to Macia Construction in the amount of \$25,550 to construct the project. The project is currently under construction. Below are graphics of the design.

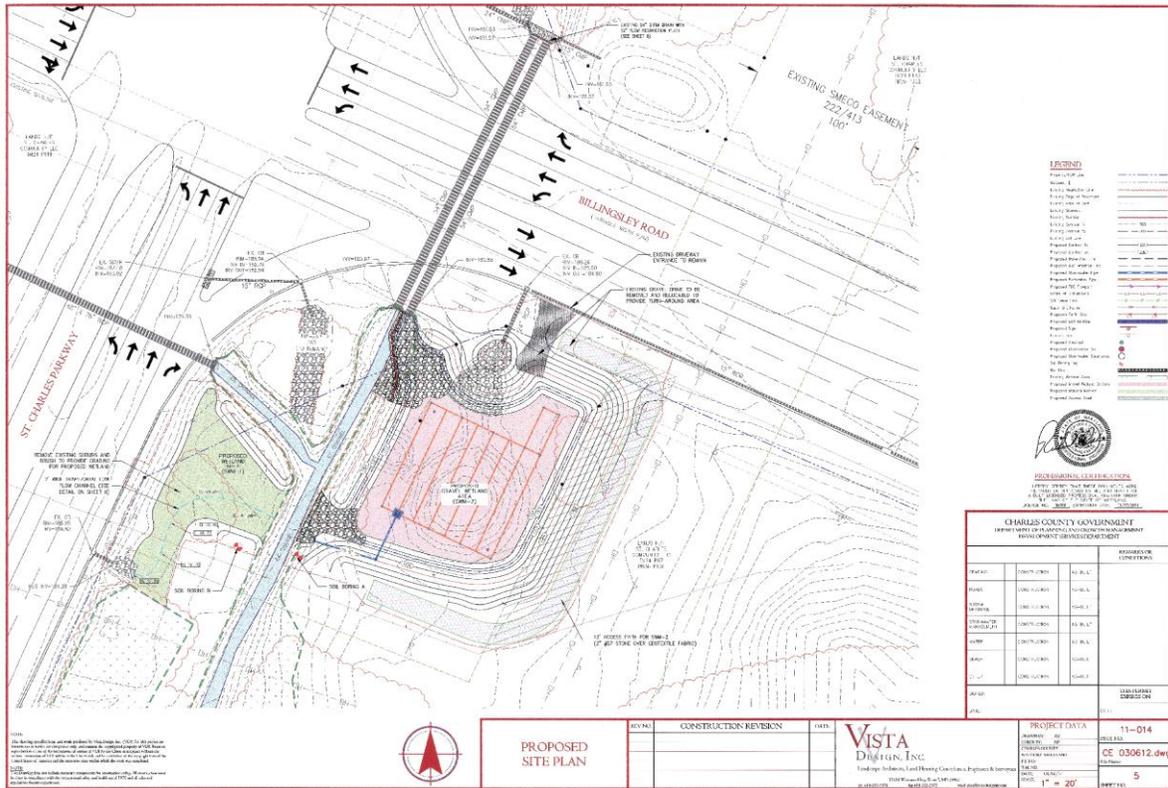
The White Plains NPDES project VCI 120067 is being designed to treat over 5 acres of impervious surfaces from the White Plains area. This project is designed as a shallow gravel wetland with minimum disturbance to the existing stream. Currently, the engineering plans are 100% complete with Charles Soil Conservation District approval and MDE permit approval imminent. There is a small list of easements required before this project can be constructed. Below is a graphic of the project.
